Helmsdale Station Building

Photographic Record, March 2013

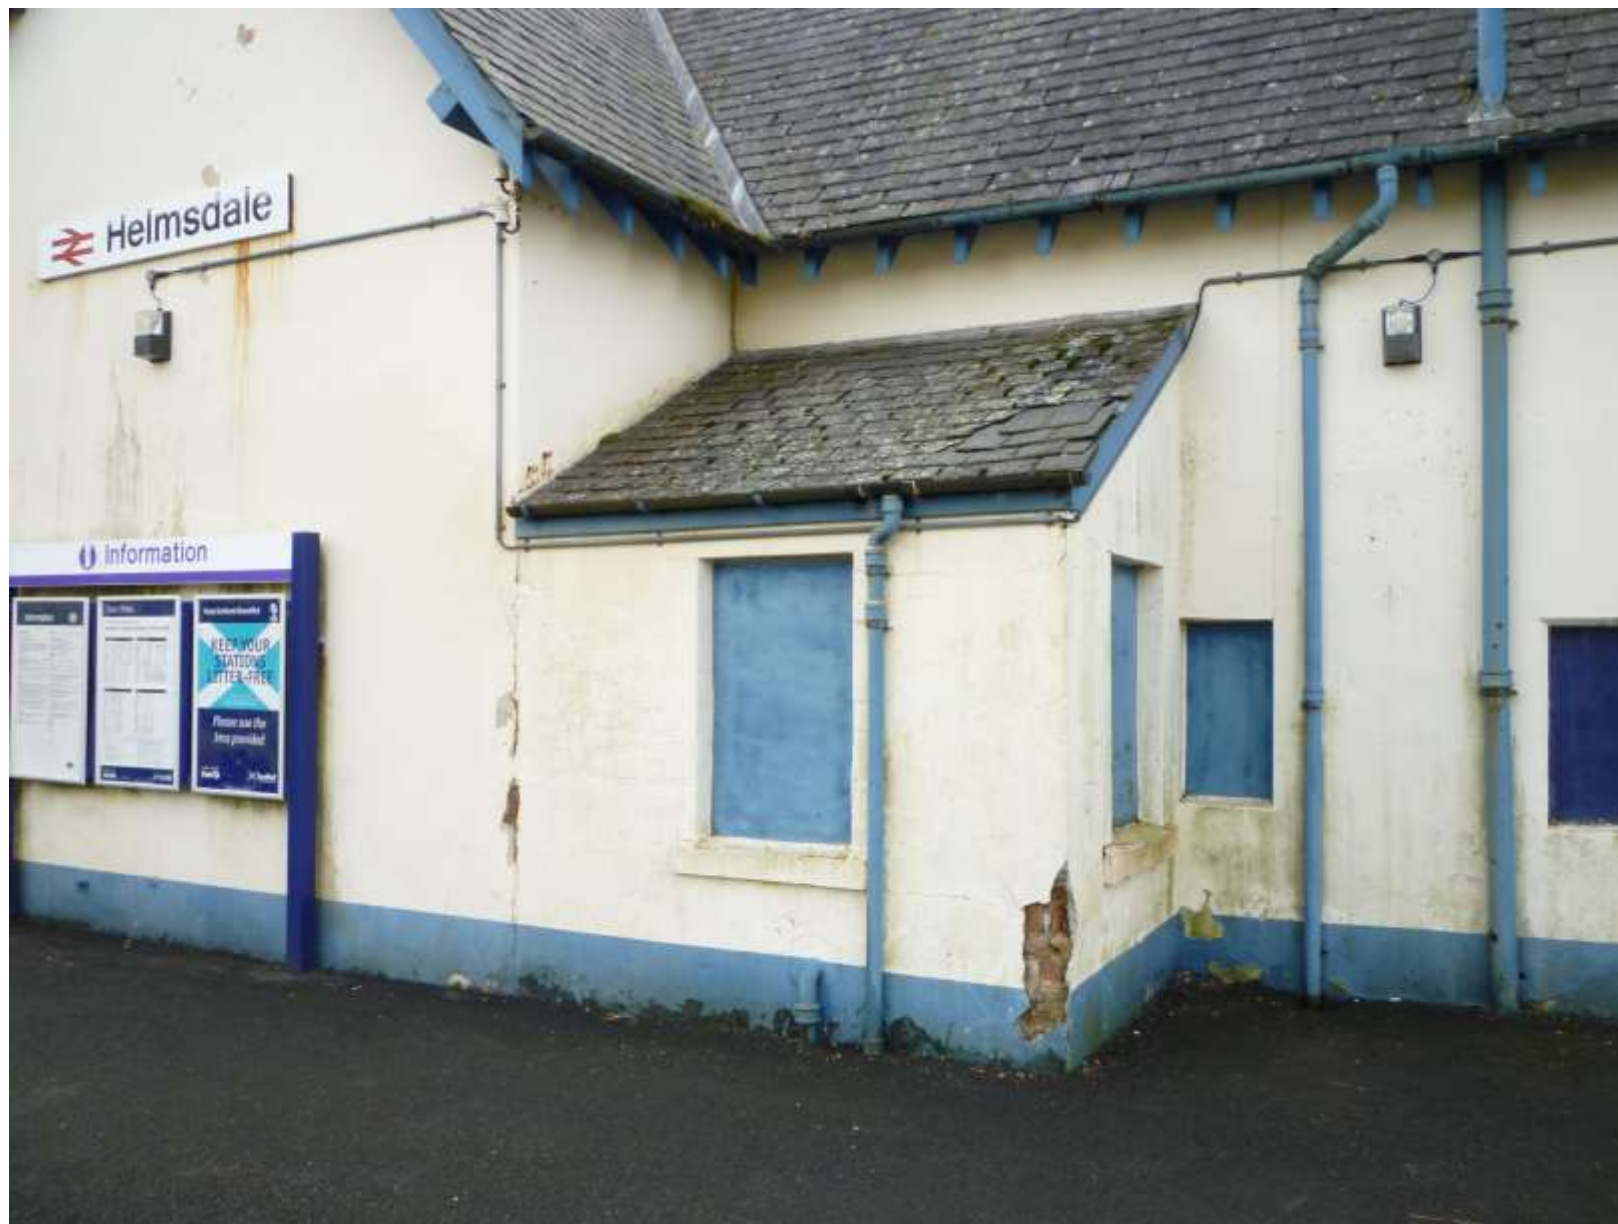
12. East elevation showing detail of scullery annexe, added at unknown date. Behind the damaged render it can be seen that this is brick built, unlike the concrete construction of the rest of the building.

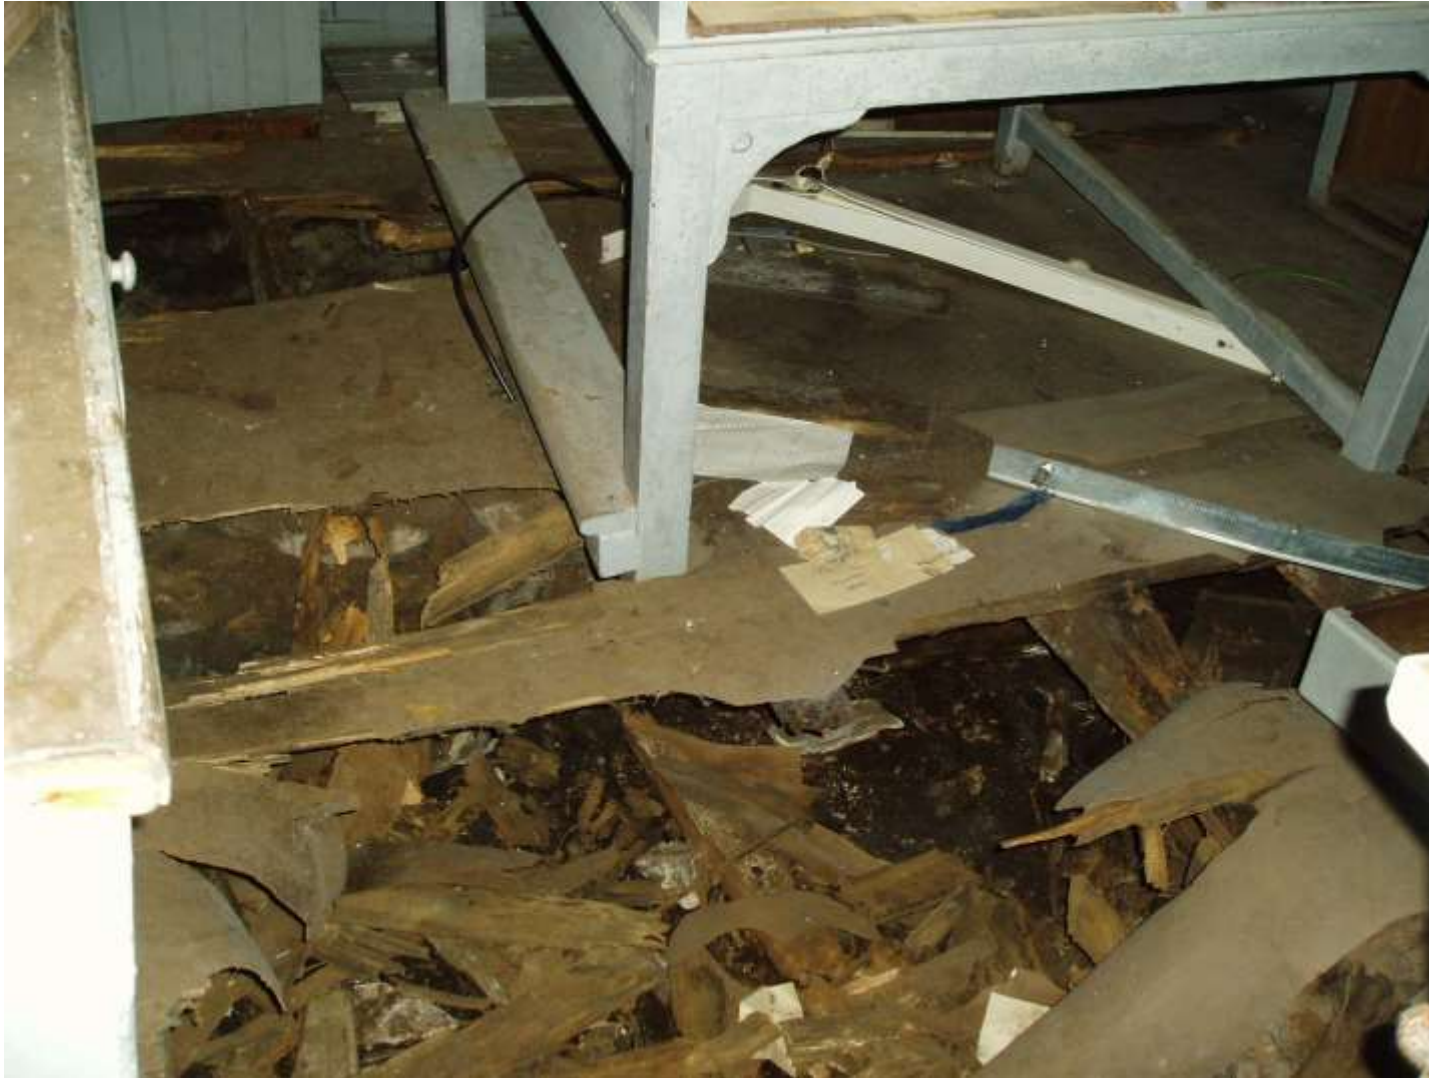
35. In both the office and the store, the suspended floors are rotten and very hazardous. This has restricted the photos in these two areas.

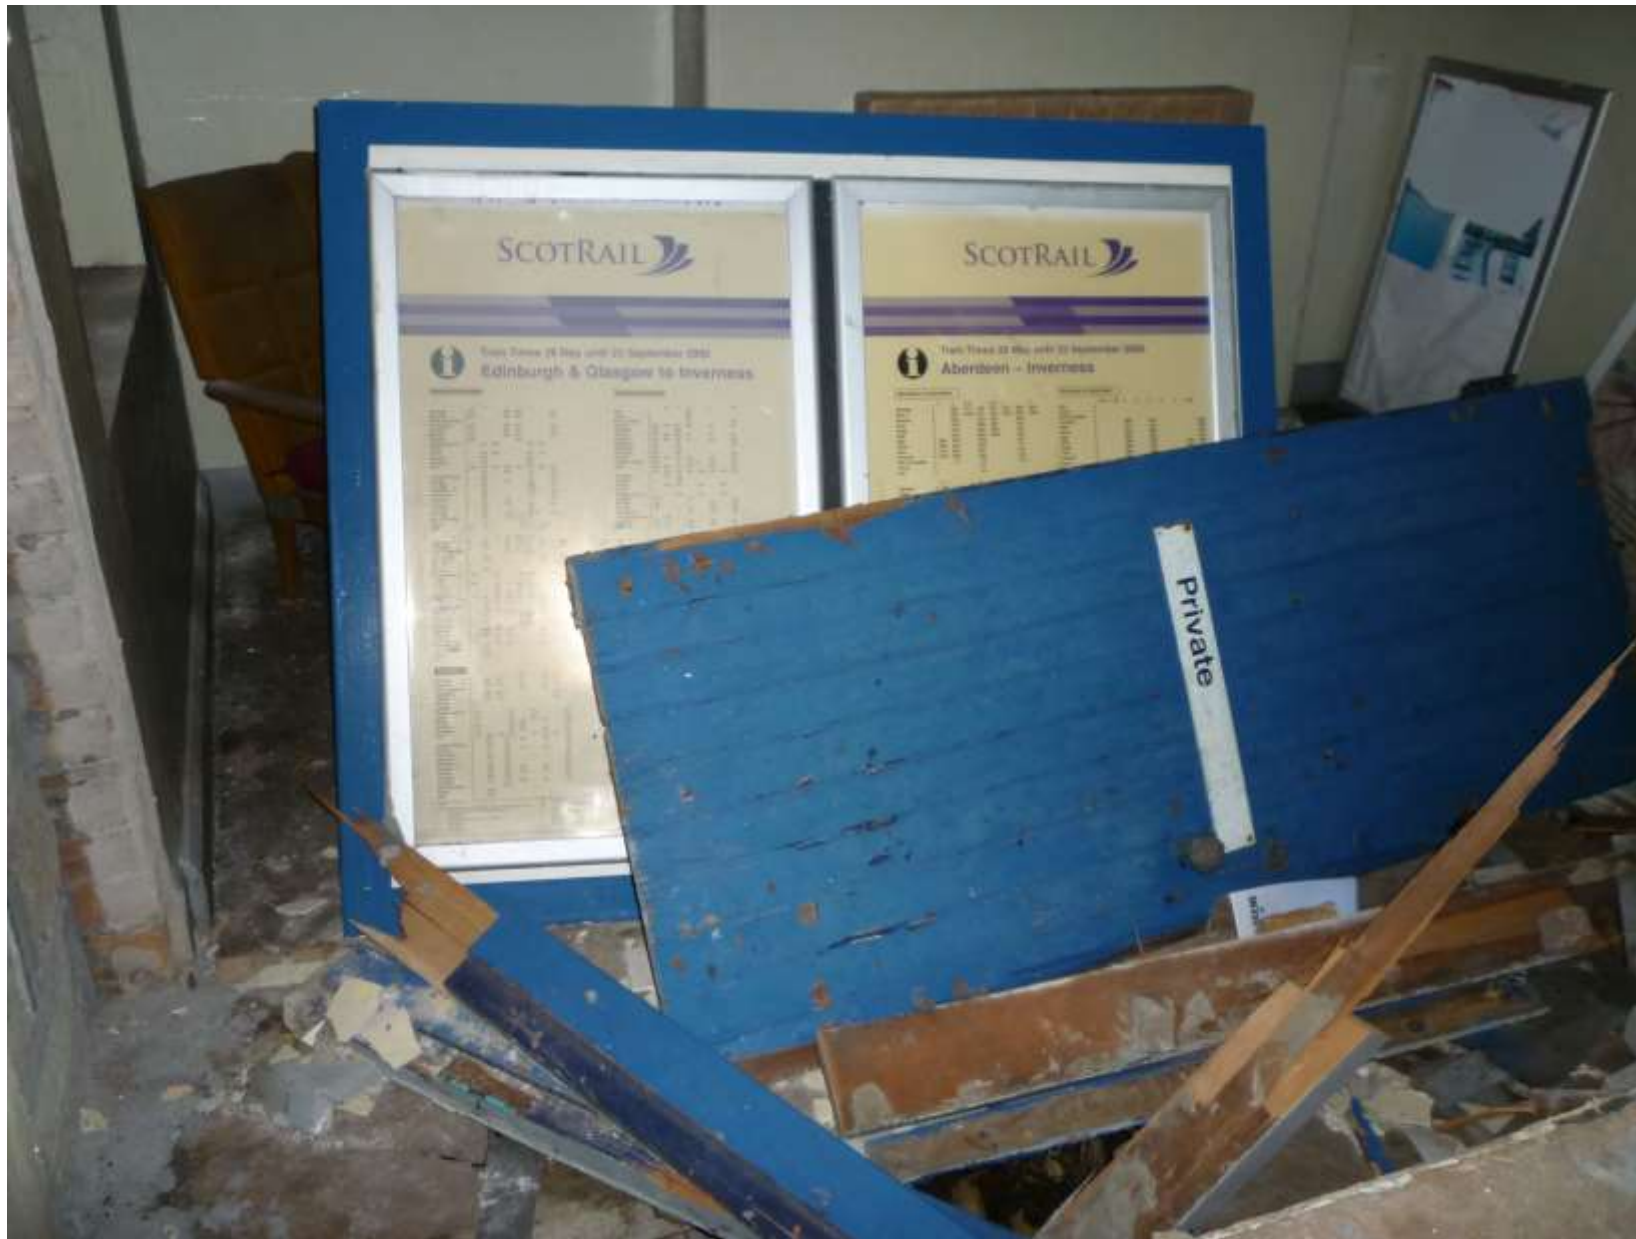
40. Old door frame has been cut up (and it has fallen through the floor!)

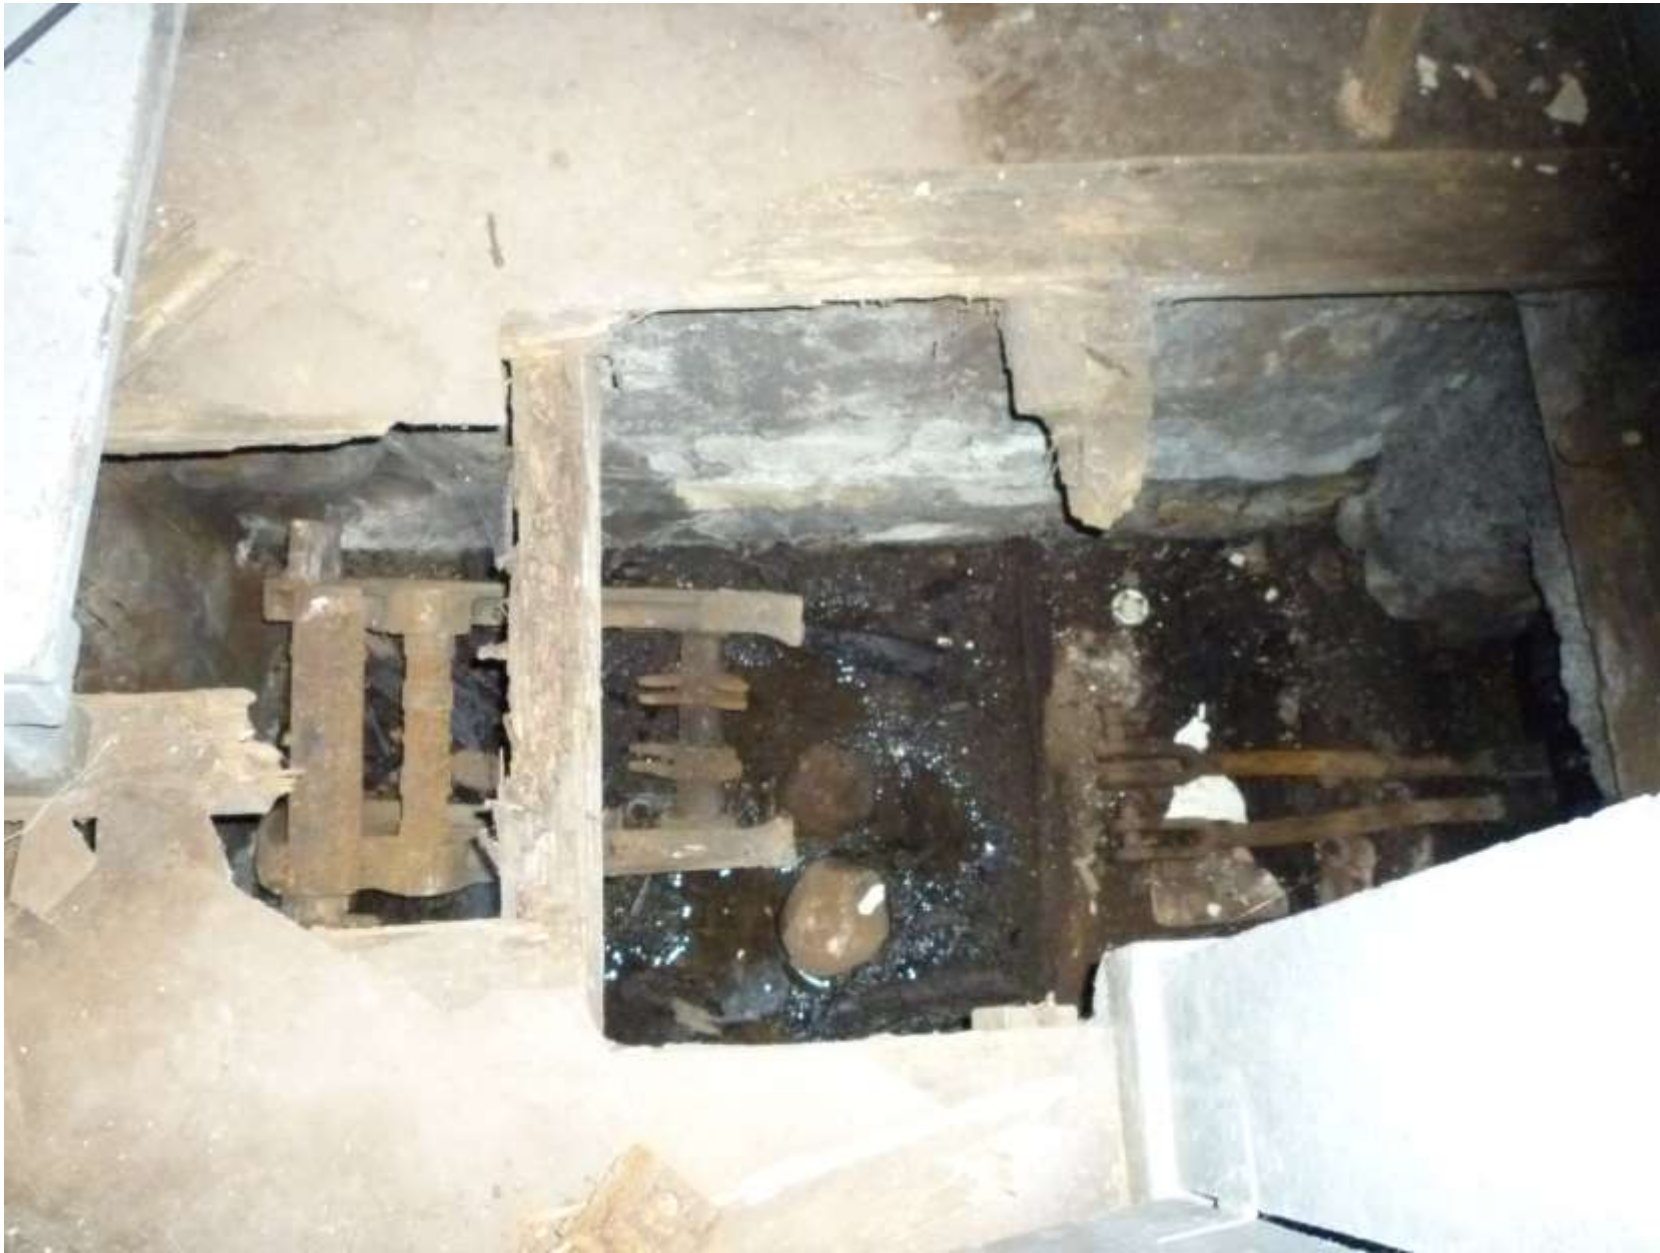
55. Rotten floor reveals hole under west wall. There was once a point or signal lever in the office with under platform tunnel for trackside connection

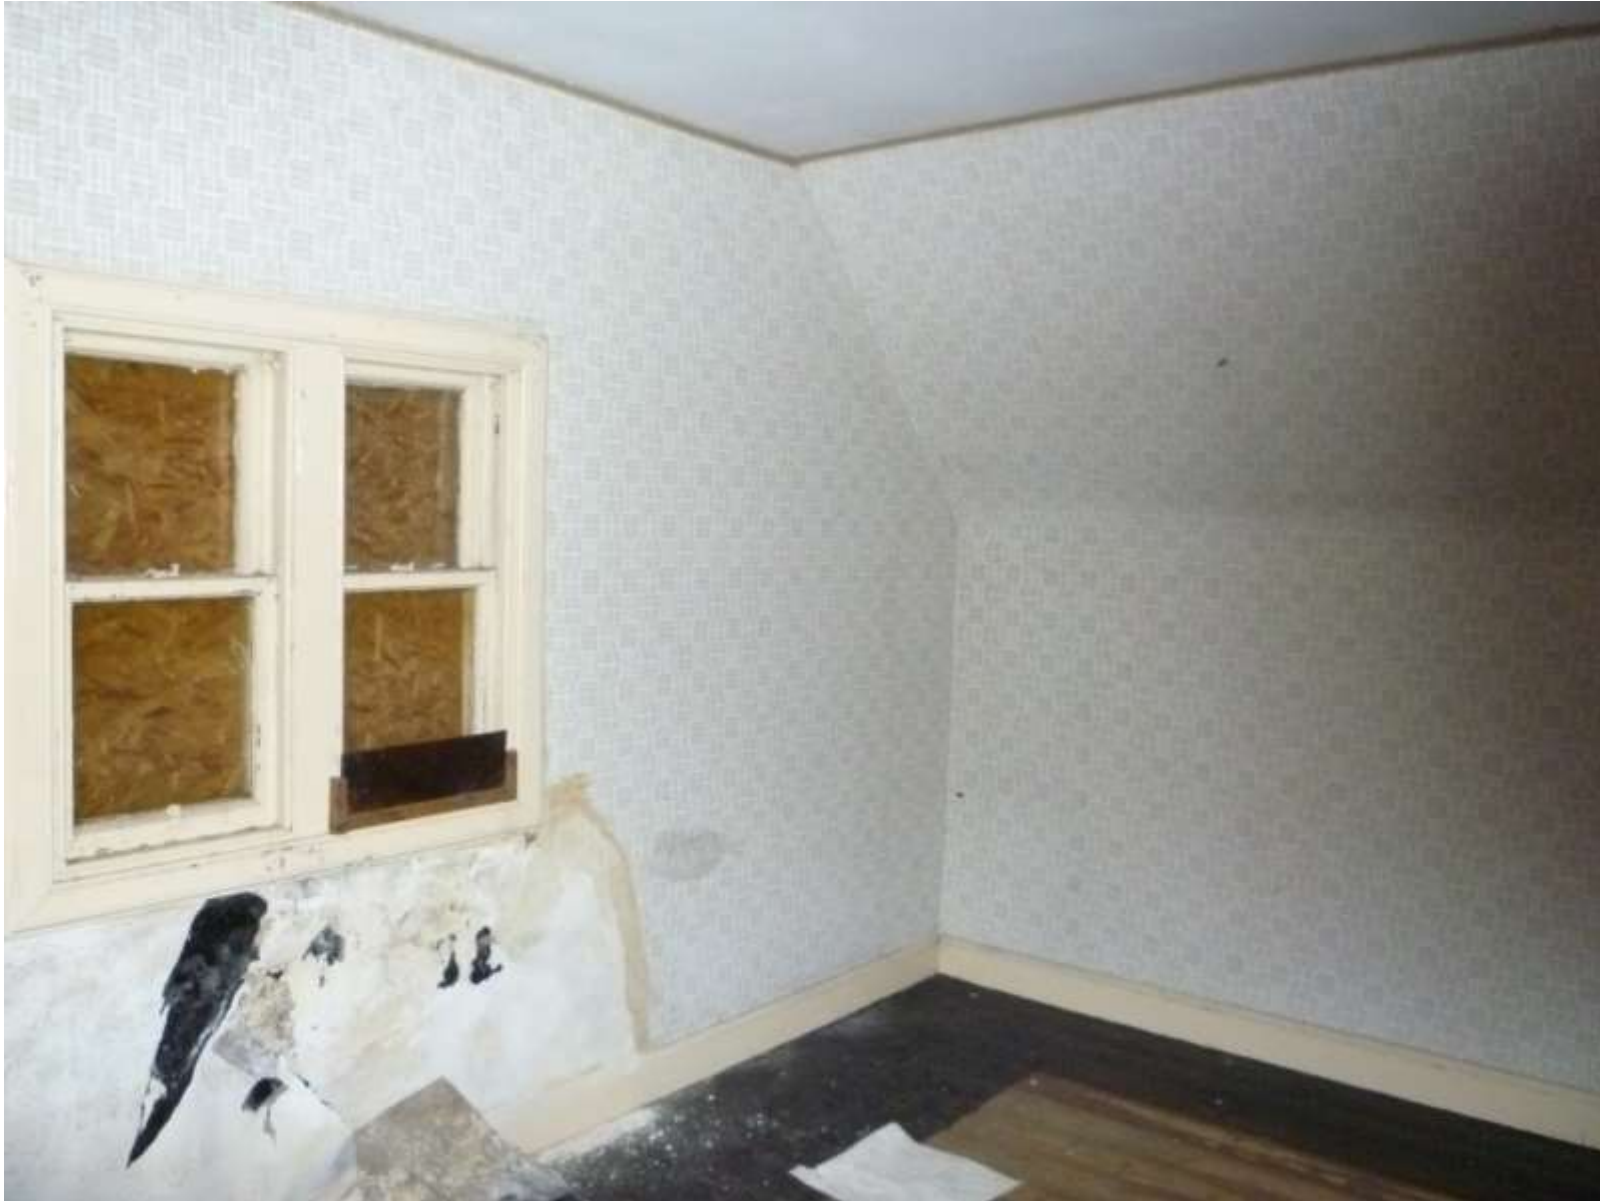
99. Bedroom 1: angles of walls and ceiling above fireplace (as well as long term roof leak)

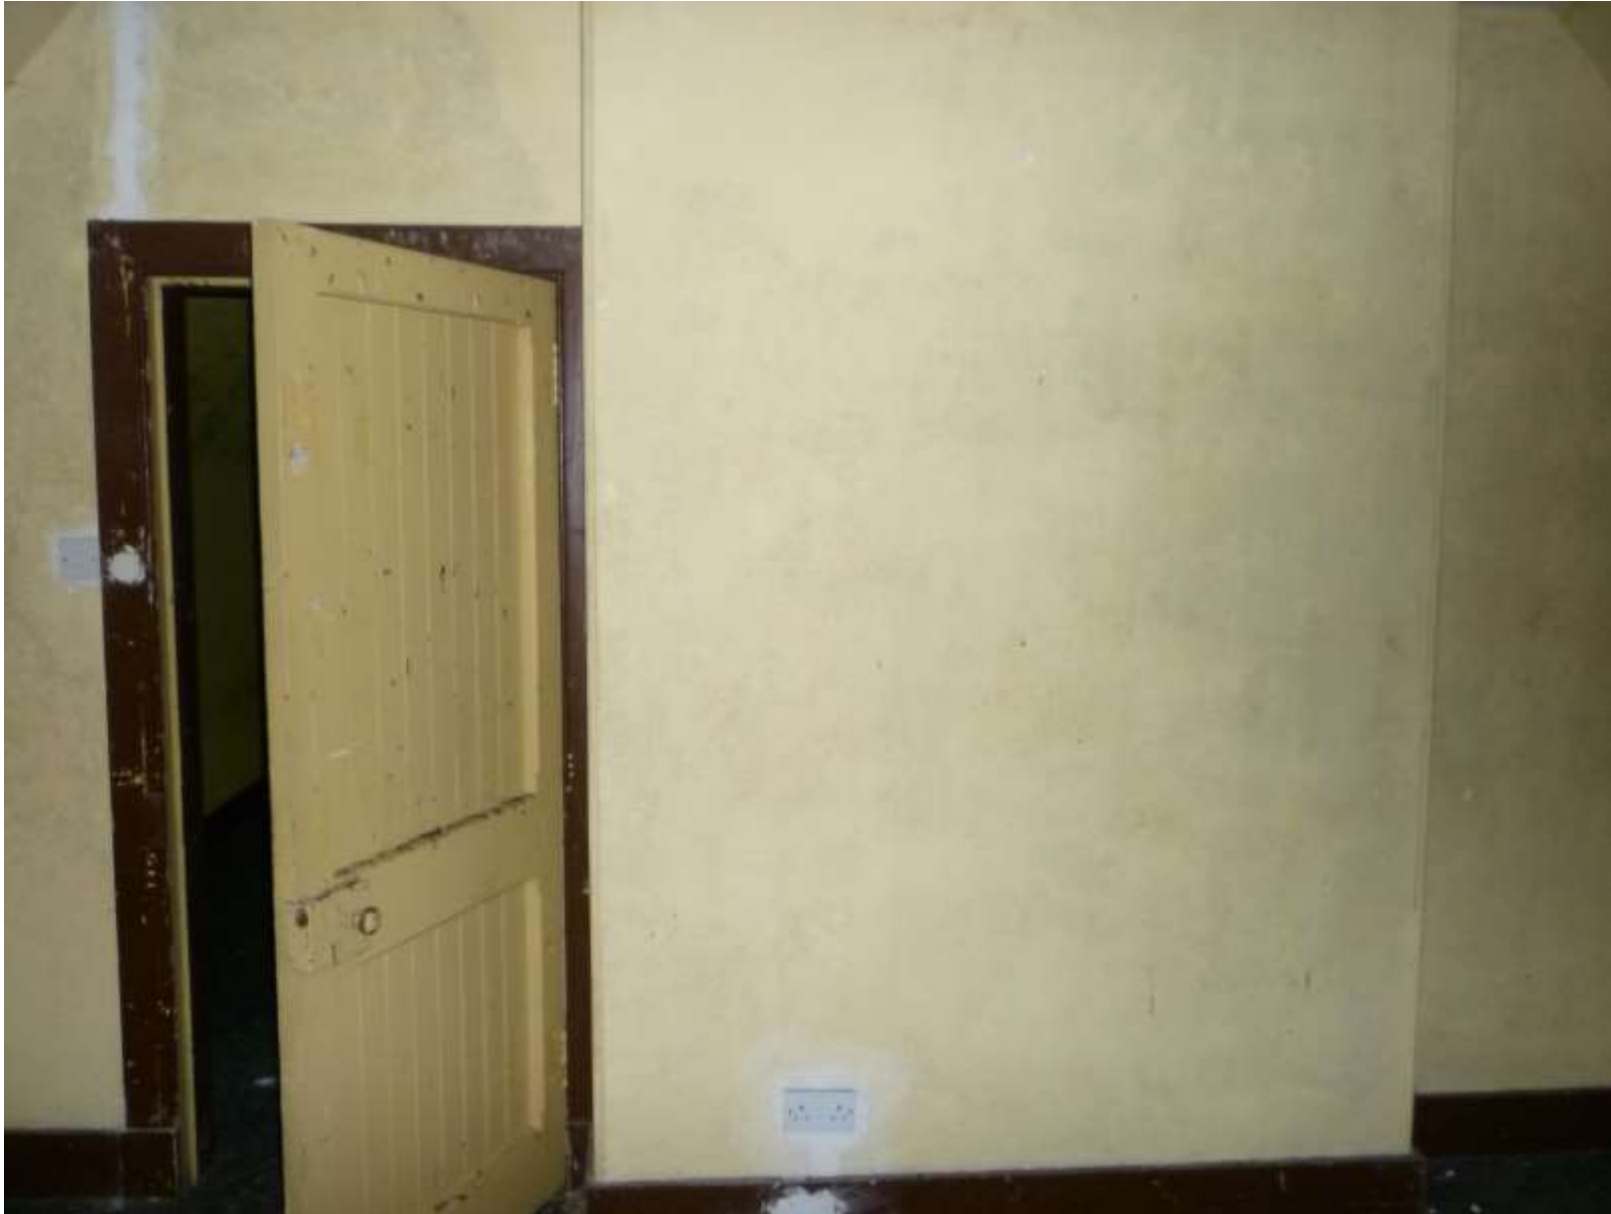
116. Bedroom 4 Floor in NE corner above blocked off stair case outside waiting room (see pic 18). No sign of access 'patch' indicating whole floor must have been replaced since stair access was blocked off.
