Perth Delivery Unit

Infrastructure Maintenance Delivery Manager
Lee Ross

Providing Maintenance and Response
Services for the following:

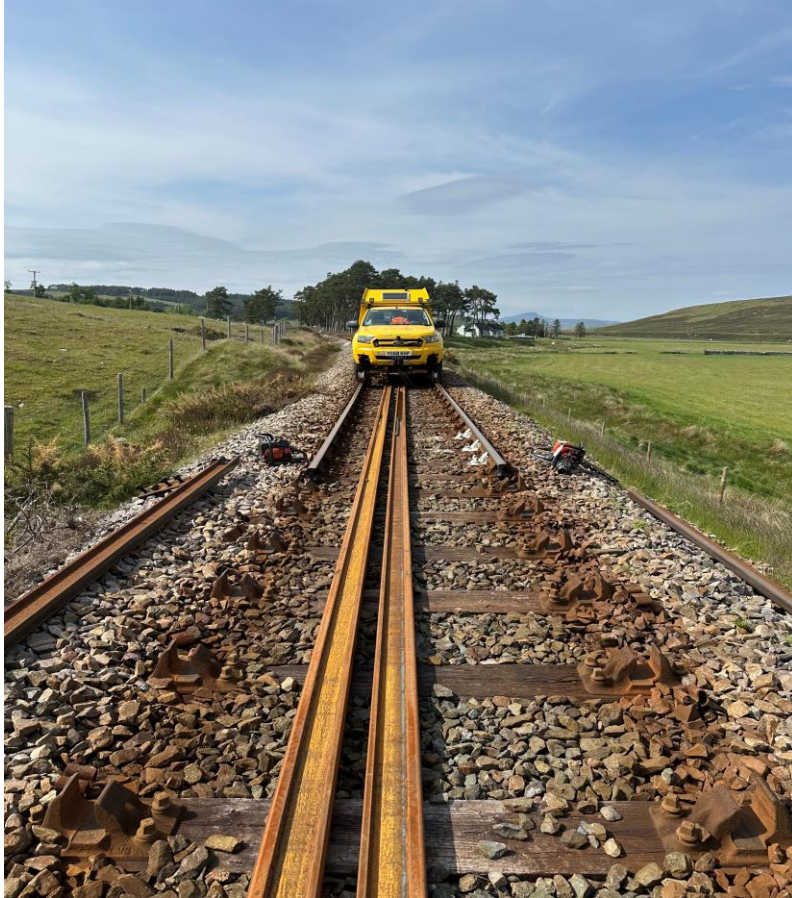
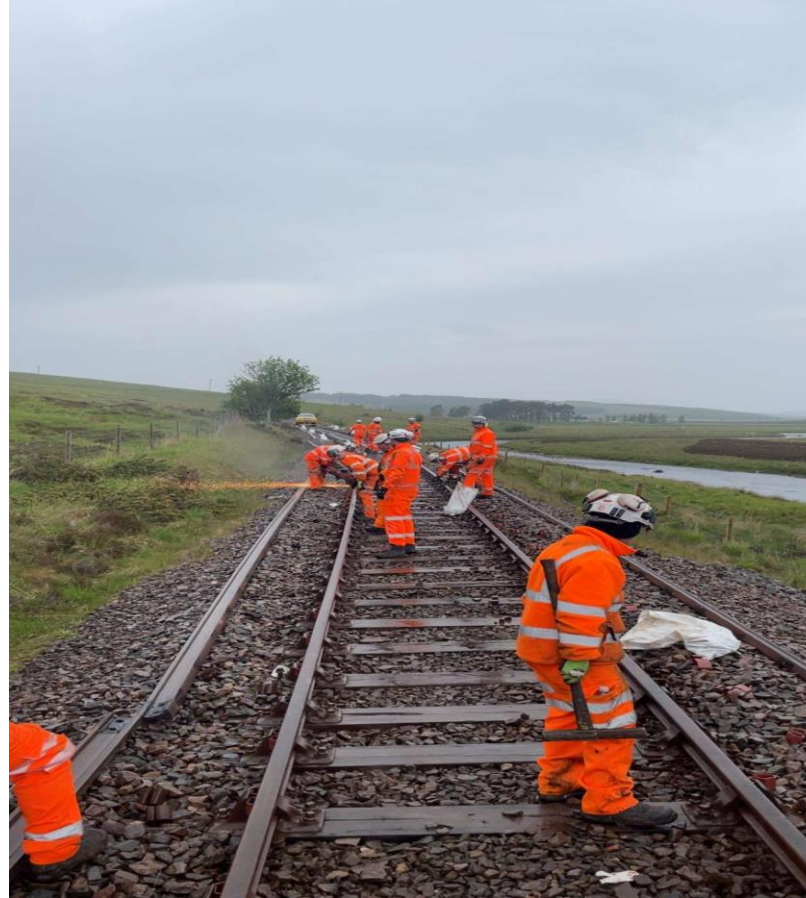
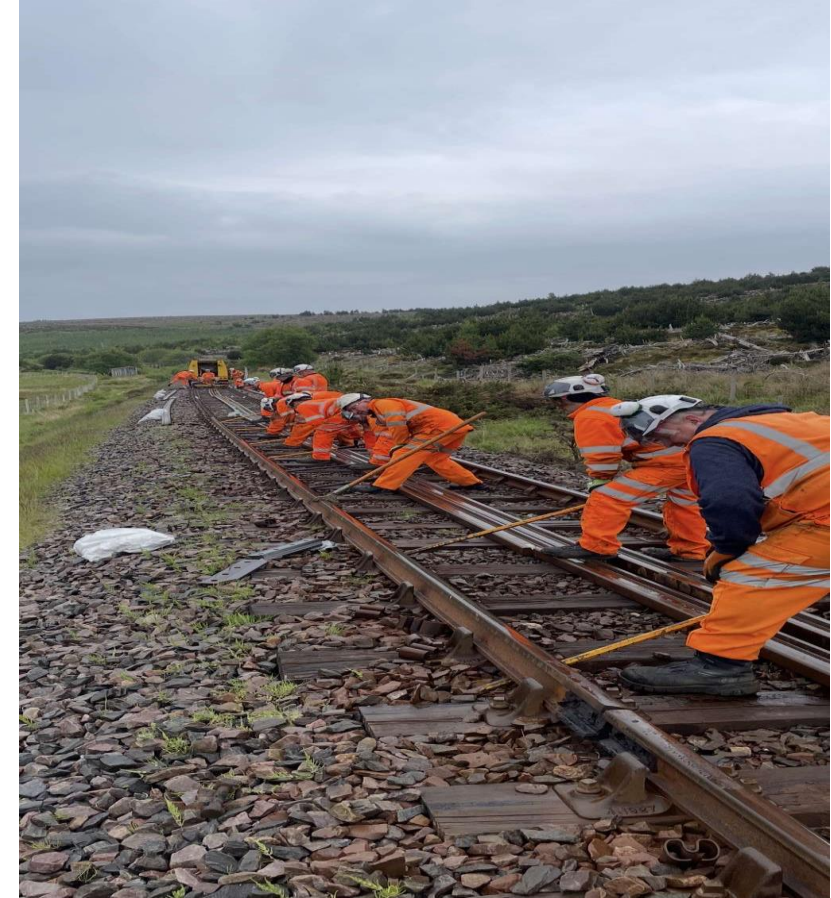
Wet bed removal	497 bays
Lubricate fishplates	16,177 joints
Track patrolling (BVI only)	12,743 miles
Stress CWR	4.86 miles
Unload ballast	6,418 tonnes
Renew rail	3.97 miles
Replace sleepers	1,449 sleepers

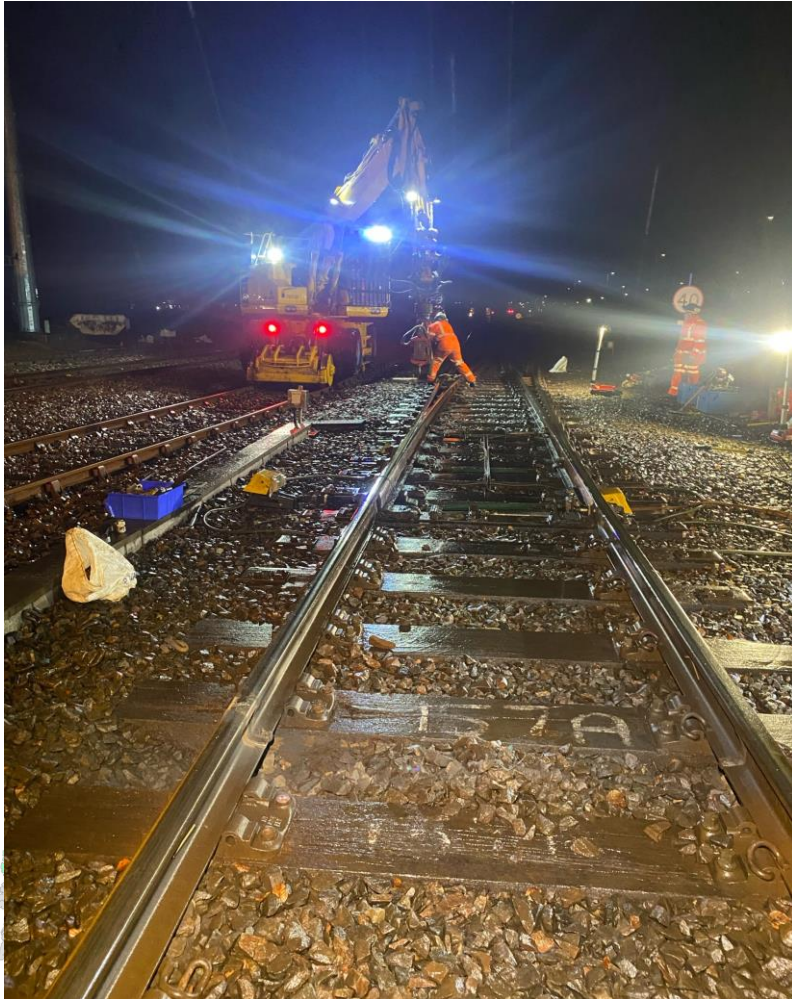
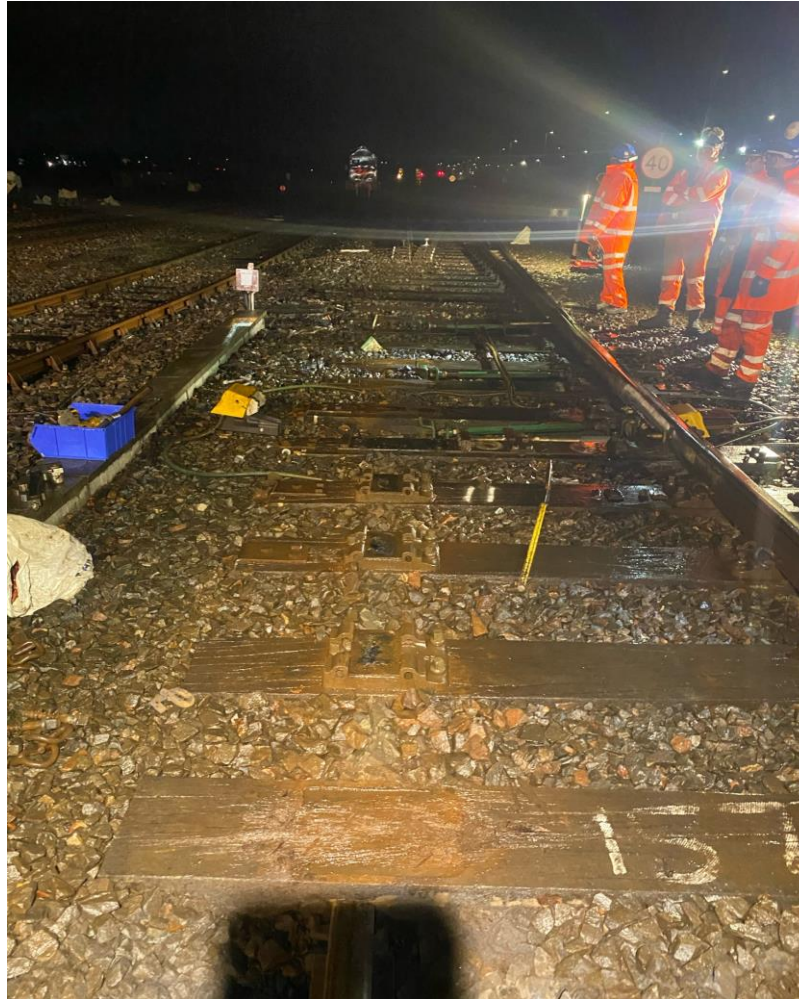
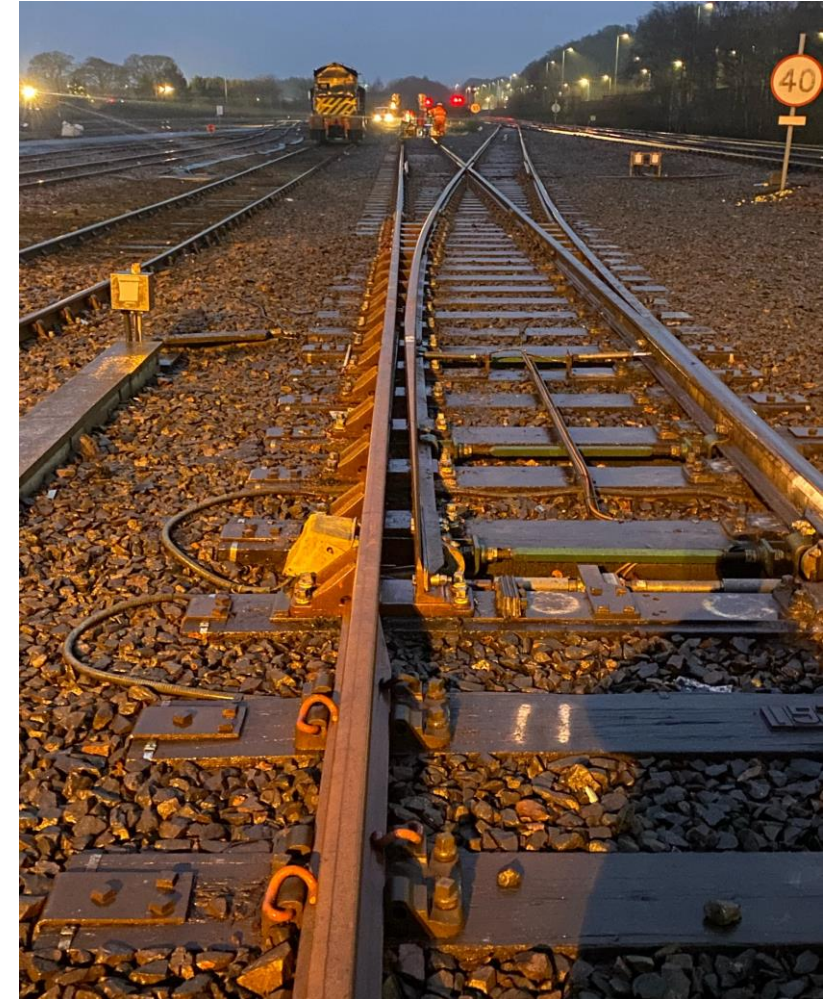
Inverness Station – Renewal of 157A Left Hand half set

Inverness Track and Inverness S&T team replaced the left-hand half set of 157A pts in Inverness Station. Replacement was required due to side wear on the asset, and a requirement for increased inspections. S&T renewed the full clamp lock set. A critical set of points in the station area which control moves from the ScotRail Inverness Depot onto the mainline.

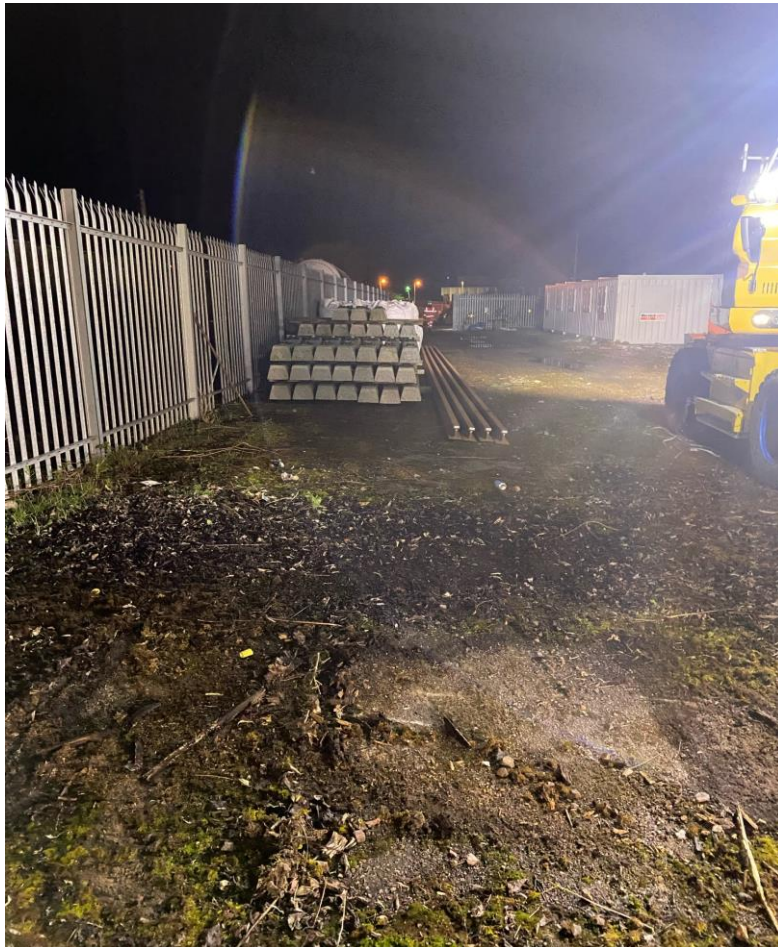
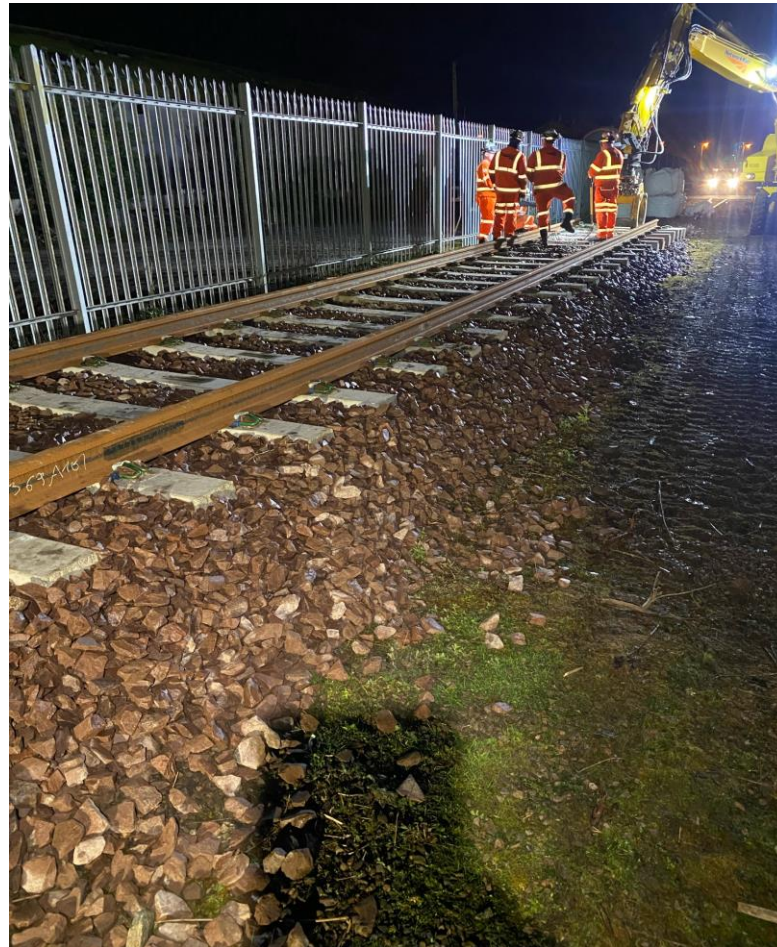
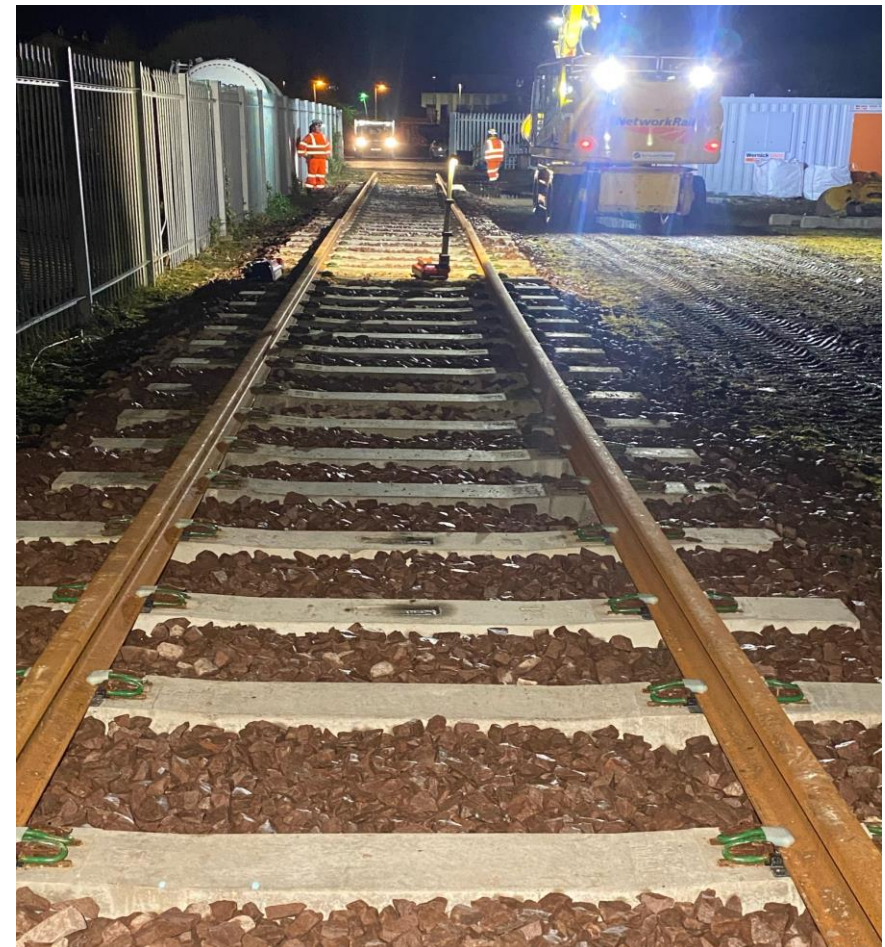
Inverness – Track Training Panel

The Inverness Track Team recently installed a new 40m concrete sleeper test track in Inverness as a sandpit for maintenance training courses for Far North teams. This removes the requirement for the teams to travel to the central belt (Larbert) for practical courses, reducing fatigue, increasing availability for fault response/maintenance, and reducing the financial burden of travelling/hotels. There was also another 5m wooden sleeper panel installed for softwood plant courses.

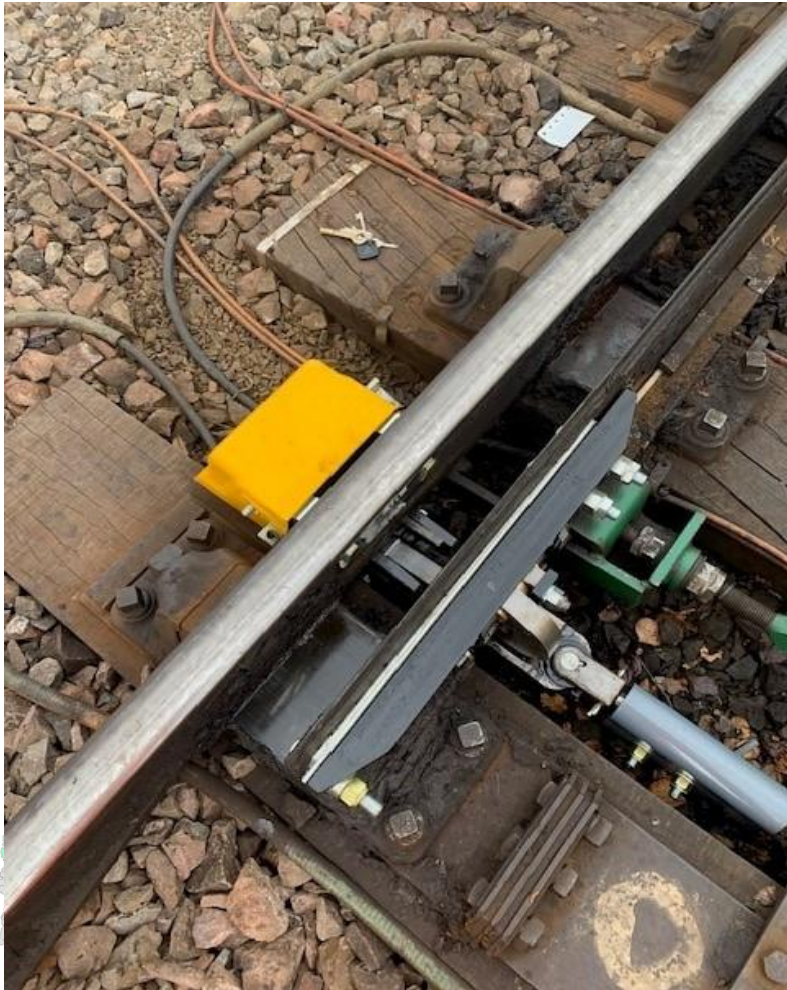
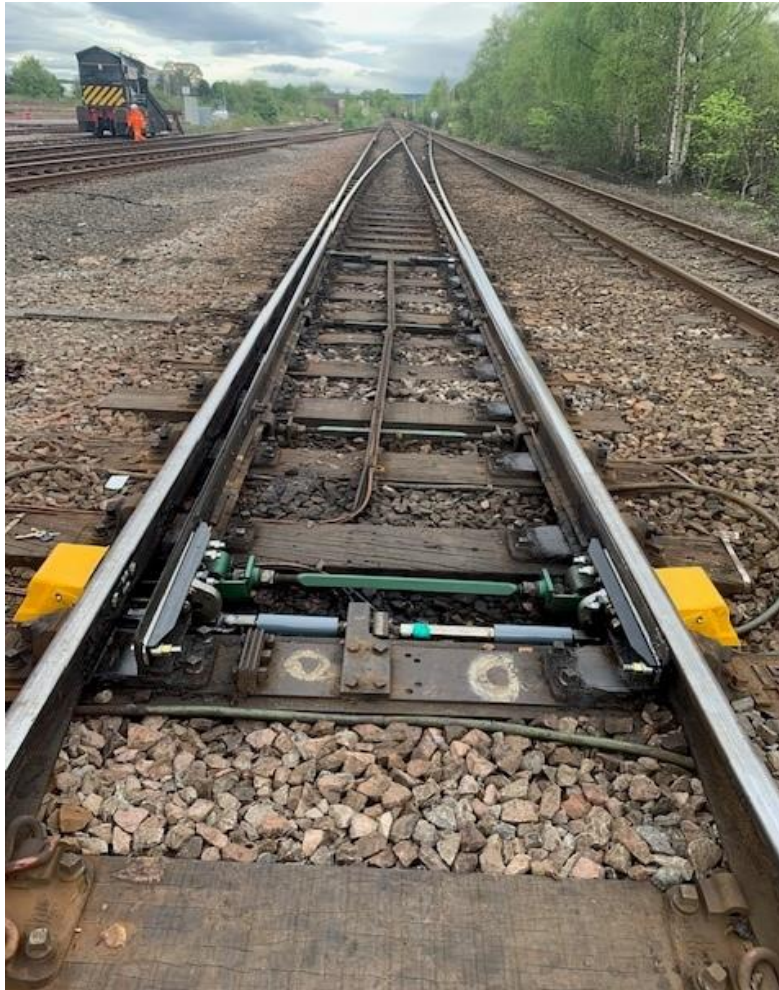
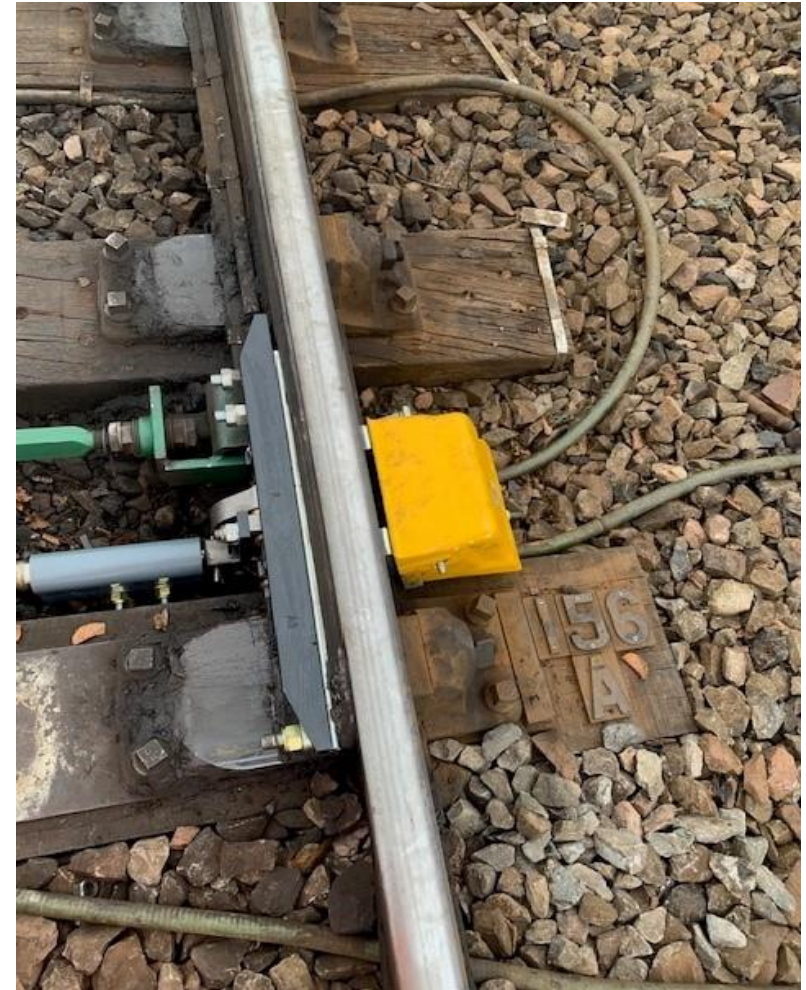
Inverness 156A – Renewal of clamp lock body

Inverness 156A is a critical set of switches used to regulate services and units in and out of Inverness Station and Inverness Yards/Depots. Recent reliability issues led to multiple components being continually adjusted. Despite these interventions, reliability remained a concern. The decision was made to renew the full clamp lock assembly to remove the reliability risk. Delivered internally by Inverness S&T team.

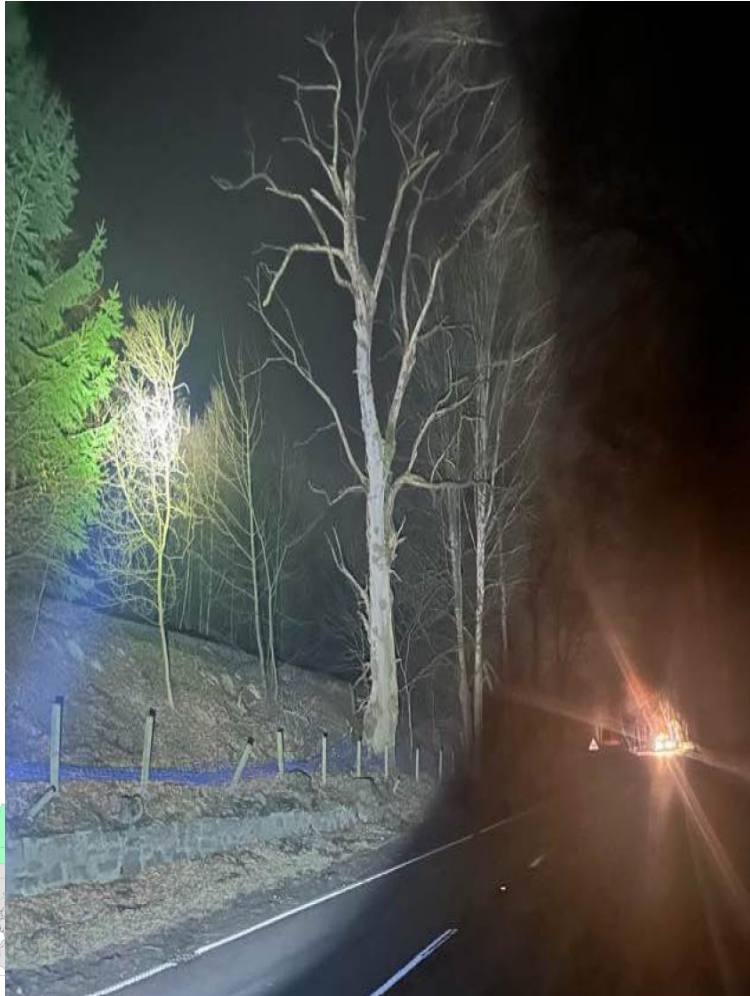
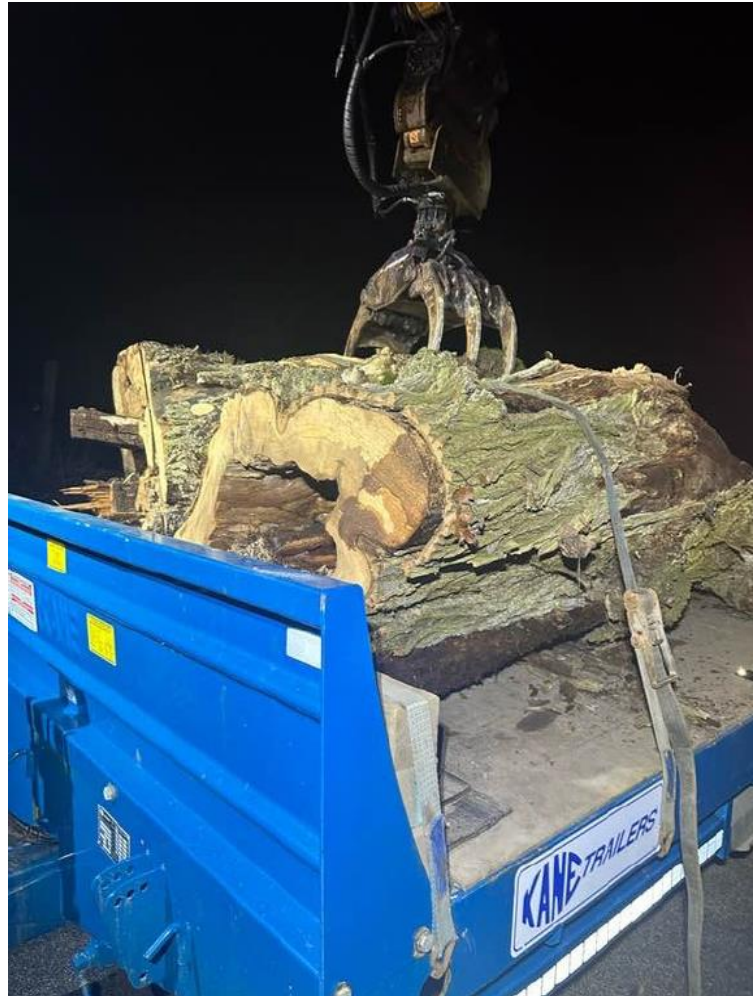
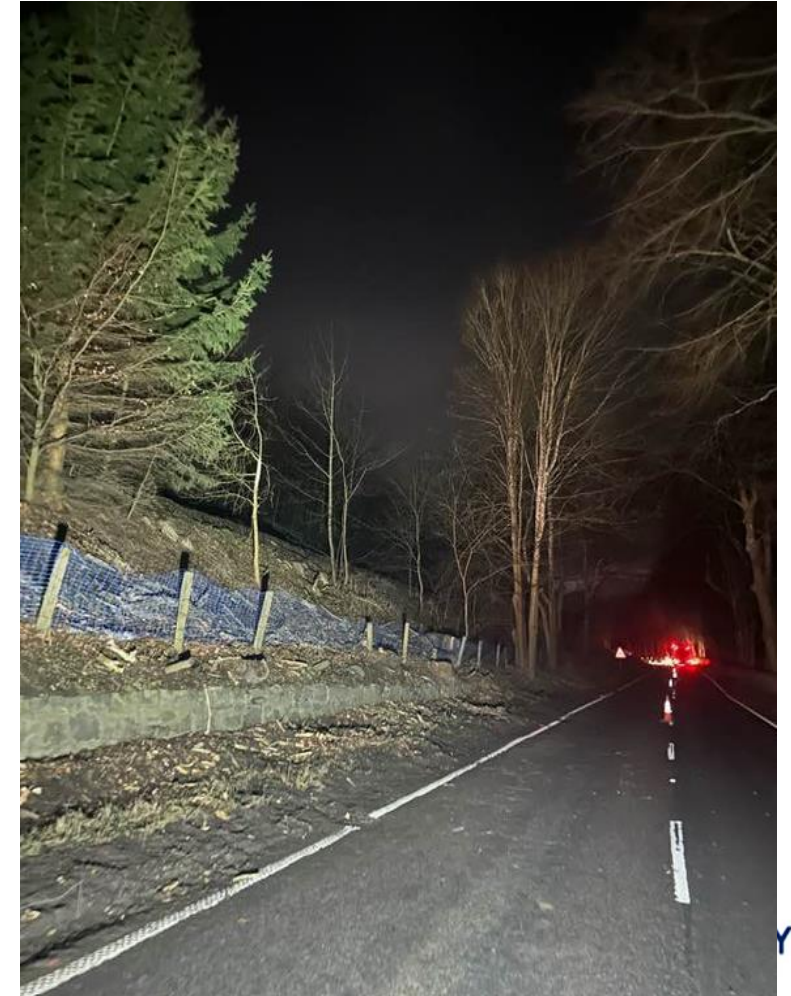
Dangerous Tree Removal – Inverurie (ANI1, 20m1649y)

Prior to weather events, all known hazardous trees are surveyed to ensure that their condition has not deteriorated. If health of tree or surrounding land has worsened, then they are removed .

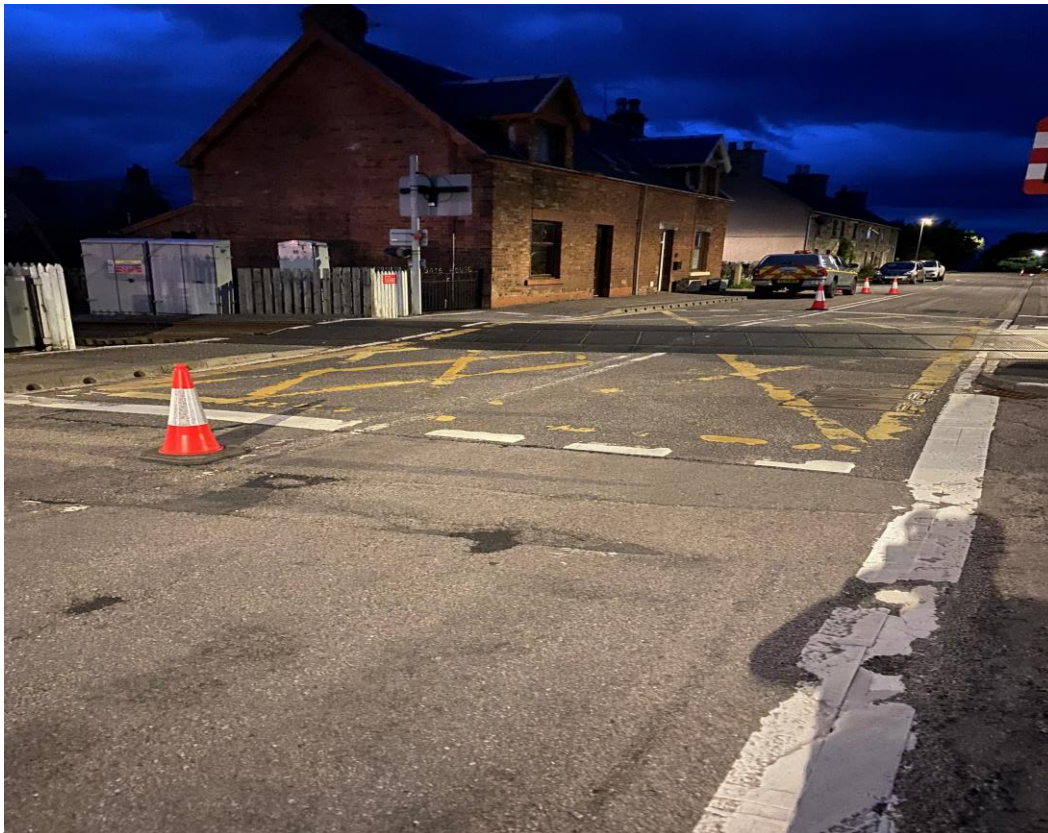
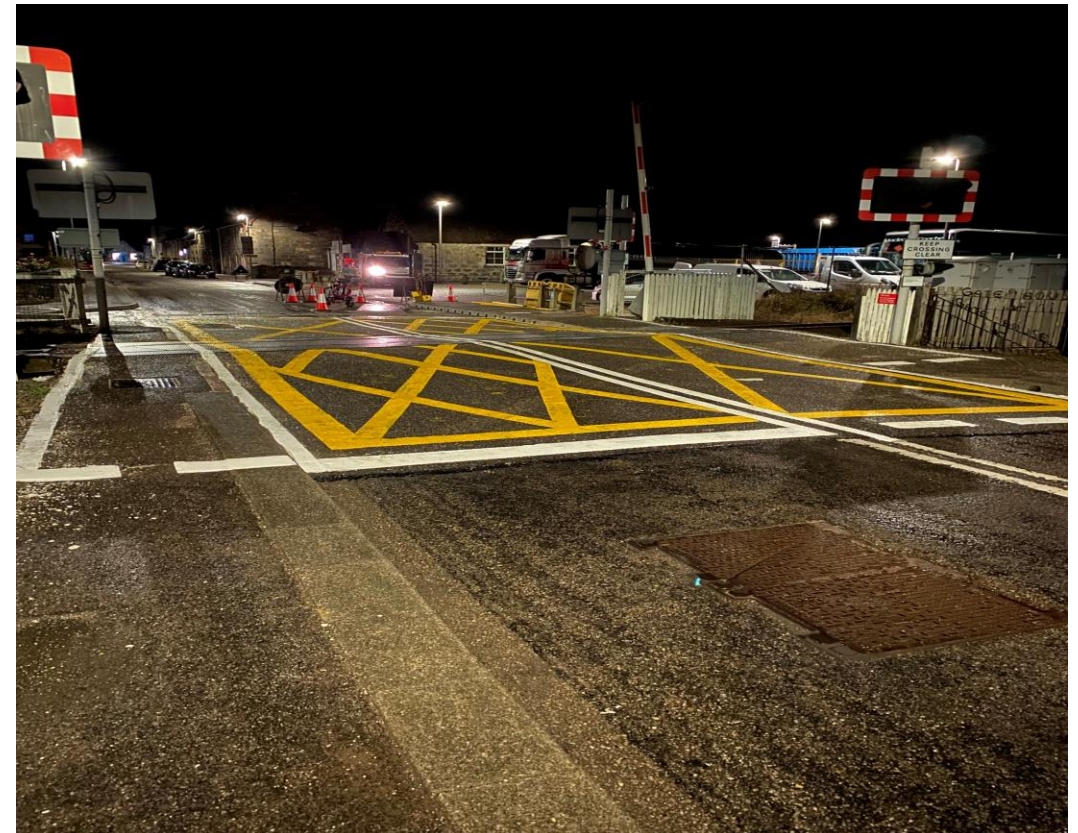
Brora AOCL+B level crossing, WCK – line refresh

Off Track teams are responsible for a large amount of Level Crossings. At such a critical interface with road users, it is imperative that the surface is regularly maintained to ensure user safety and minimise user error or misuse. Working with local supplier the Off Track team purchased the equipment, sourced training and now deliver the re-lining in house maximising efficiencies and keeping money in the railway for further re-investment.

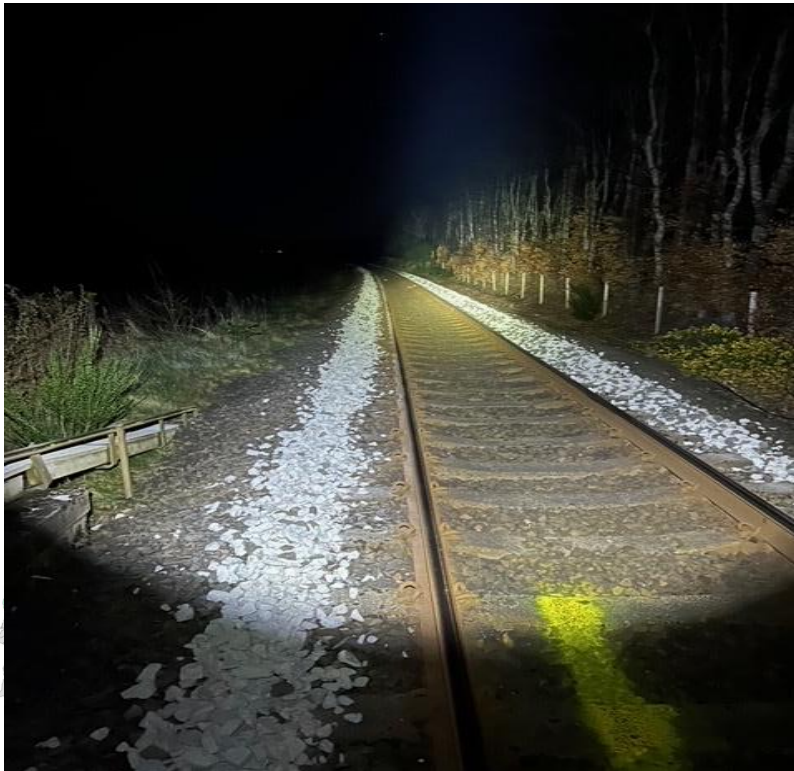
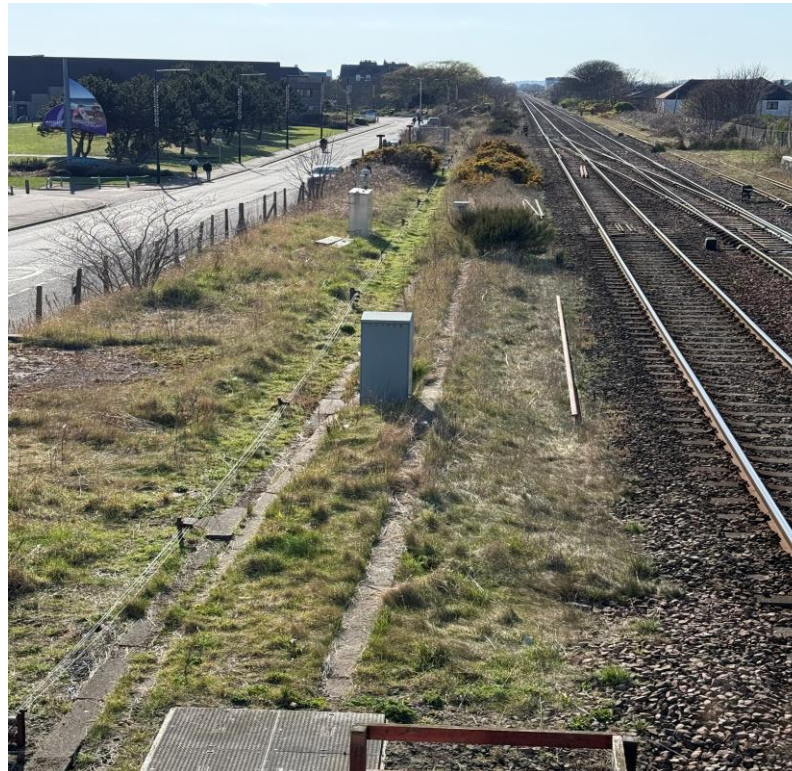
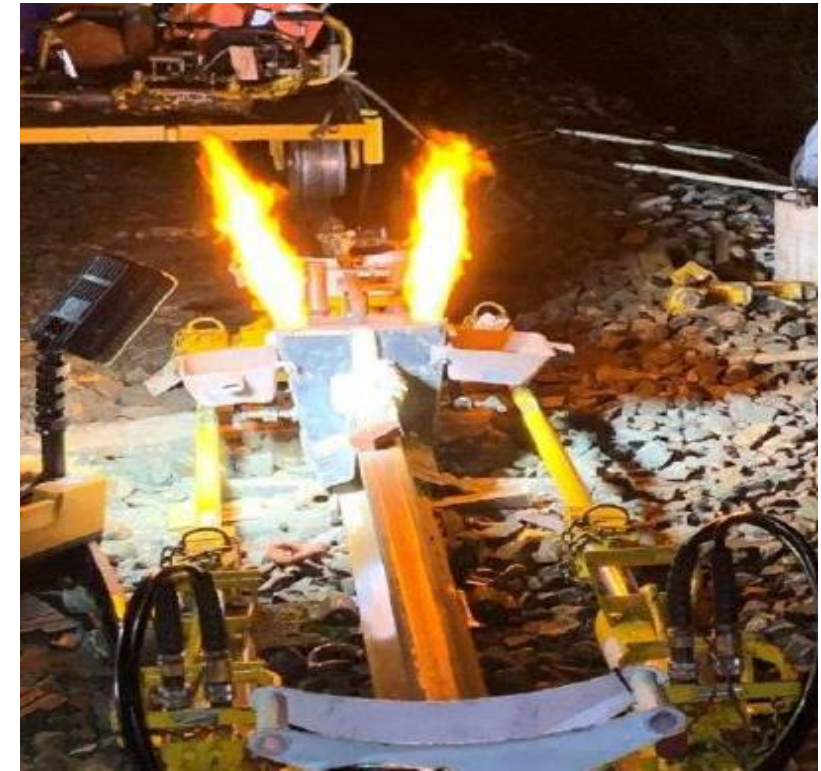
Hot Weather preparations Perth DU – Numbers since Nov'24 (ongoing)

5,336T of ballast dropped

47.11miles of ballast regulated

8.29miles of rail stressed

514 wet beds removed

2,280 IBJs inspected (173 refurbed)

237 adjustment switches inspected

309 adjustment switches lubricated

24,828 pairs of fishplates lubricated

6,746 joint closure surveys

256,500m² of vegetation removed for Level Crossing, Signal Sighting, Mechanical Signal Wire Runs

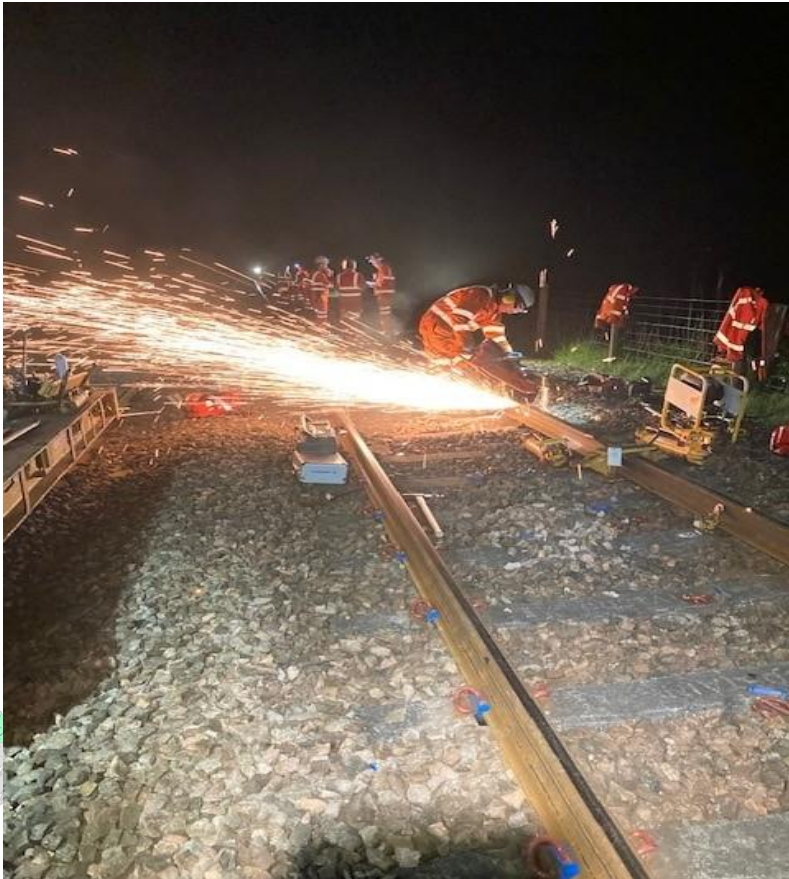
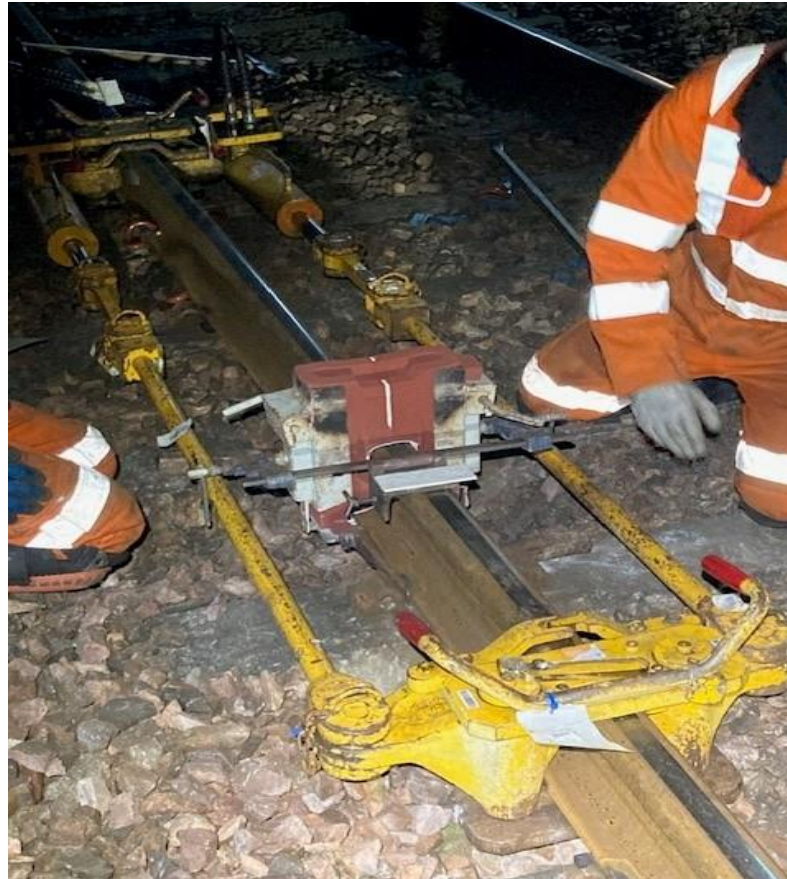
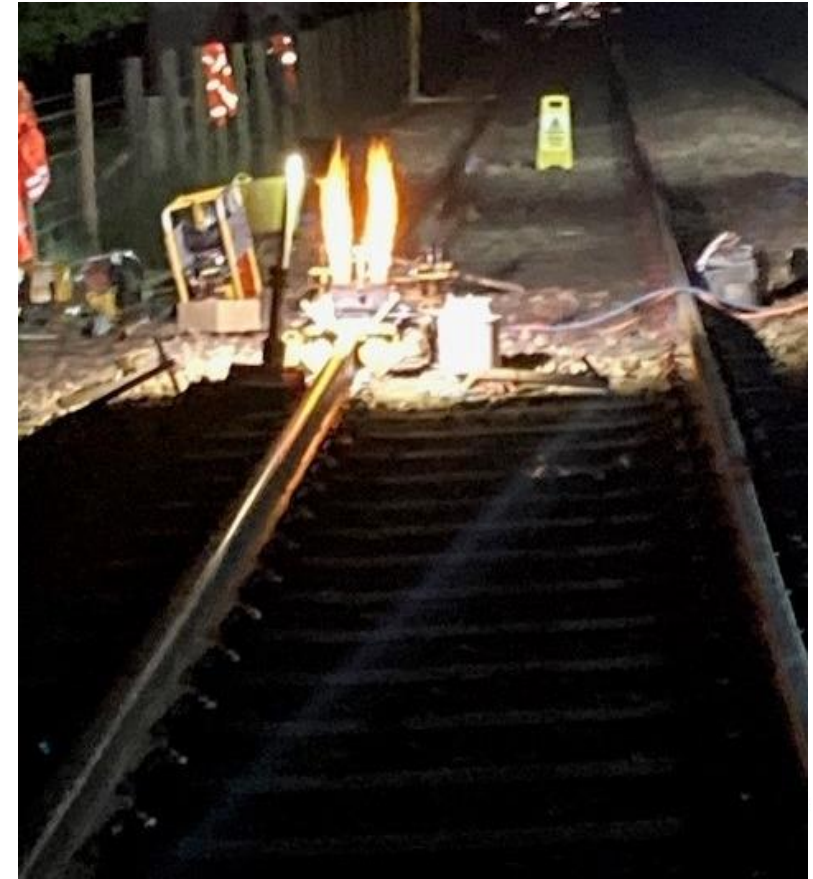
Stressing – Hot Weather Preparations

To minimise risks of track buckles, rail breaks or weld failures, CWR should be installed where no thermal stresses exist within the rail. British Rail determined CWR is, most often, in a stress-free state between 21°C and 27°C. However, maintenance takes place at night where rail temperatures are considerably lower. Consequently, when installed, rail length is adjusted using hydraulic tensors to compensate. Implementing mandated stressing procedures ensure compressive and tensile forces, caused by thermal movement, are controlled. Effective CRT management means that the requirement for heat related ESRs is greatly reduced.

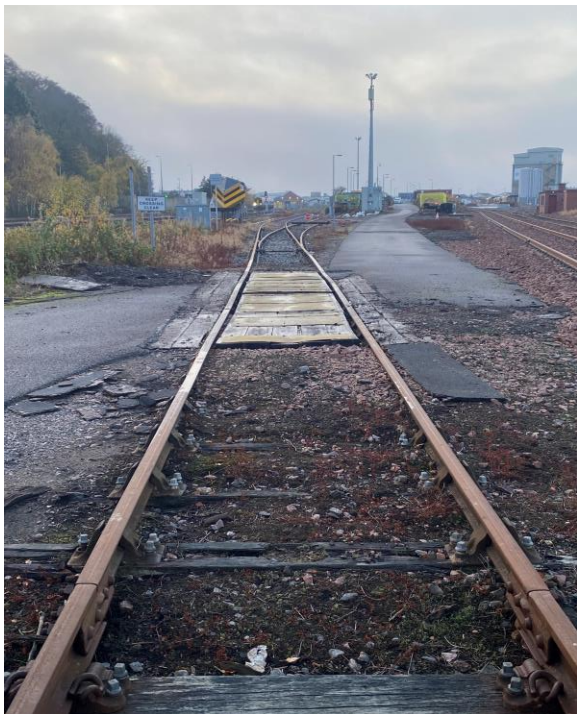
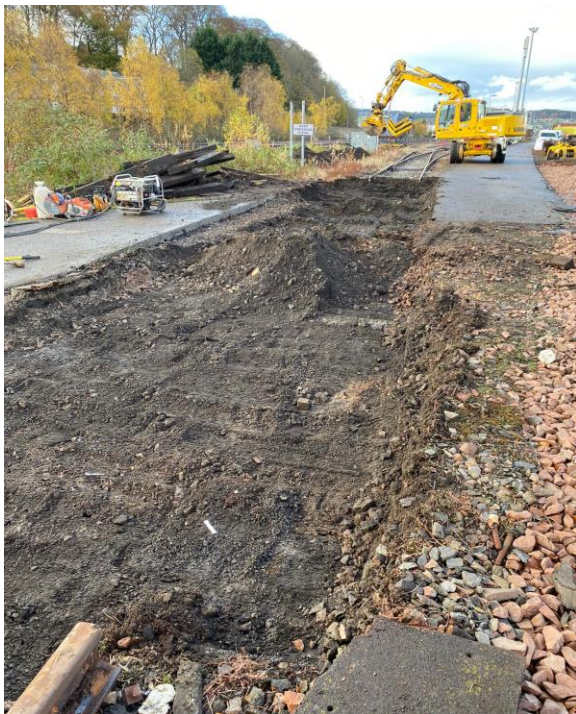
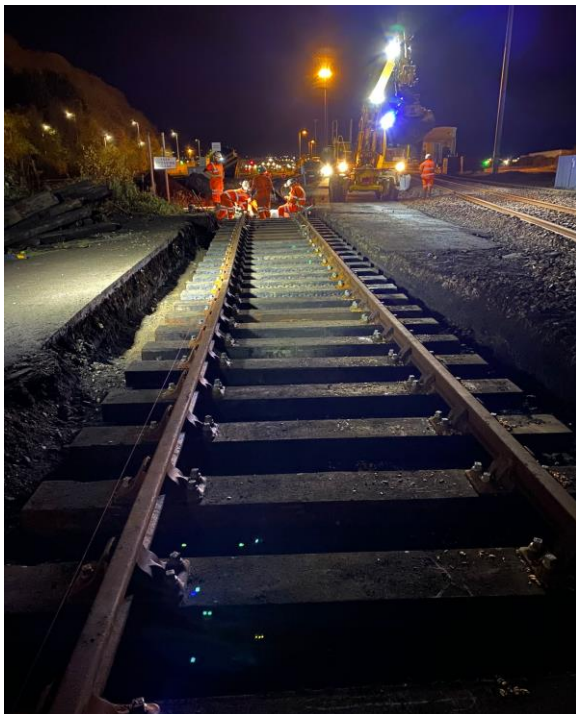
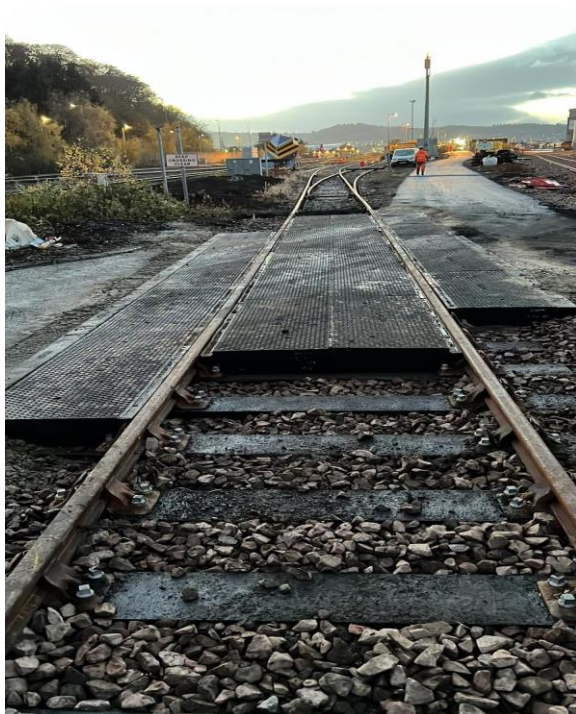
Inverness Station – Right Time Departures

The finishing touches to a new connection from the Inverness WH Malcolm's yard into the Inverness Freight yard was completed by Inverness and Dingwall Track teams. This work removed the need for the Tesco Freight Train to shunt onto the mainline whilst loading containers at Millburn Junction, reducing Signaller workload and increasing the safety and efficiency of loading manoeuvres. This also reduced the risk of services being delayed by shunting moves. The track panel which was removed contained 85lb rail from 1929.

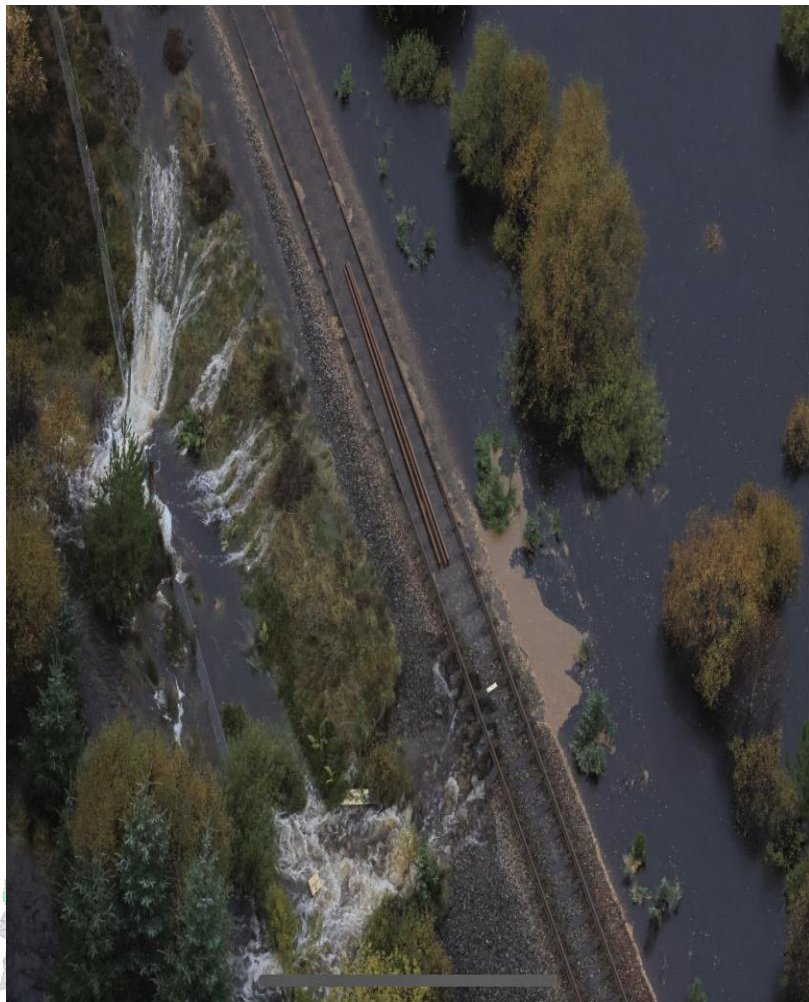
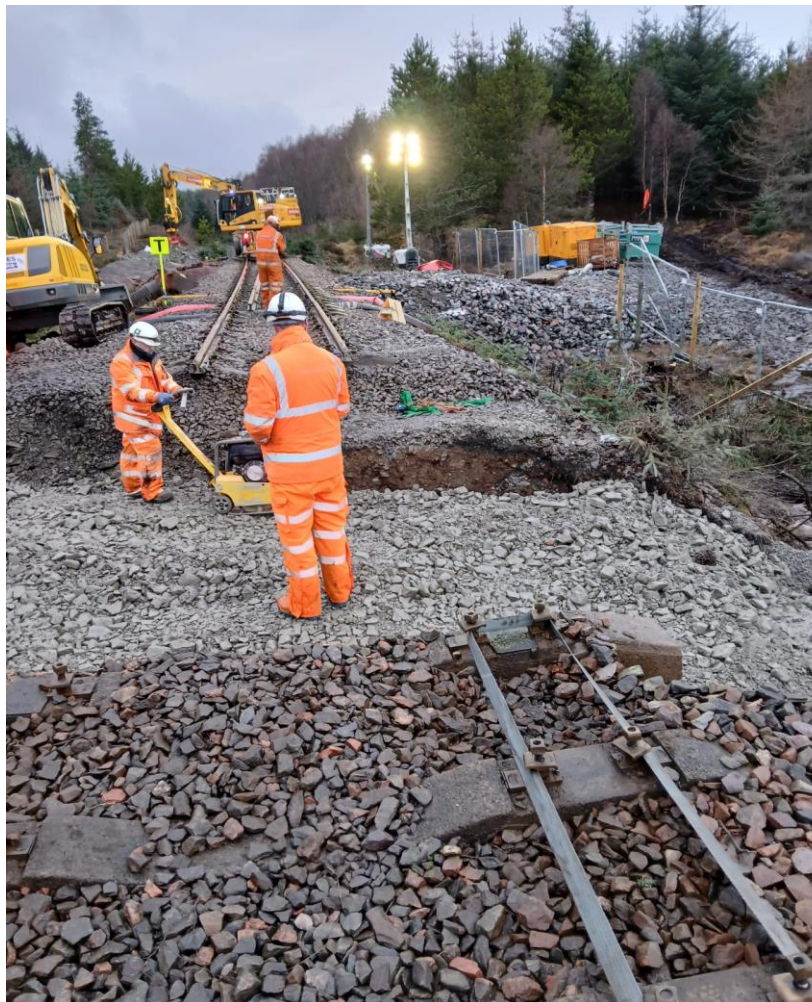
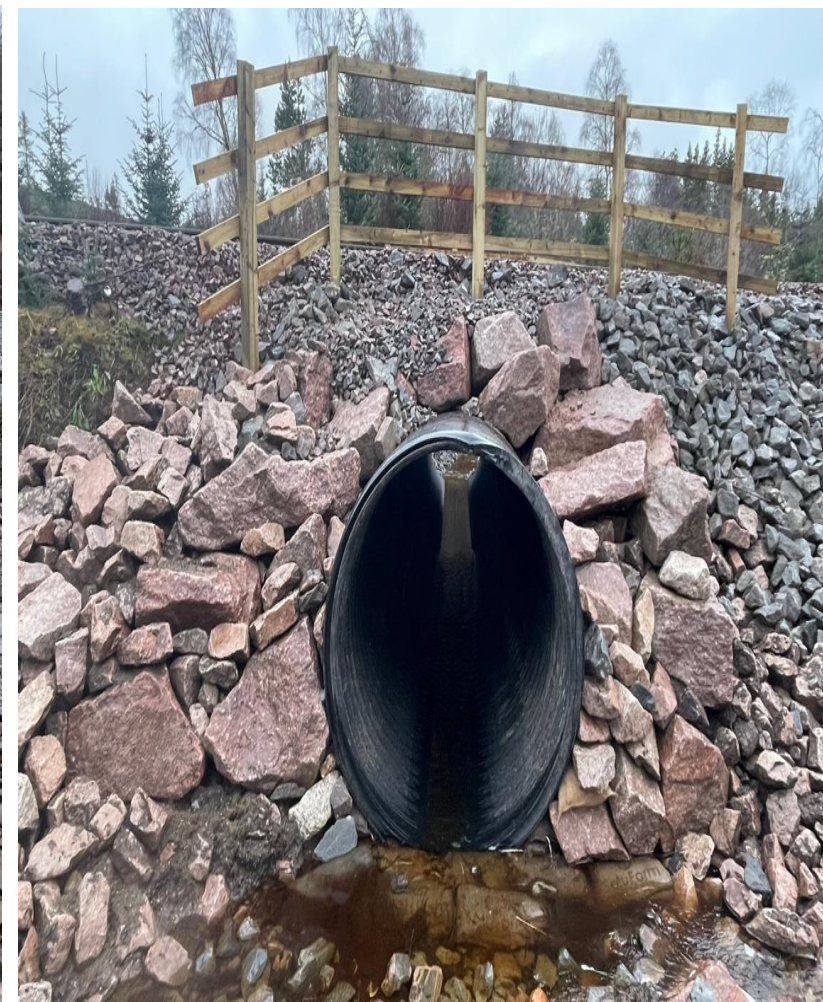
T2023/206110 – Bi-Directional – KYL Rogie

Working with Structures and AMCO drove the completion of work during a recent closure, installing a 1.5m culvert to manage and control water on the nearby flood plain. Completion allowed for the removal of a longstanding 20mph speed restriction.
