Perth Delivery Unit

Infrastructure Maintenance Delivery Manager
Lee Ross

Providing Maintenance and Response
Services for the following:

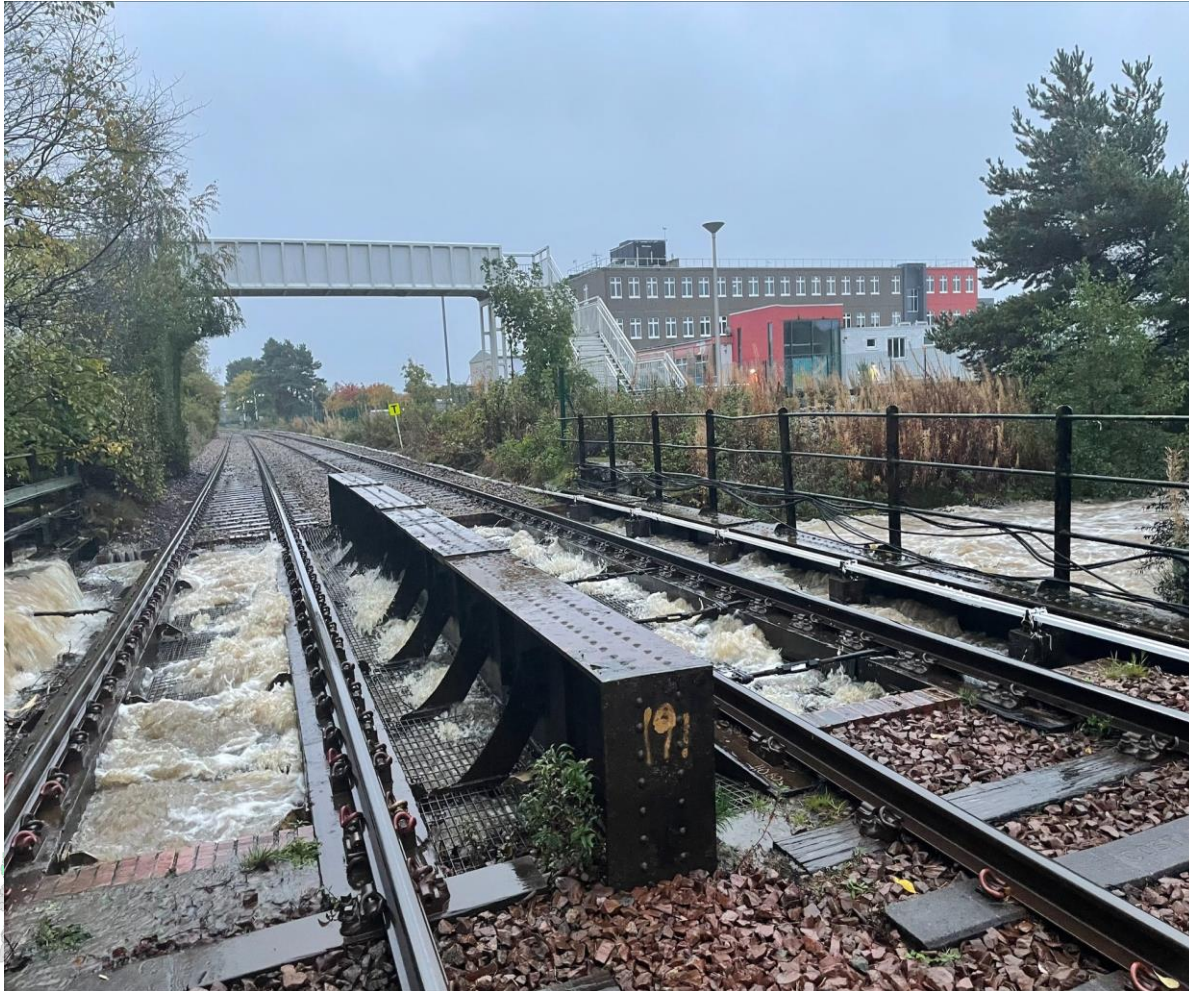
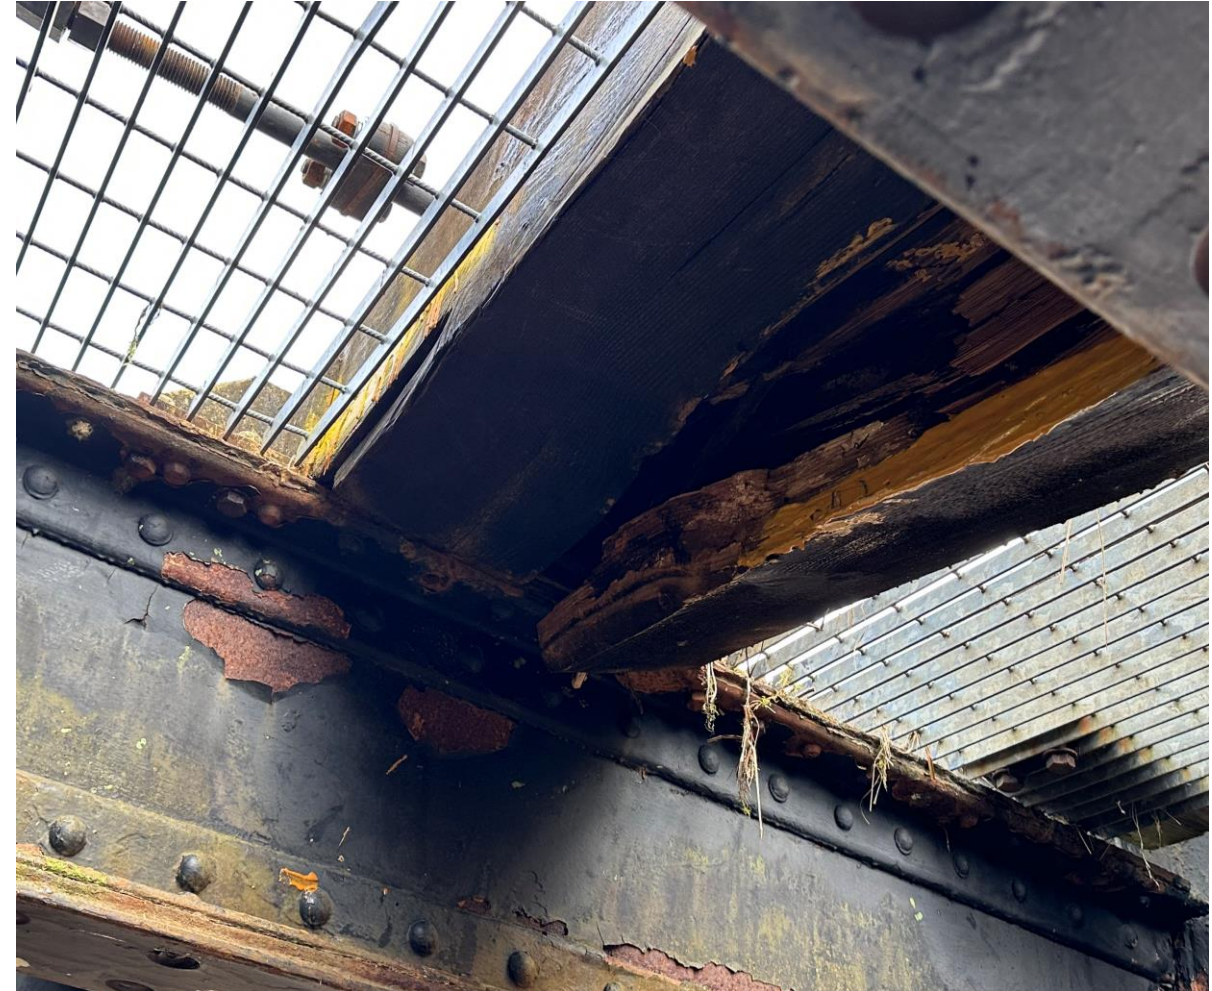
Down Line – Gynack Burn – HGL2 Kingussie

Deteriorating asset condition of longitudinal timbers at Kingussie resulted in a long standing 20mph TSR whilst enhanced access was arranged to rectify. Close work with several work parties and planning teams allowed for the renewal of bearers.

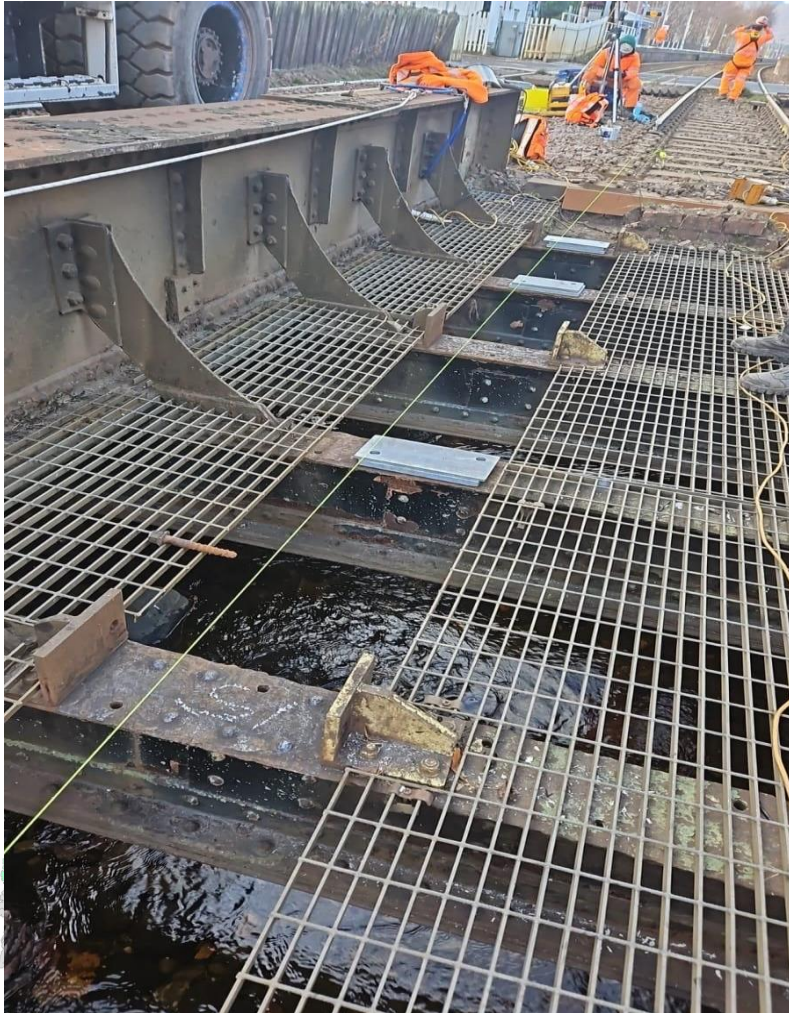
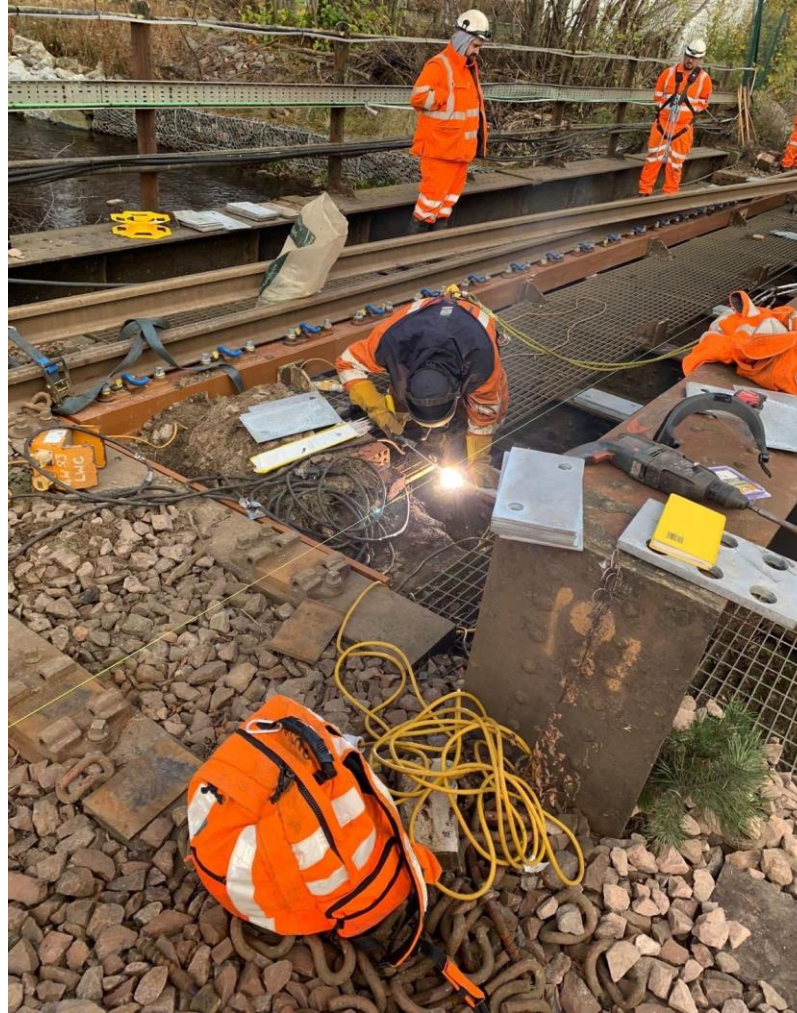
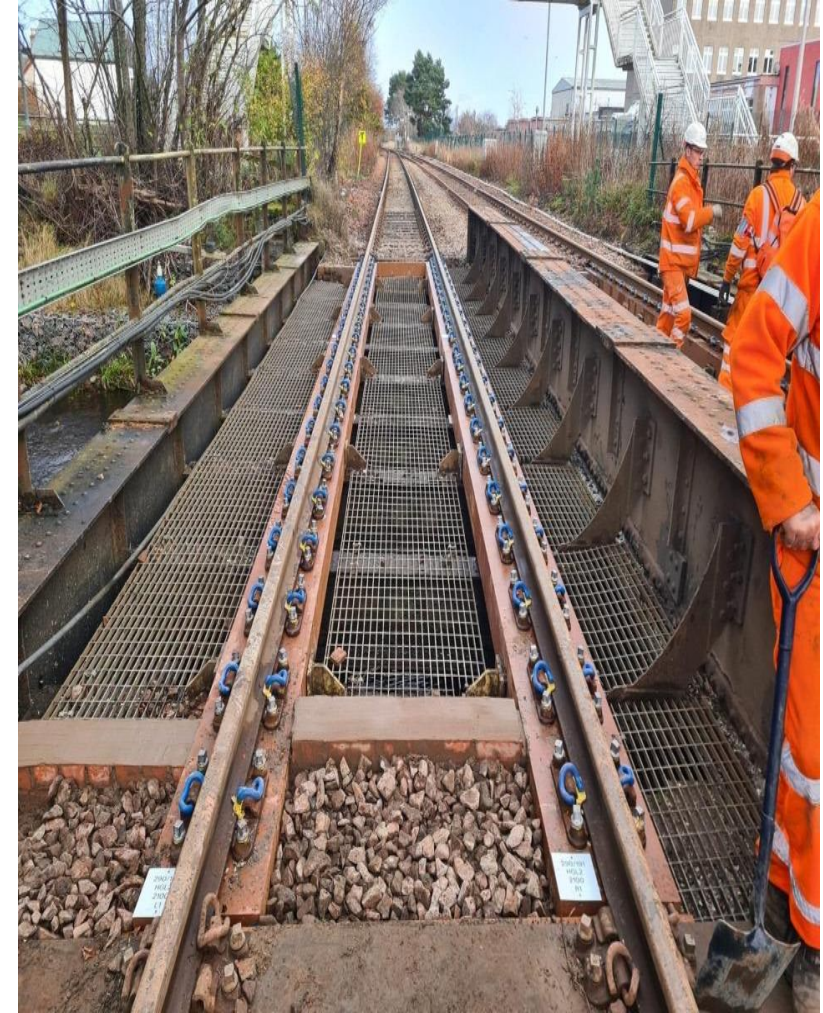
Down Line – Gynack Burn – HGL2 Kingussie

Works completed during recent closure, renewing split and life expired longitudinal timbers with new FFU (fibre-reinforced foamed urethane) sleepers. Synthetic sleeper with 50-year life expectancy, and enhanced ability to withstand river forces during adverse weather.

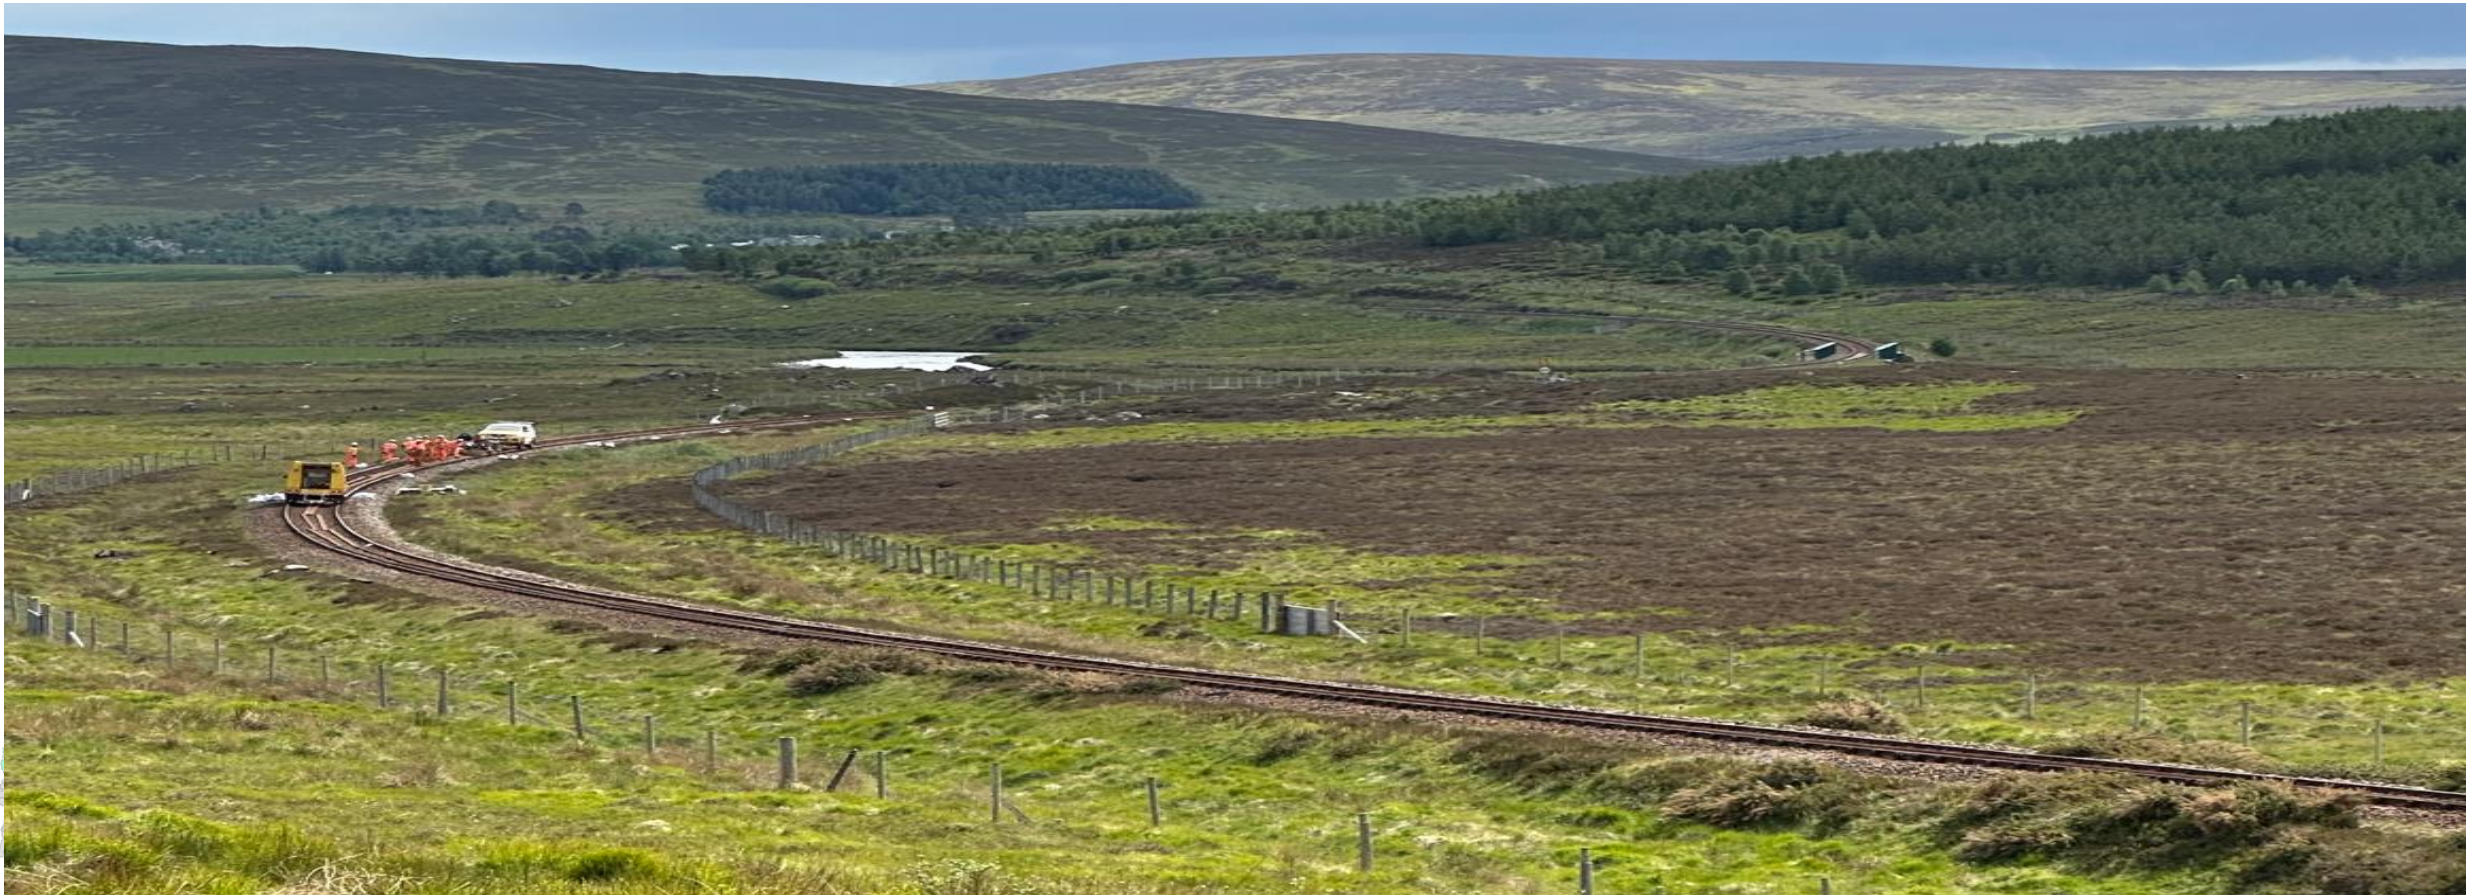
Wick Line Closure – Maintenance Delivered Renewals

The CP7 Track Renewals programme places a strong emphasis on upgrading rural and remote lines, including Wick Line. Track and structures renewal works were undertaken between Dingwall and Georgemas 09/06 to 30/06. Renewing aging infrastructure on a line that play a vital role in serving rural communities and promoting tourism. TSM Helmsdale utilised this opportunity to renew 2,195yards (1.25mile) of rail across numerous sites. This has removed dipped joints, side worn curves and 85lb profile rail. The Fishplates have also been converted to Finlube oil and hardlock nuts which provides an added benefit during hot weather preparations on an annual basis
