Helmsdale Station Building

Photographic Record, March 2013

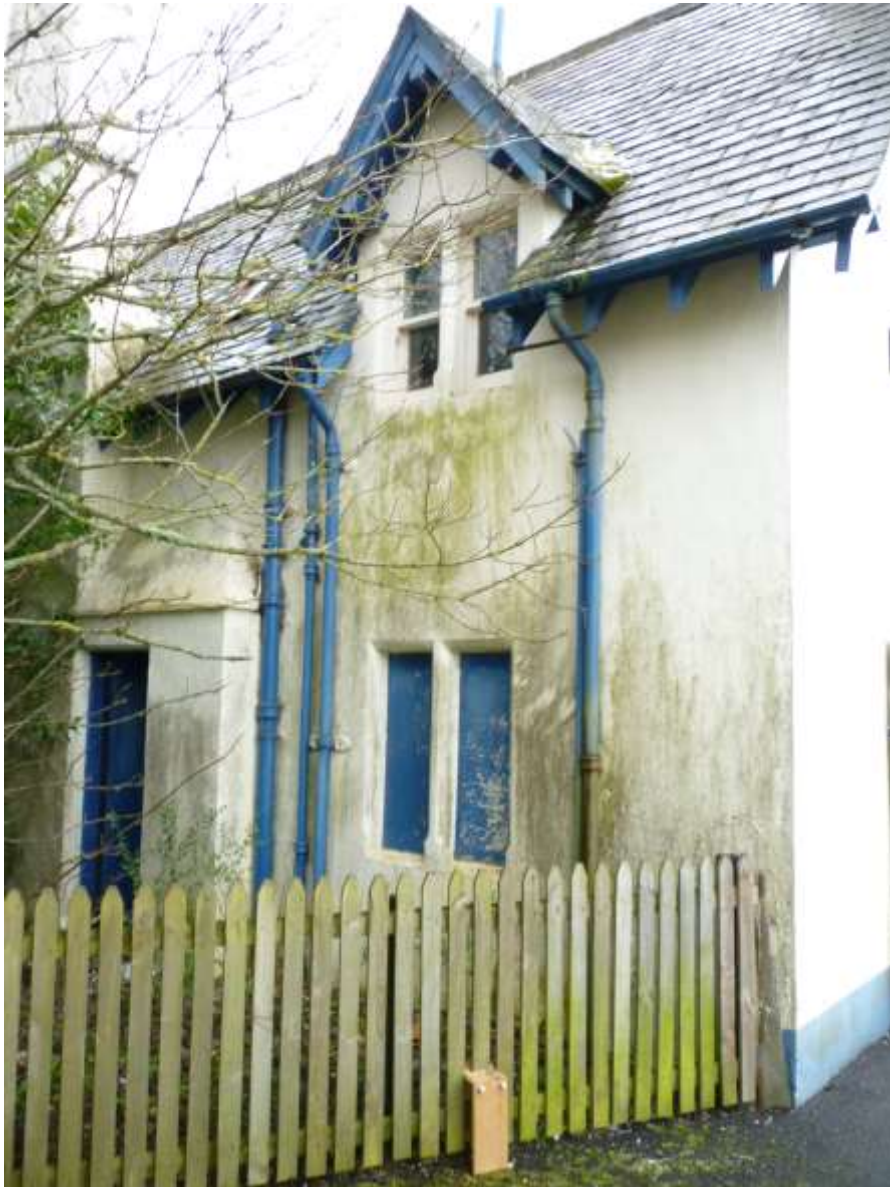
12. East elevation showing detail of scullery annexe, added at unknown date. Behind the damaged render it can be seen that this is brick built, unlike the concrete construction of the rest of the building.

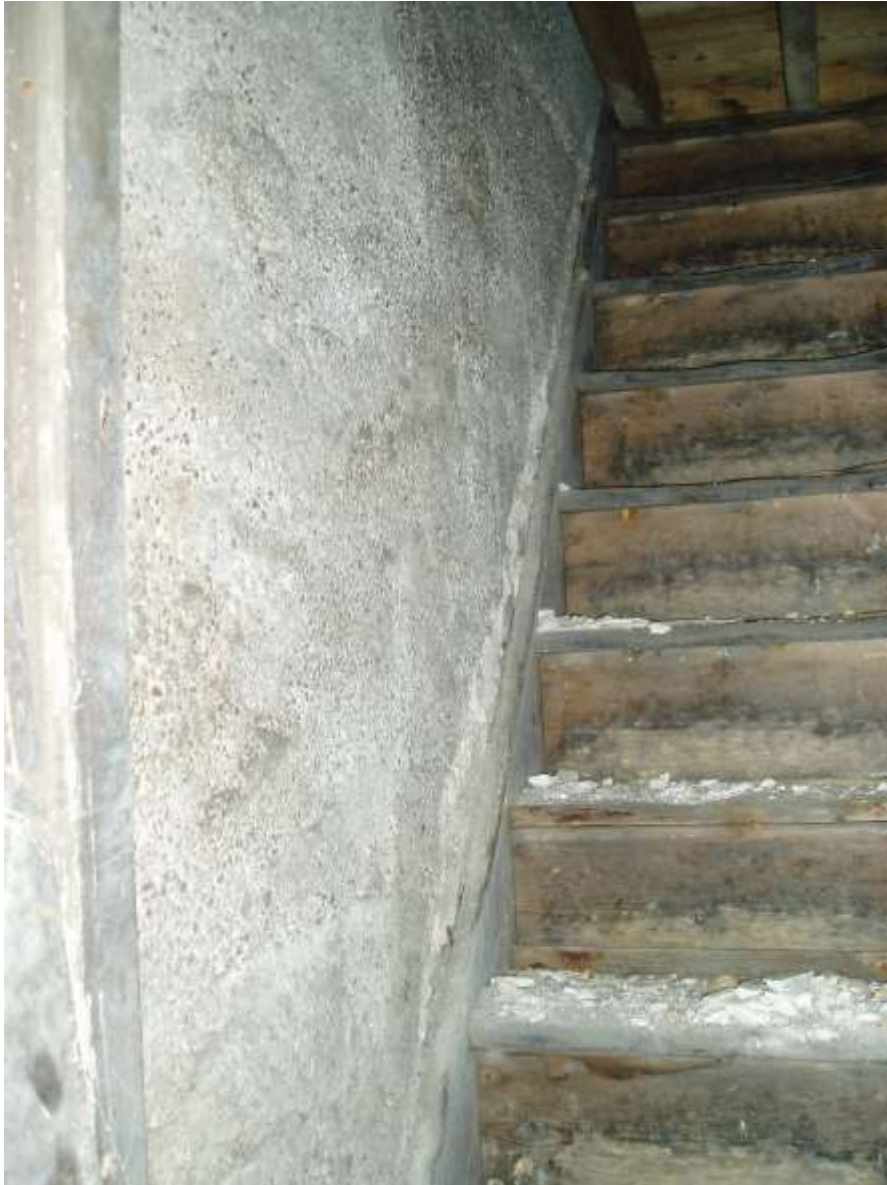
18 Stair case now blocked at top (see note above)

Kick marks on the risers suggest considerable use at some stage with not protective covering of the woodwork.

In recent years when the downstairs waiting room was in use, the door at the bottom of the stair case was sealed off behind a plaster skimmed fabric (pics 17 & 20).

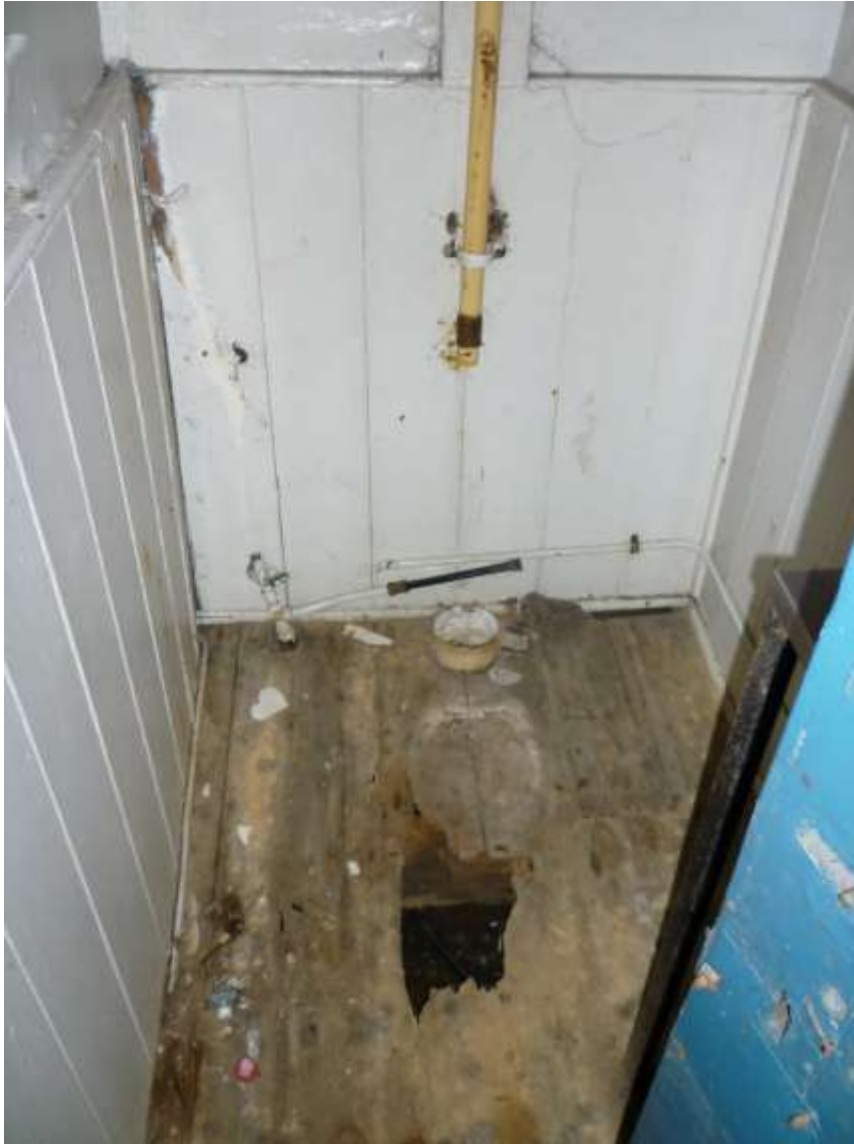
3. The floor in some ground floor rooms (toilet off waiting room, store and office) is extremely rotten and dangerous. The photographic record in these rooms is limited by safety considerations.

30. Looking in to off-waiting room toilet (rotten floor prevents access, but note aluminium wash basin behind door)

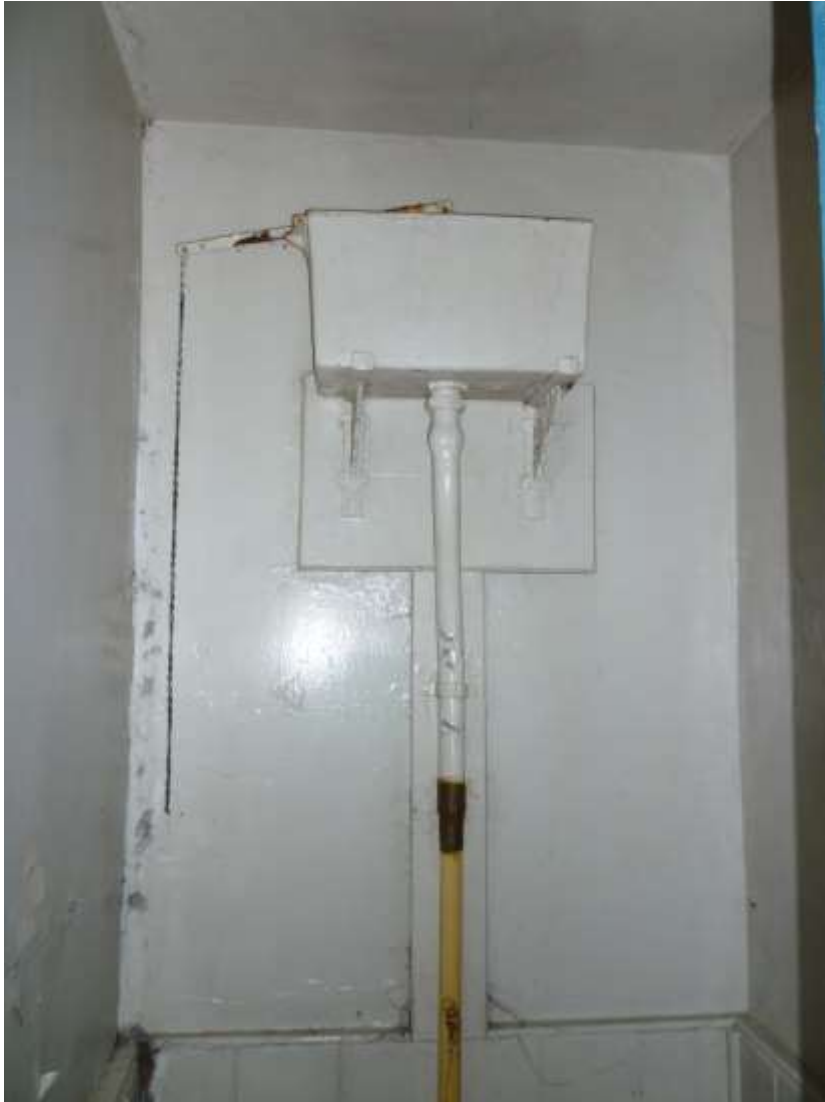
31. Although toilet has been removed, cistern remains

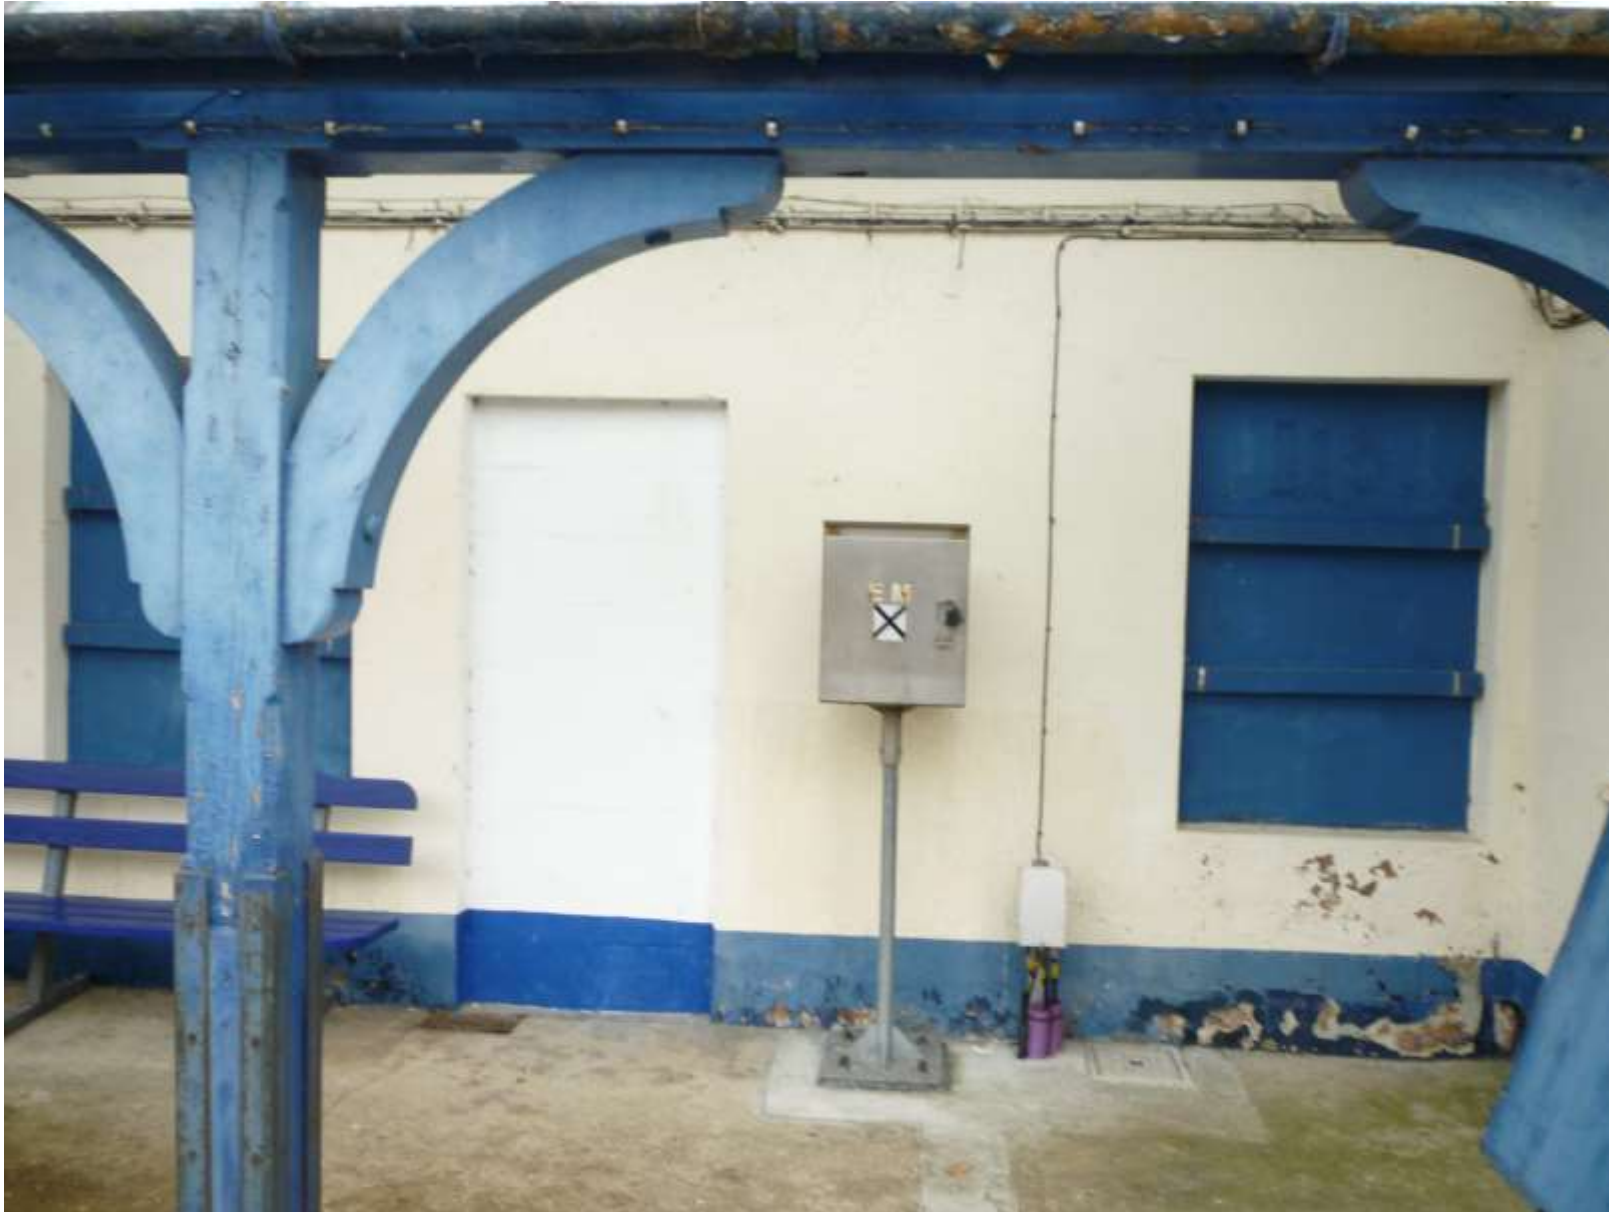
32. Blocked up door under canopy to store (#5). Although marked as store on the plan, the room beyond was once the stationmaster's office

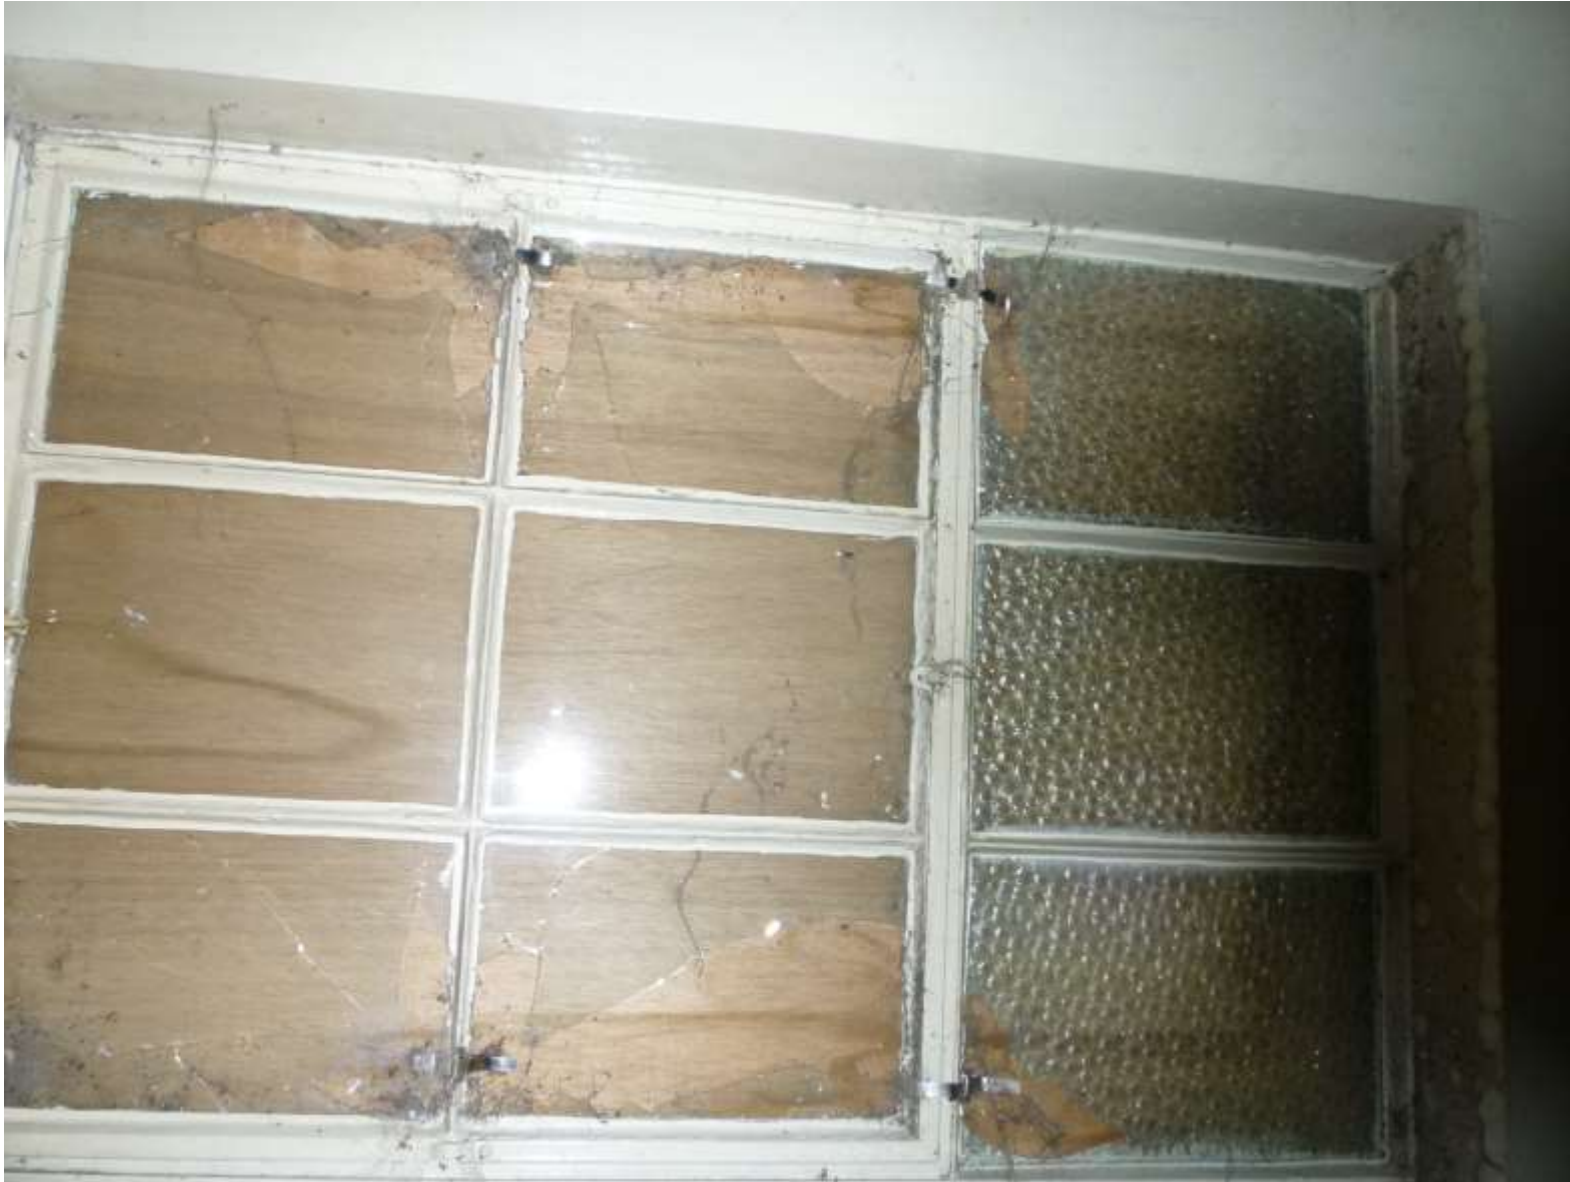
35. In both the office and the store, the suspended floors are rotten and very hazardous. This has restricted the photos in these two areas.

36. Steel window frame at south end of store from the inside (#7)

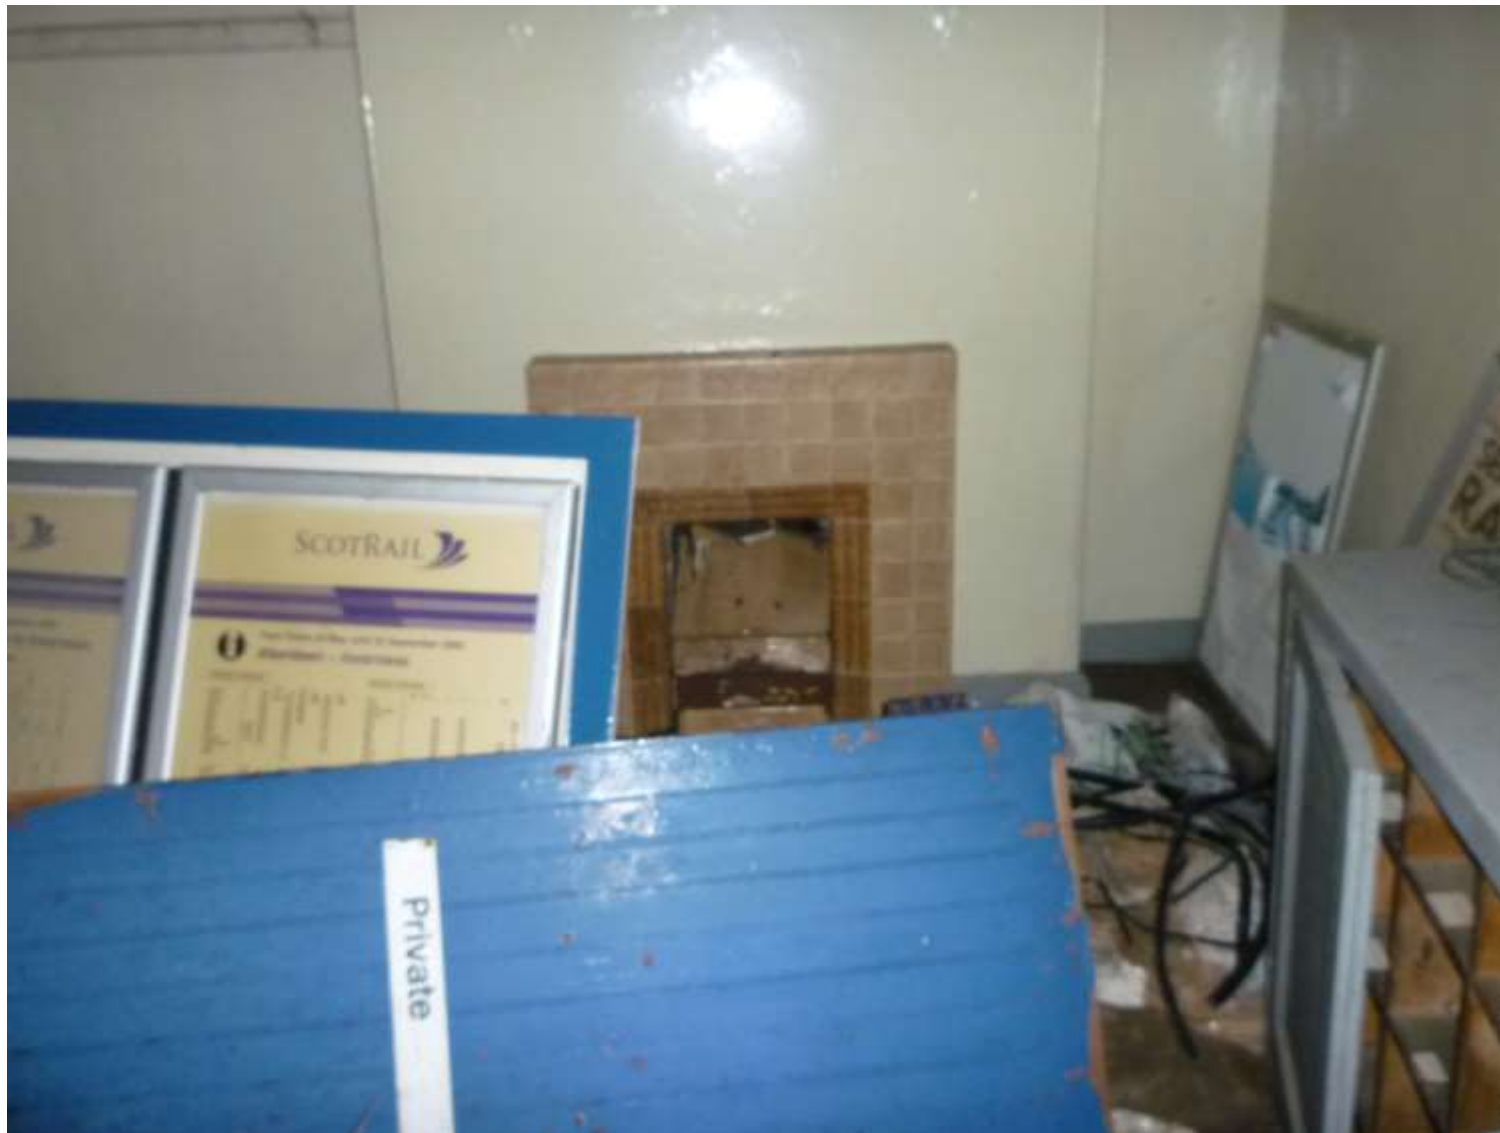
39. Another view of the store door, old timetable (dated 2000) noticeboard and fireplace in store room (all photos had to be taken from one location because of the dangerous floor)

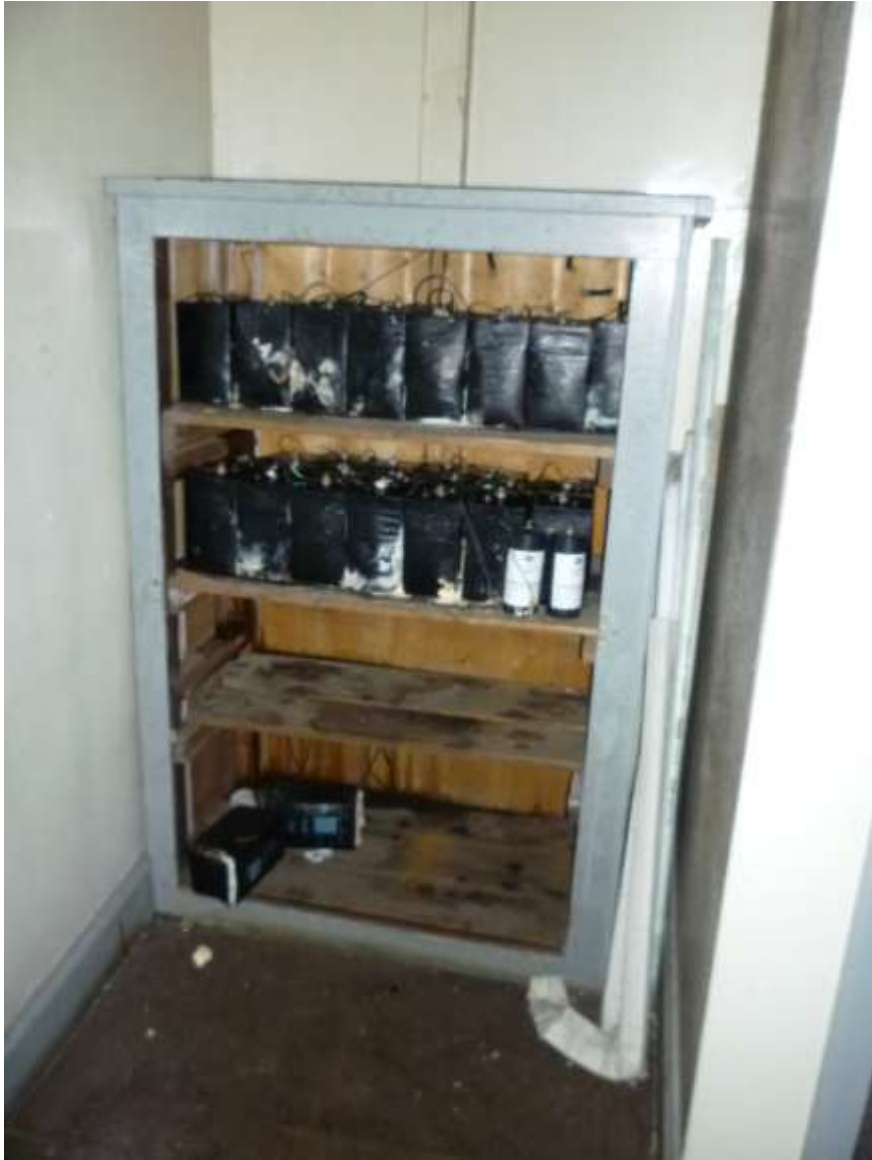
42. Cupboard of corroding British Rail batteries against the south wall (#8). It is believed that there was a door behind leading from the store (stationmaster's office) to the entrance hall or the stationmaster's house

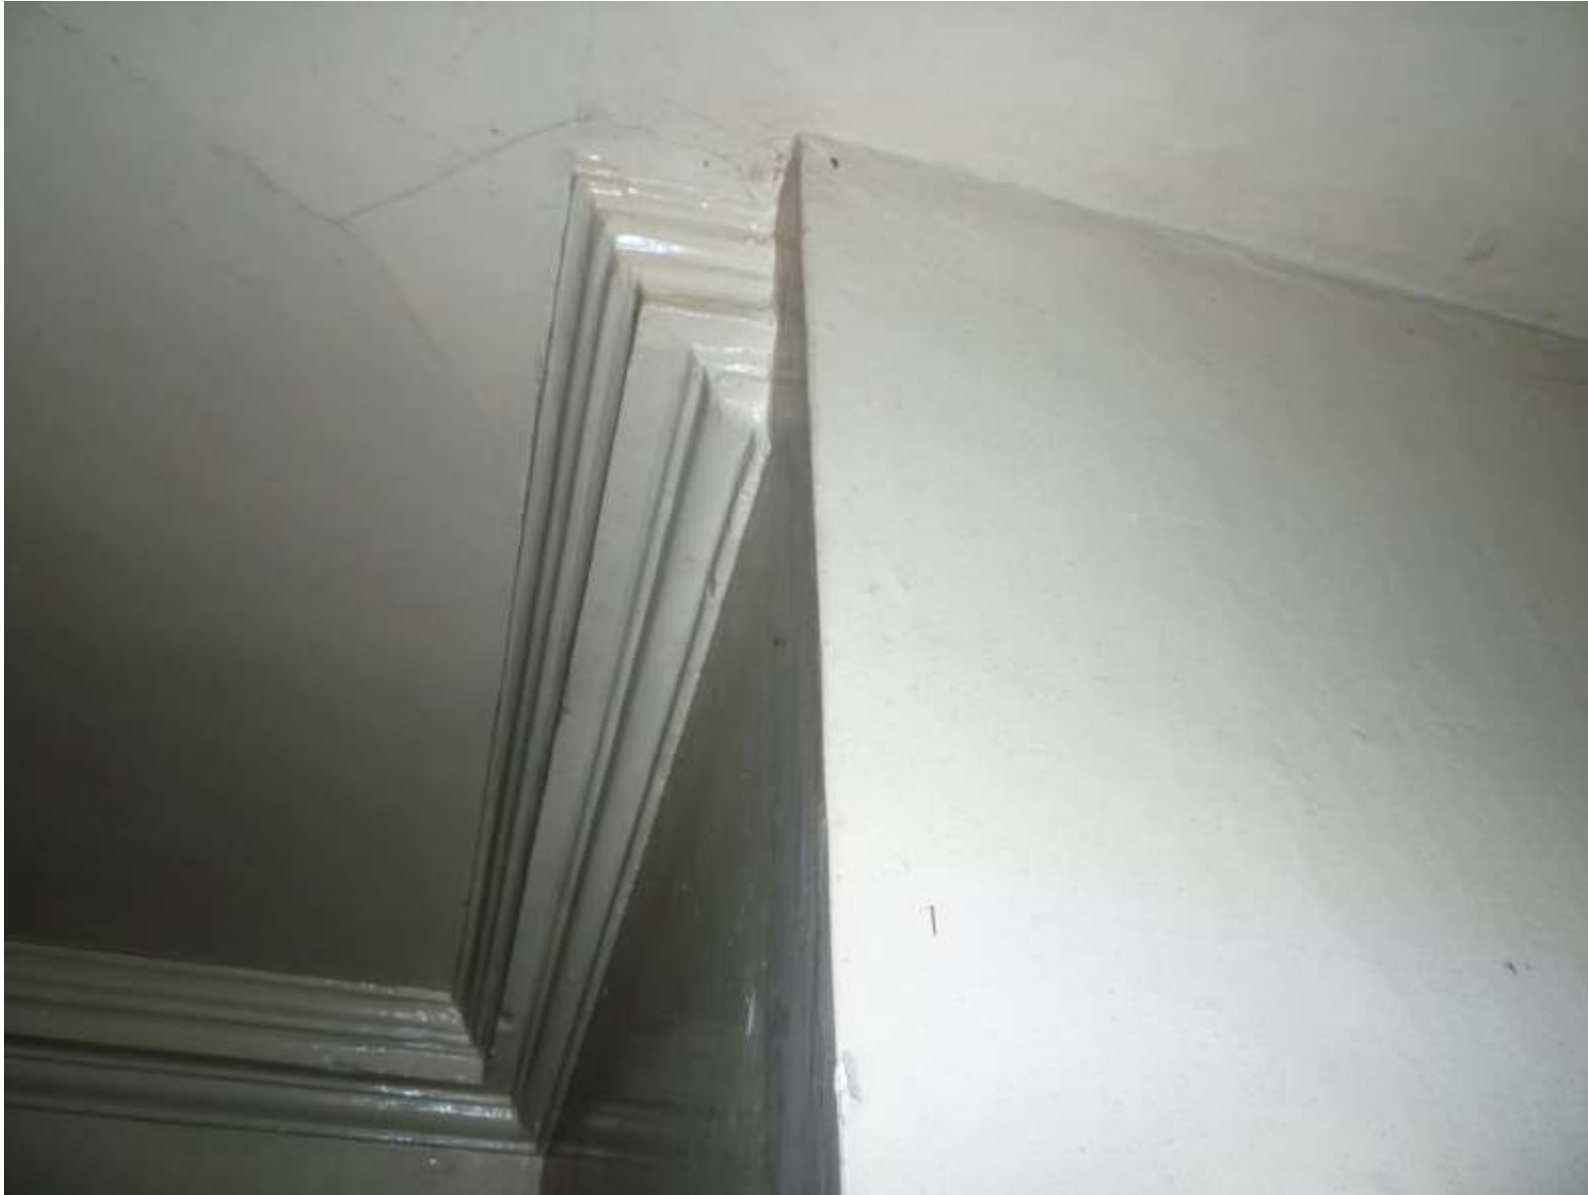
45. Cornice in store (Stationmaster's office, termination in south wall).

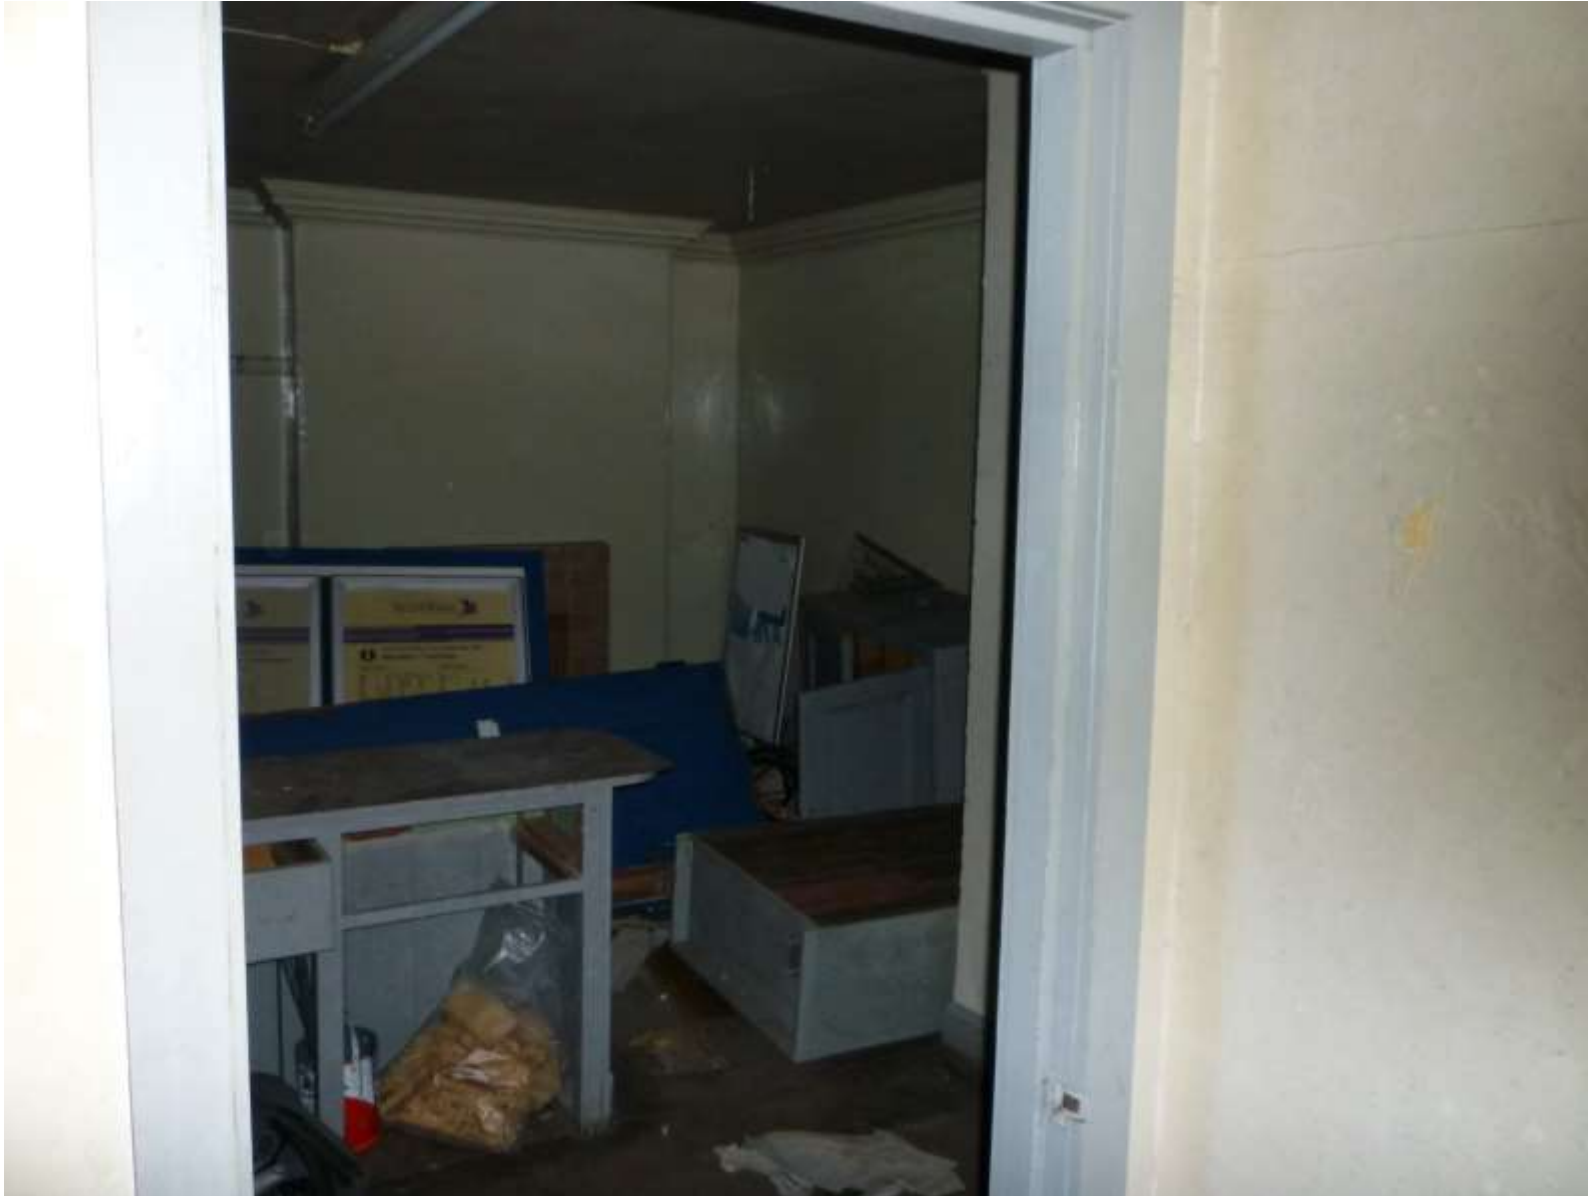
46. View through door from office to store showing desk beyond (#9)

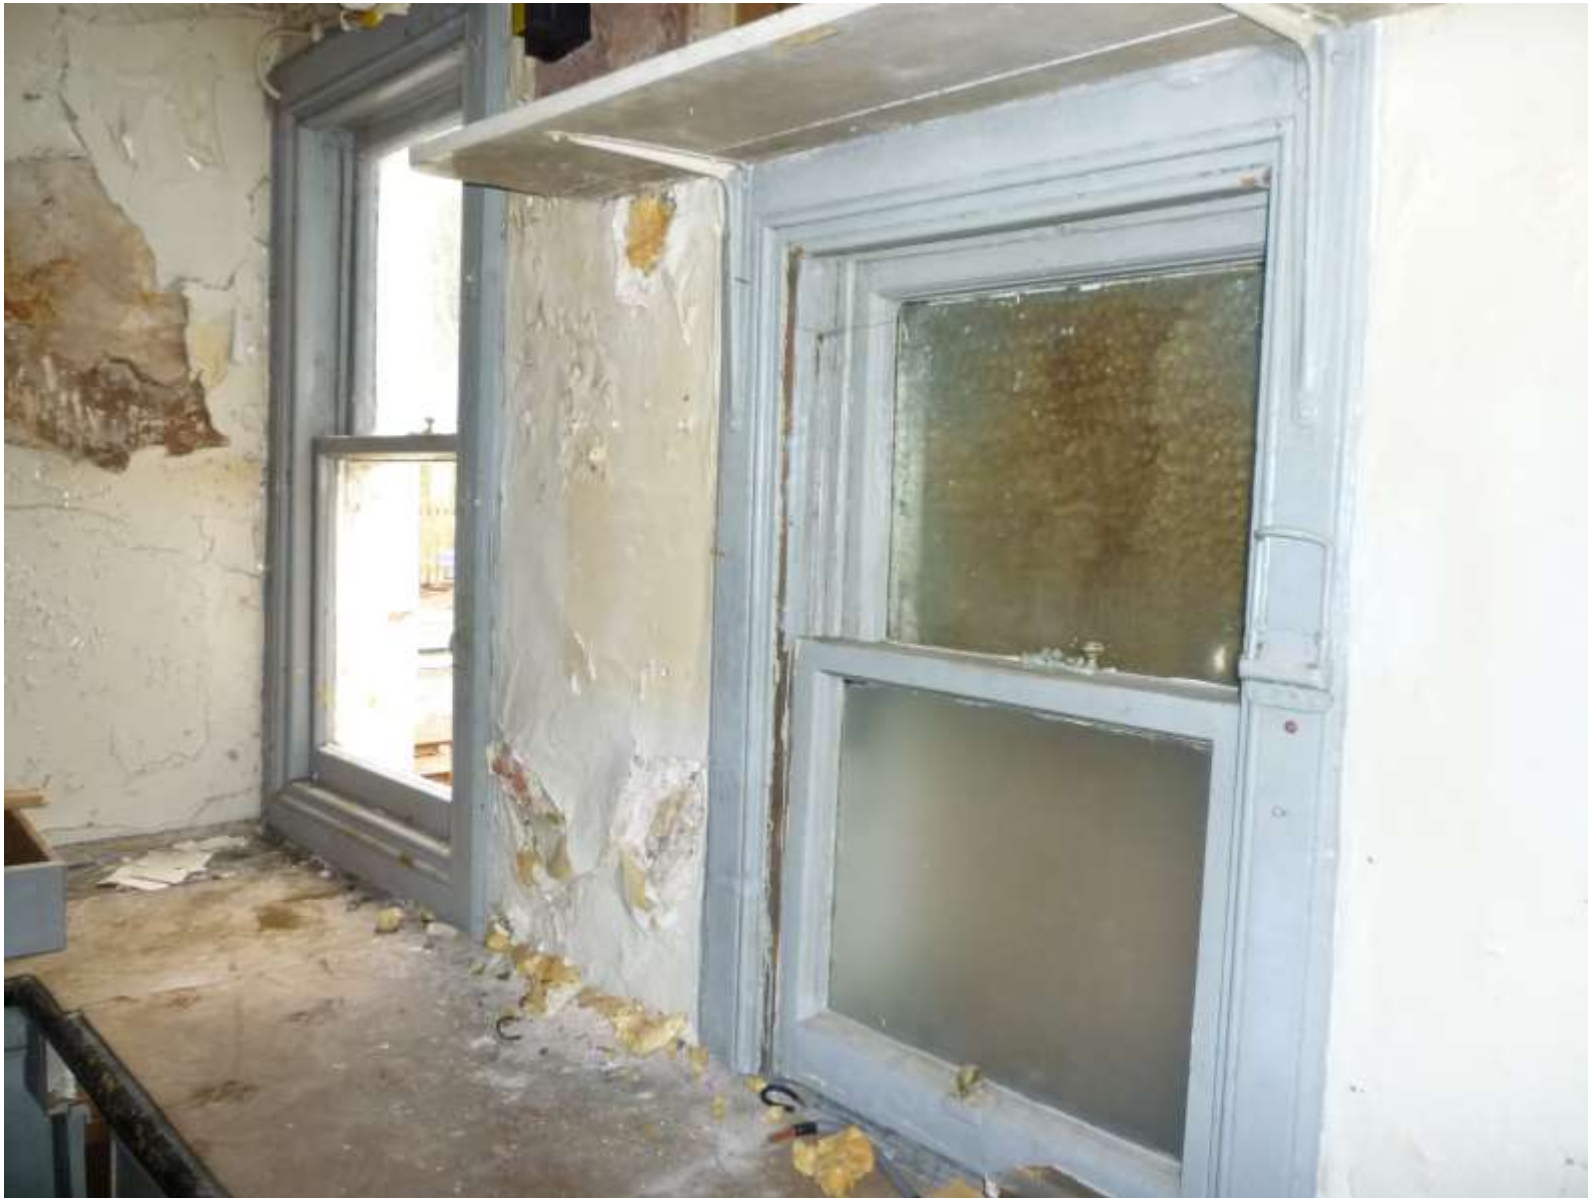
47. Windows in north wall of office (from #9). Further window is the only means of access

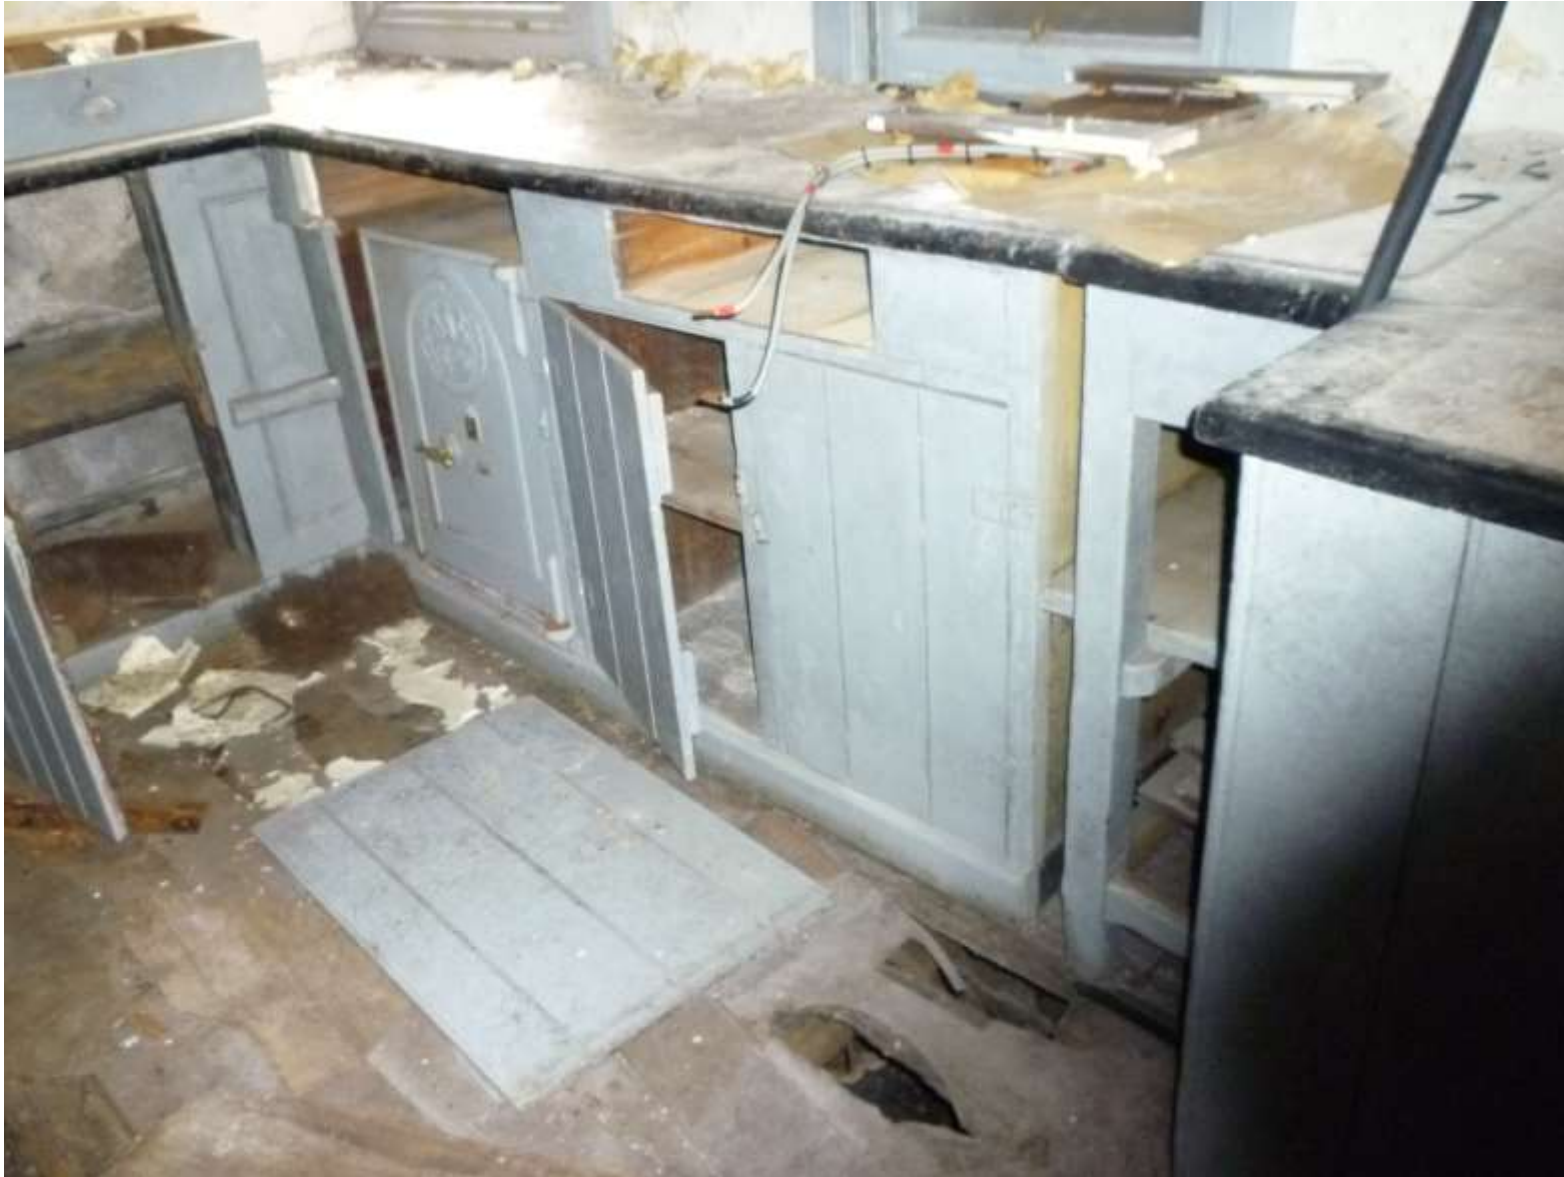
48. Counter, cupboards, safe and rotten floor below north windows in office

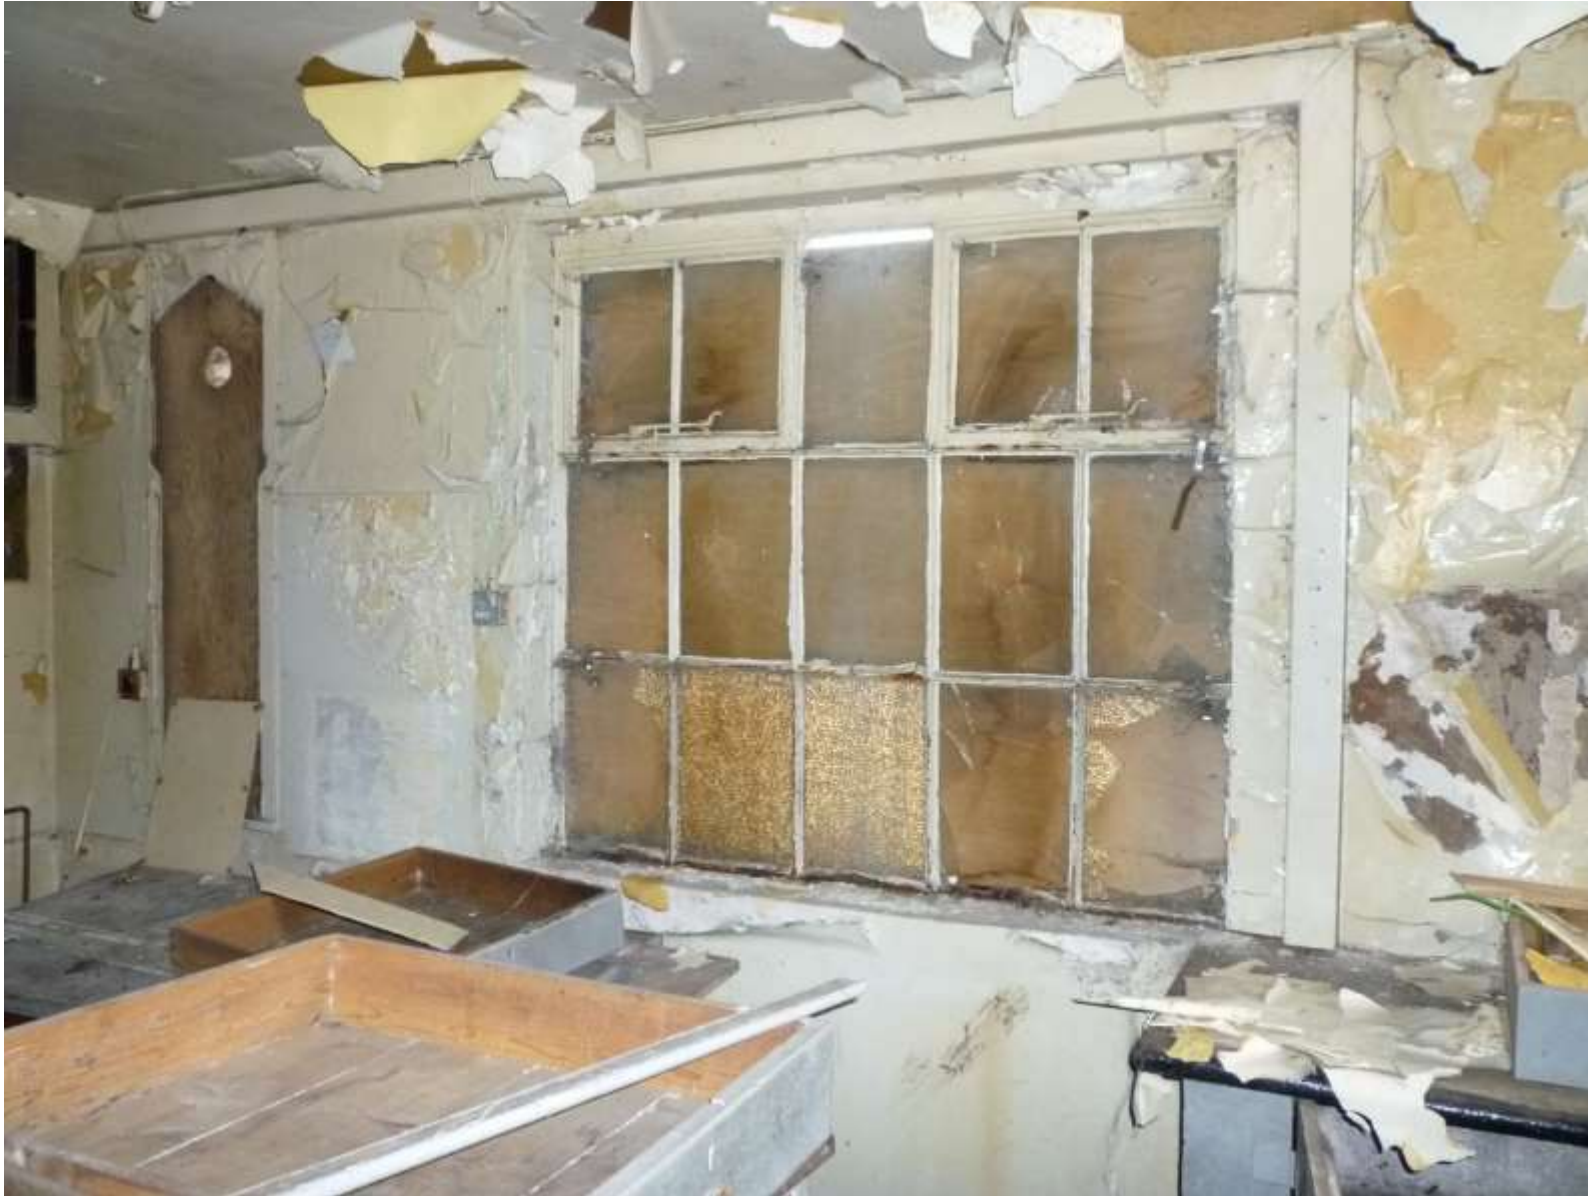
49. Window in office and outline of clock case on west (platform facing) wall

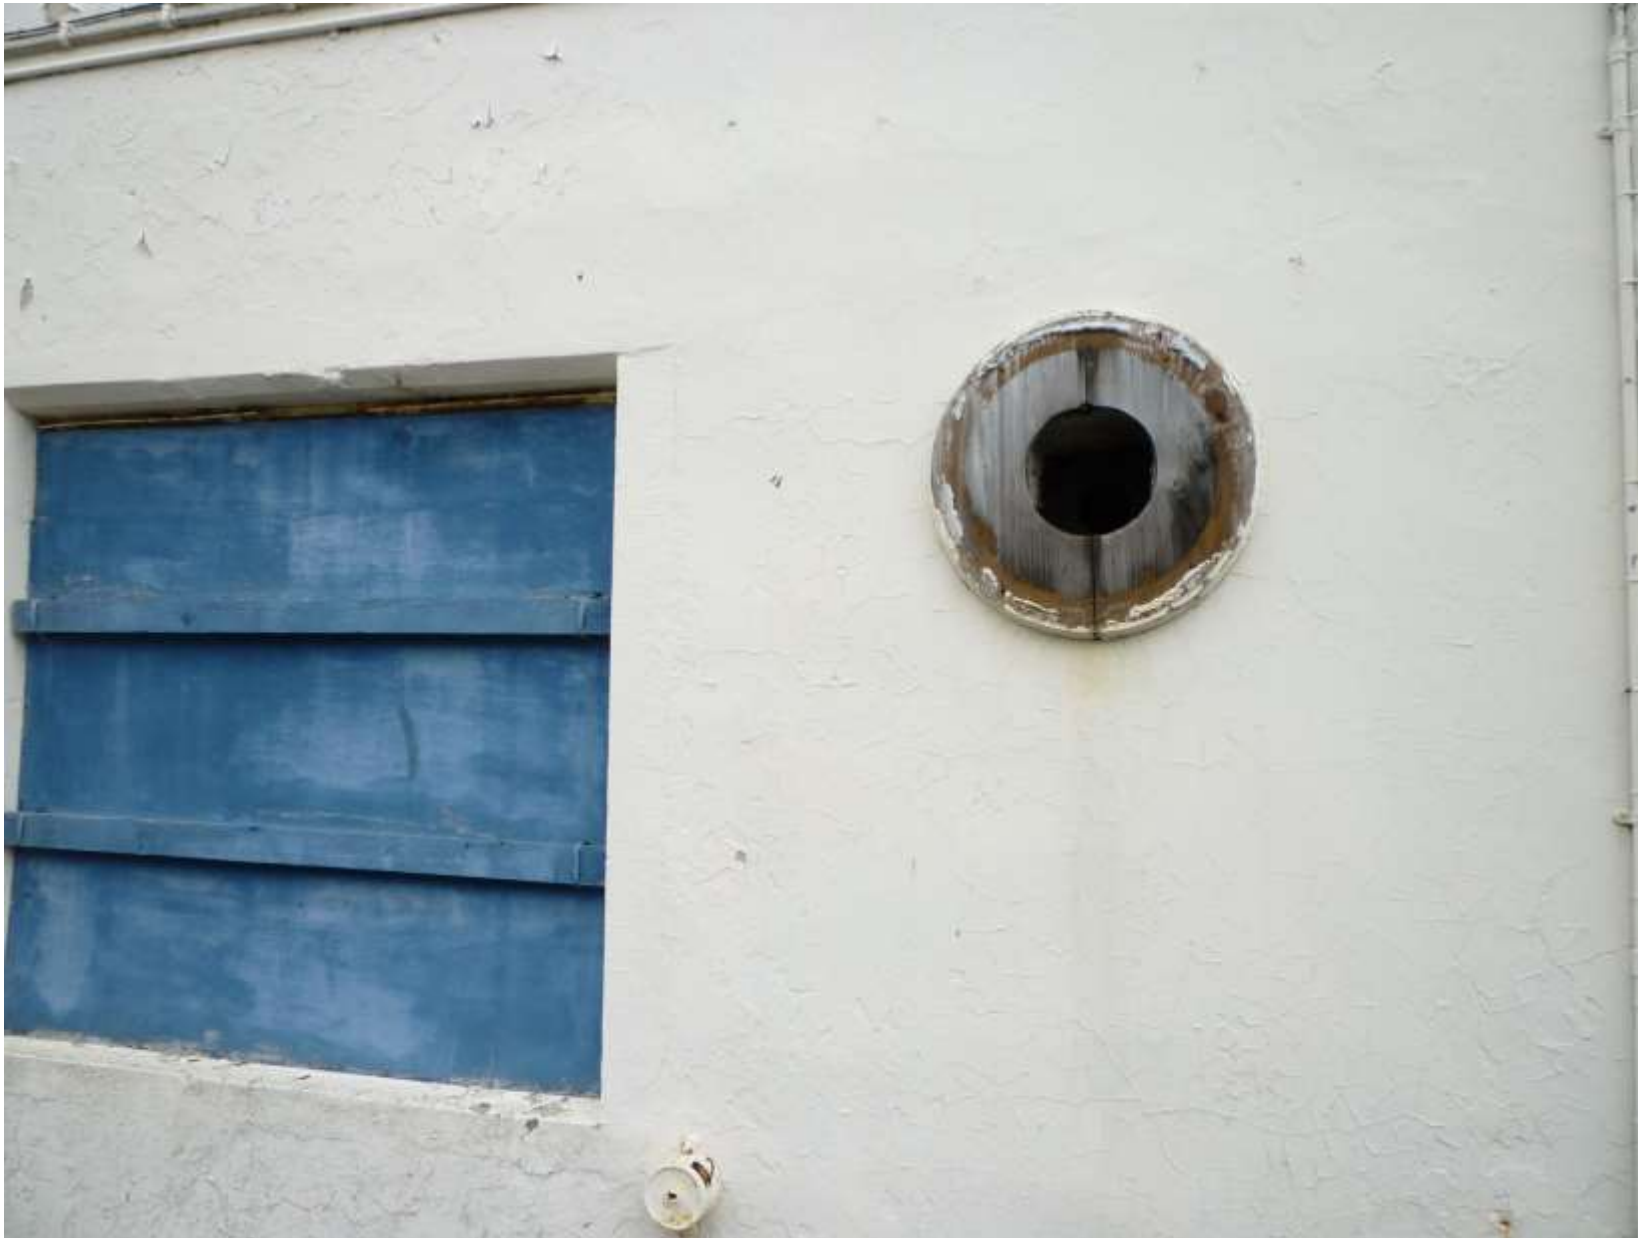
50. The outside view corresponding to the inside view in pic 49
