Helmsdale Station Building

Photographic Record, March 2013

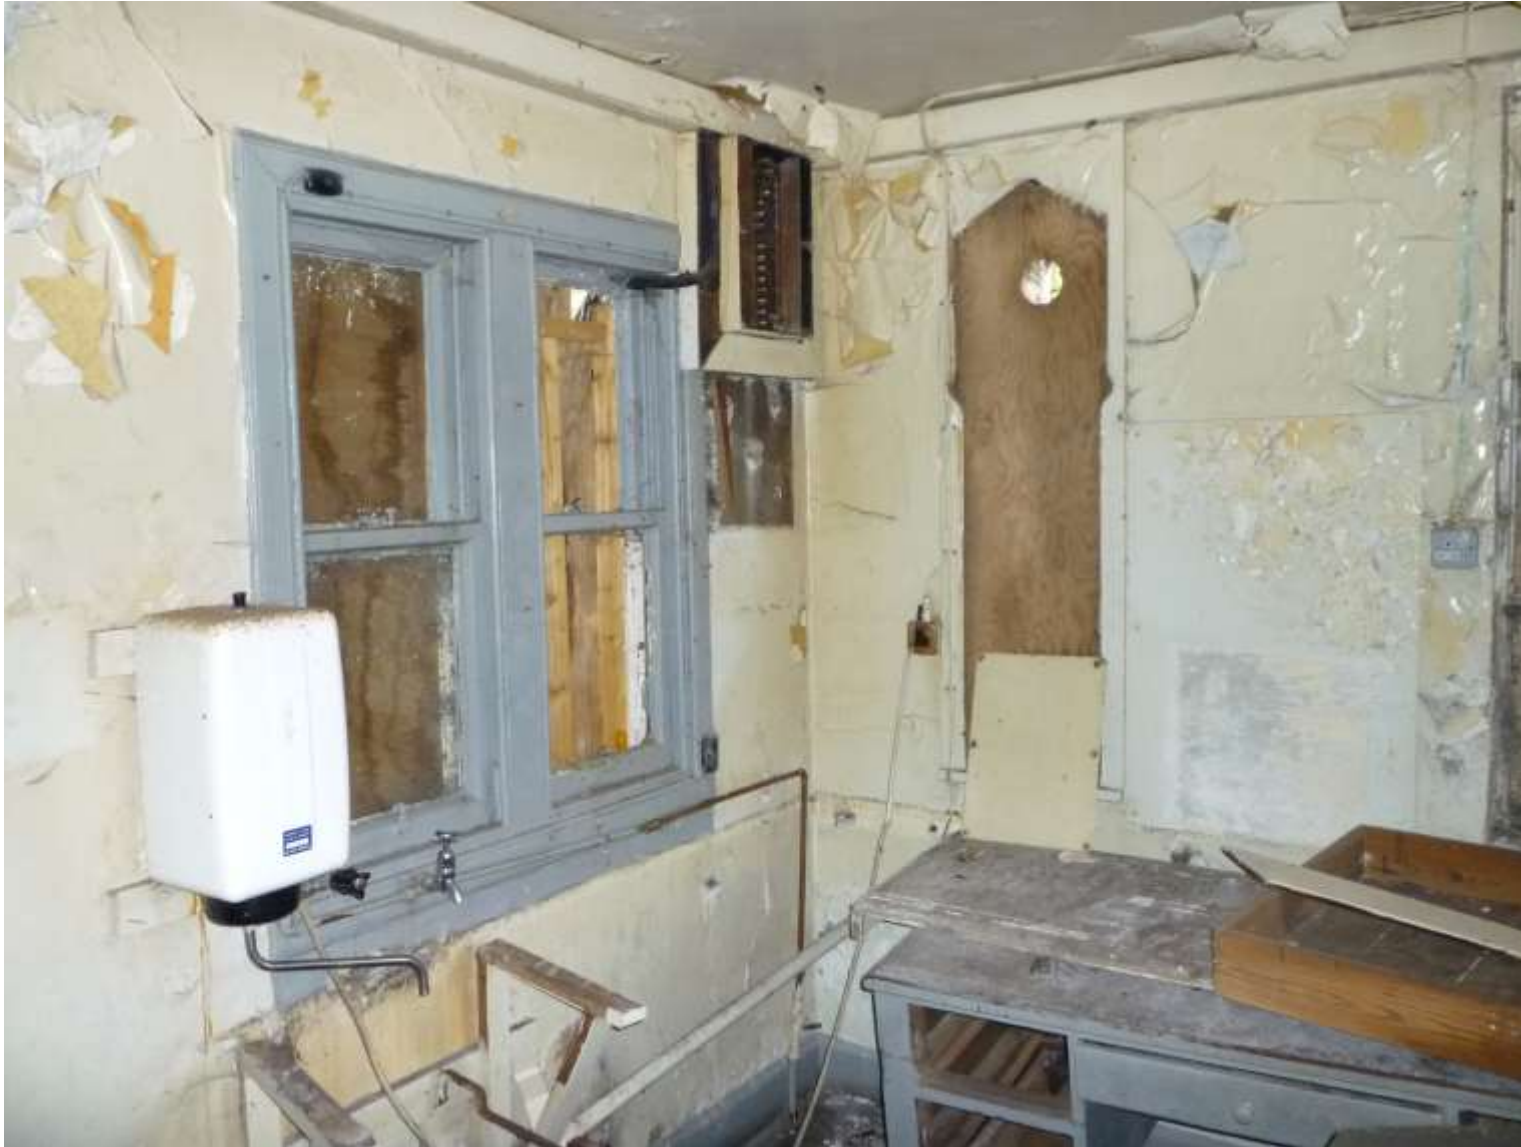
51. South window in office and outline of clock case on west wall. Sink removed.

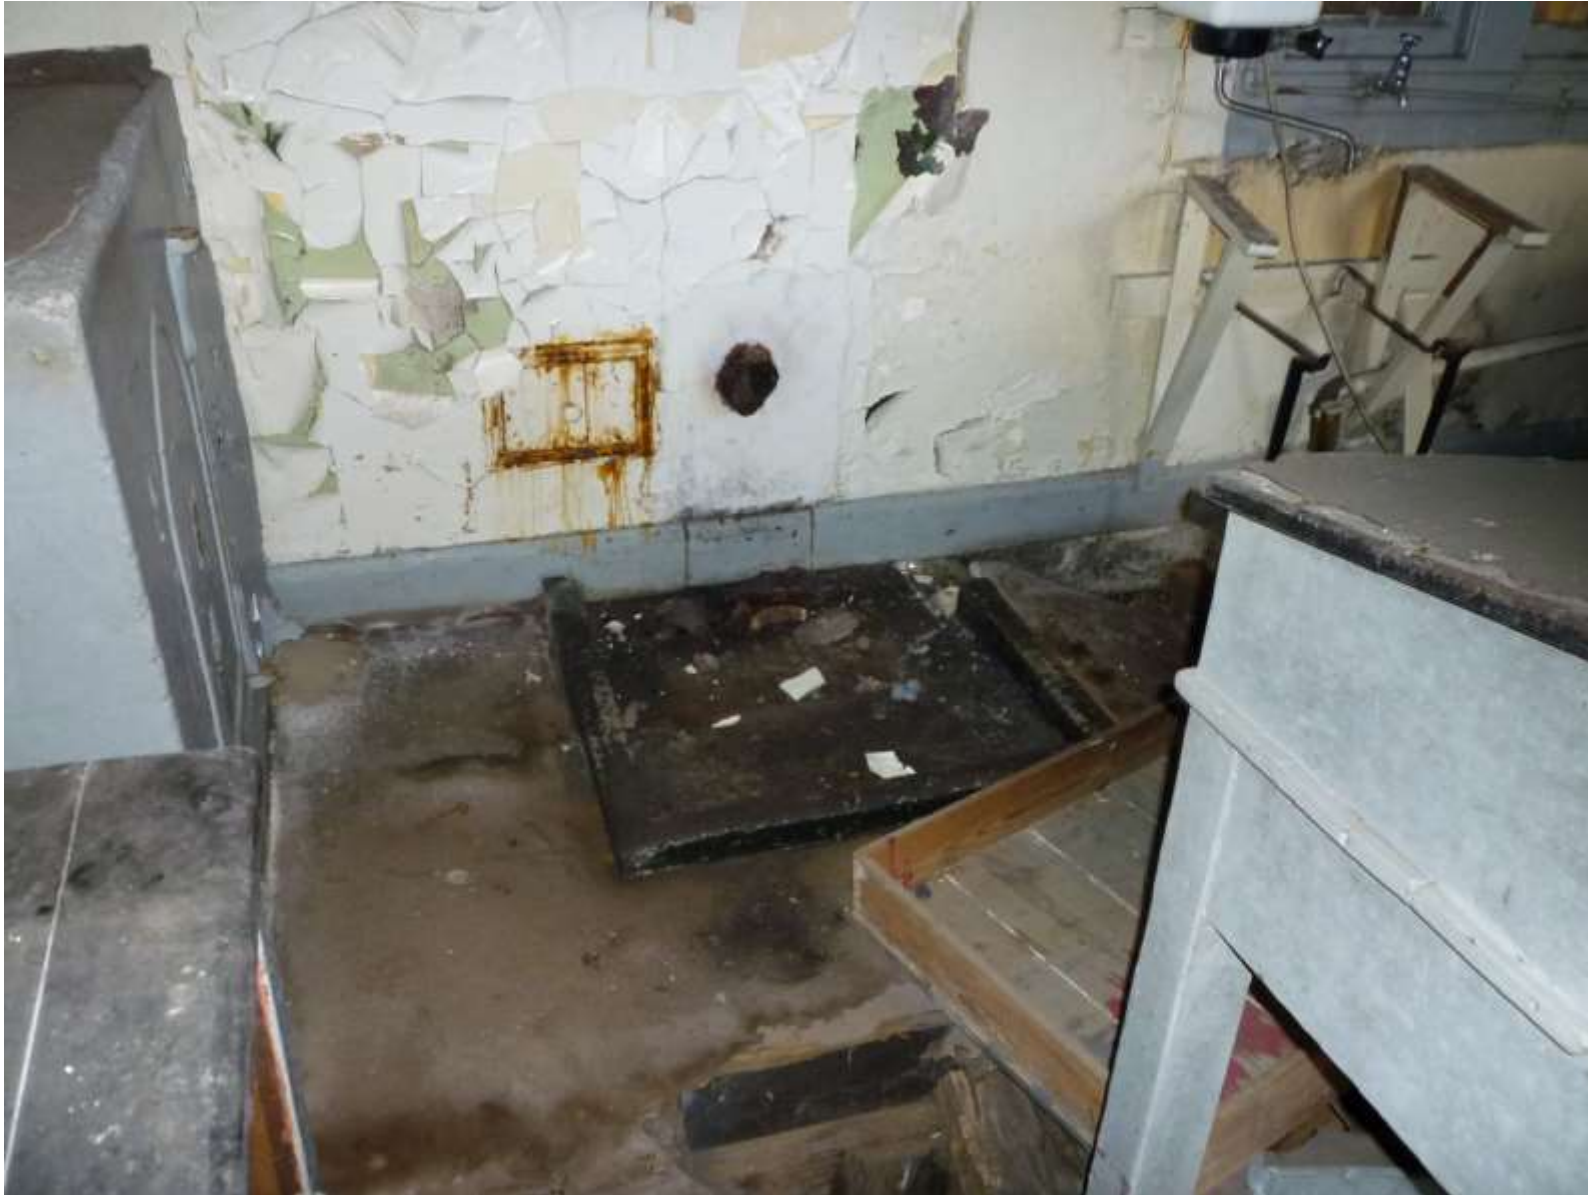
52. Location of stove in SE corner of office (#10)

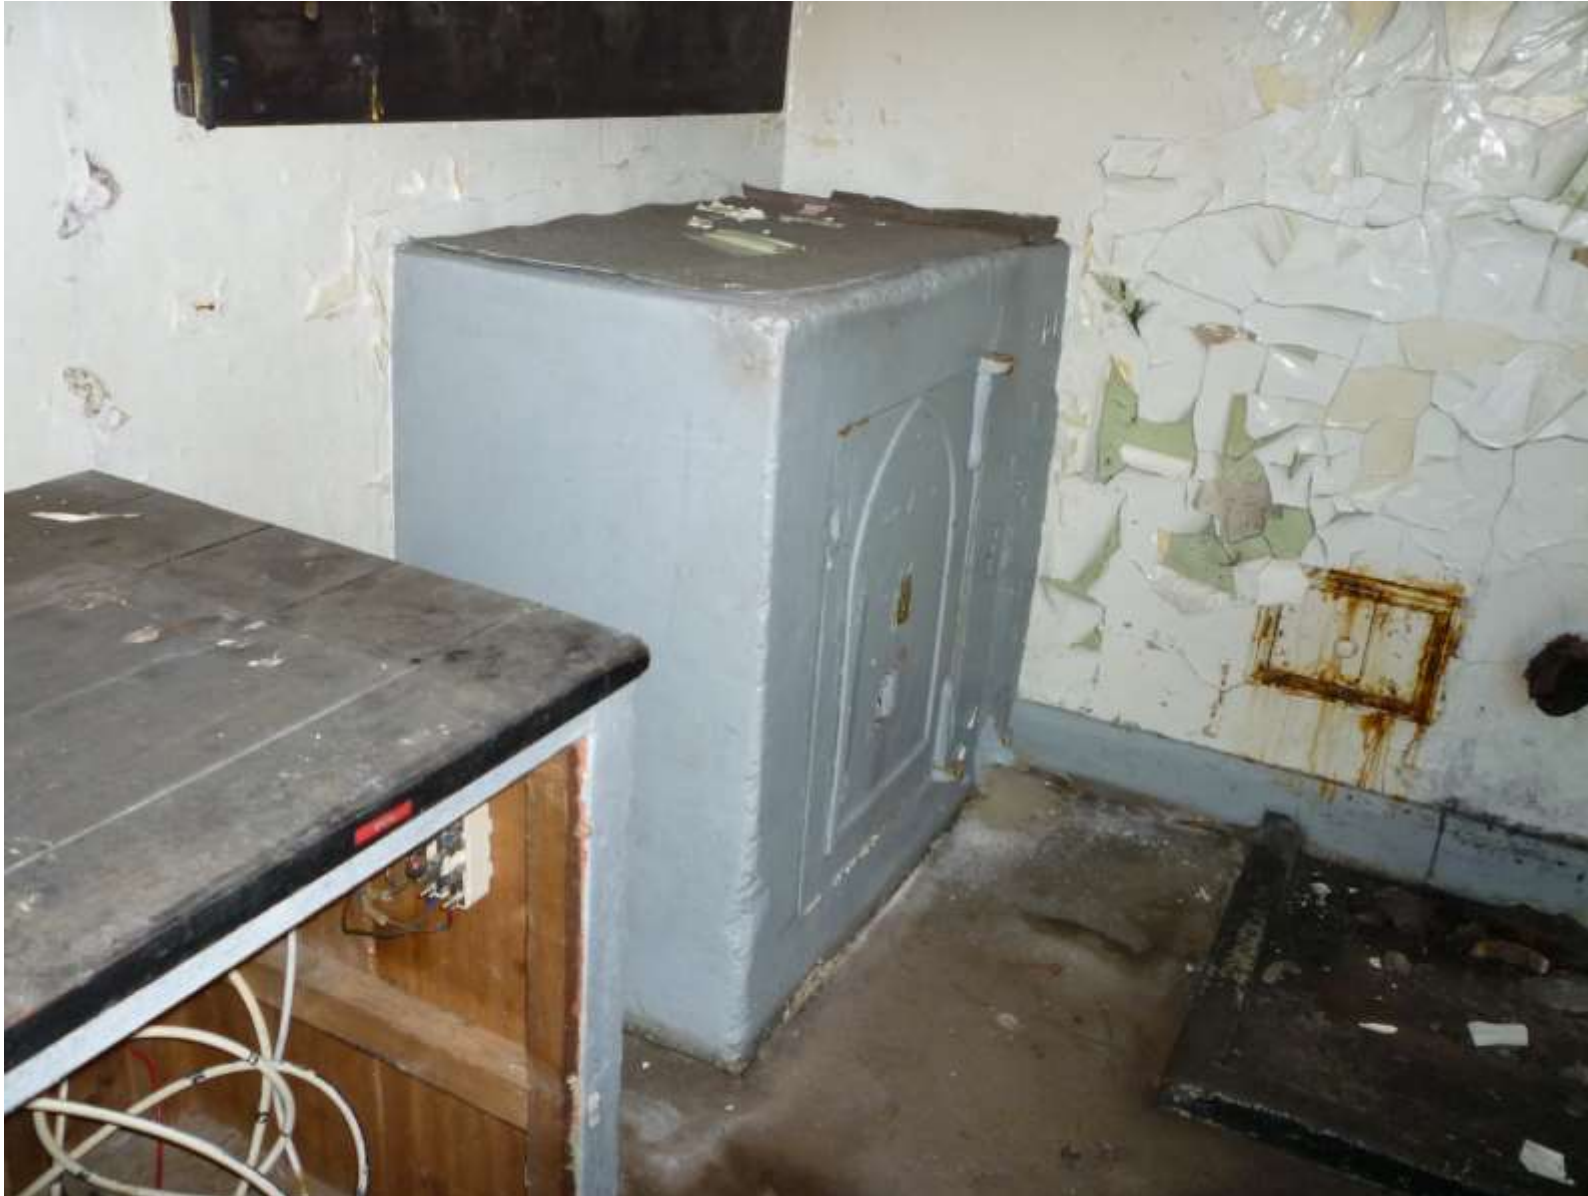
53. Safe (the second safe in this room) in SE corner of office

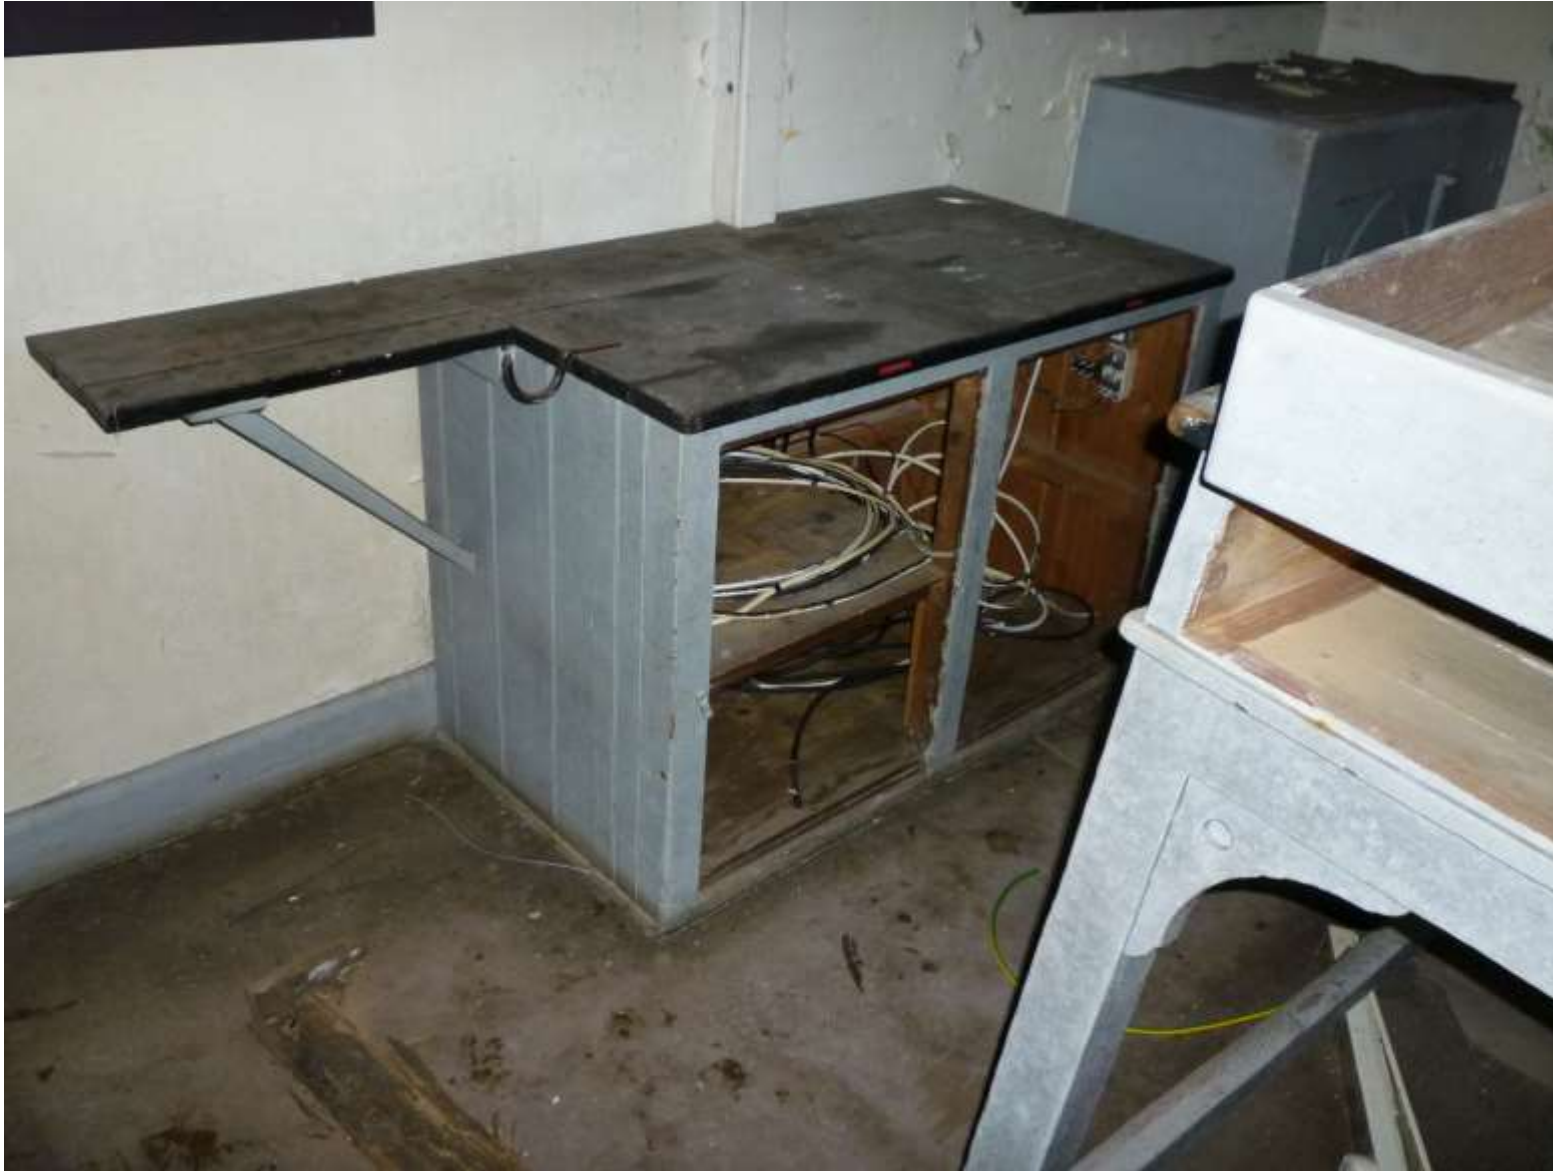
54. Cupboard against west wall of office

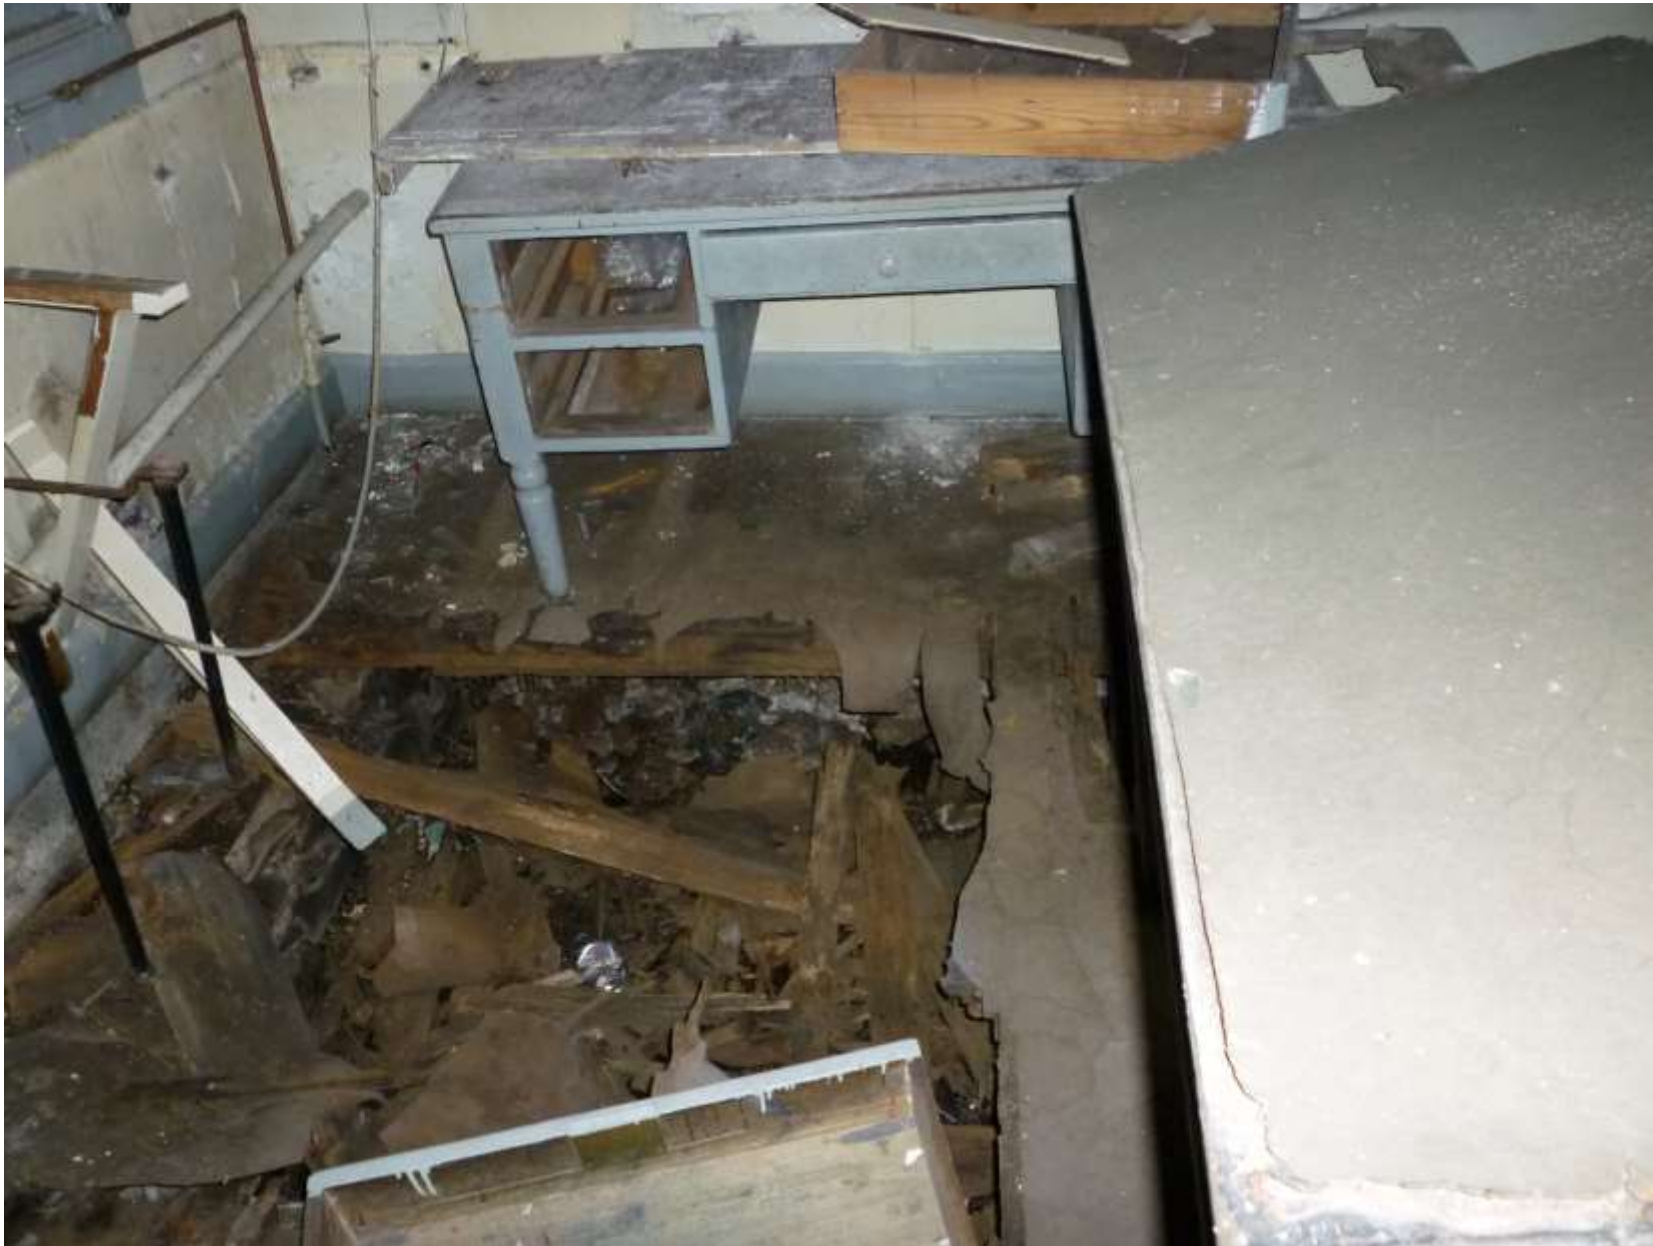
58. Low desk in SW corner of office (full view prevented by rotten floor)

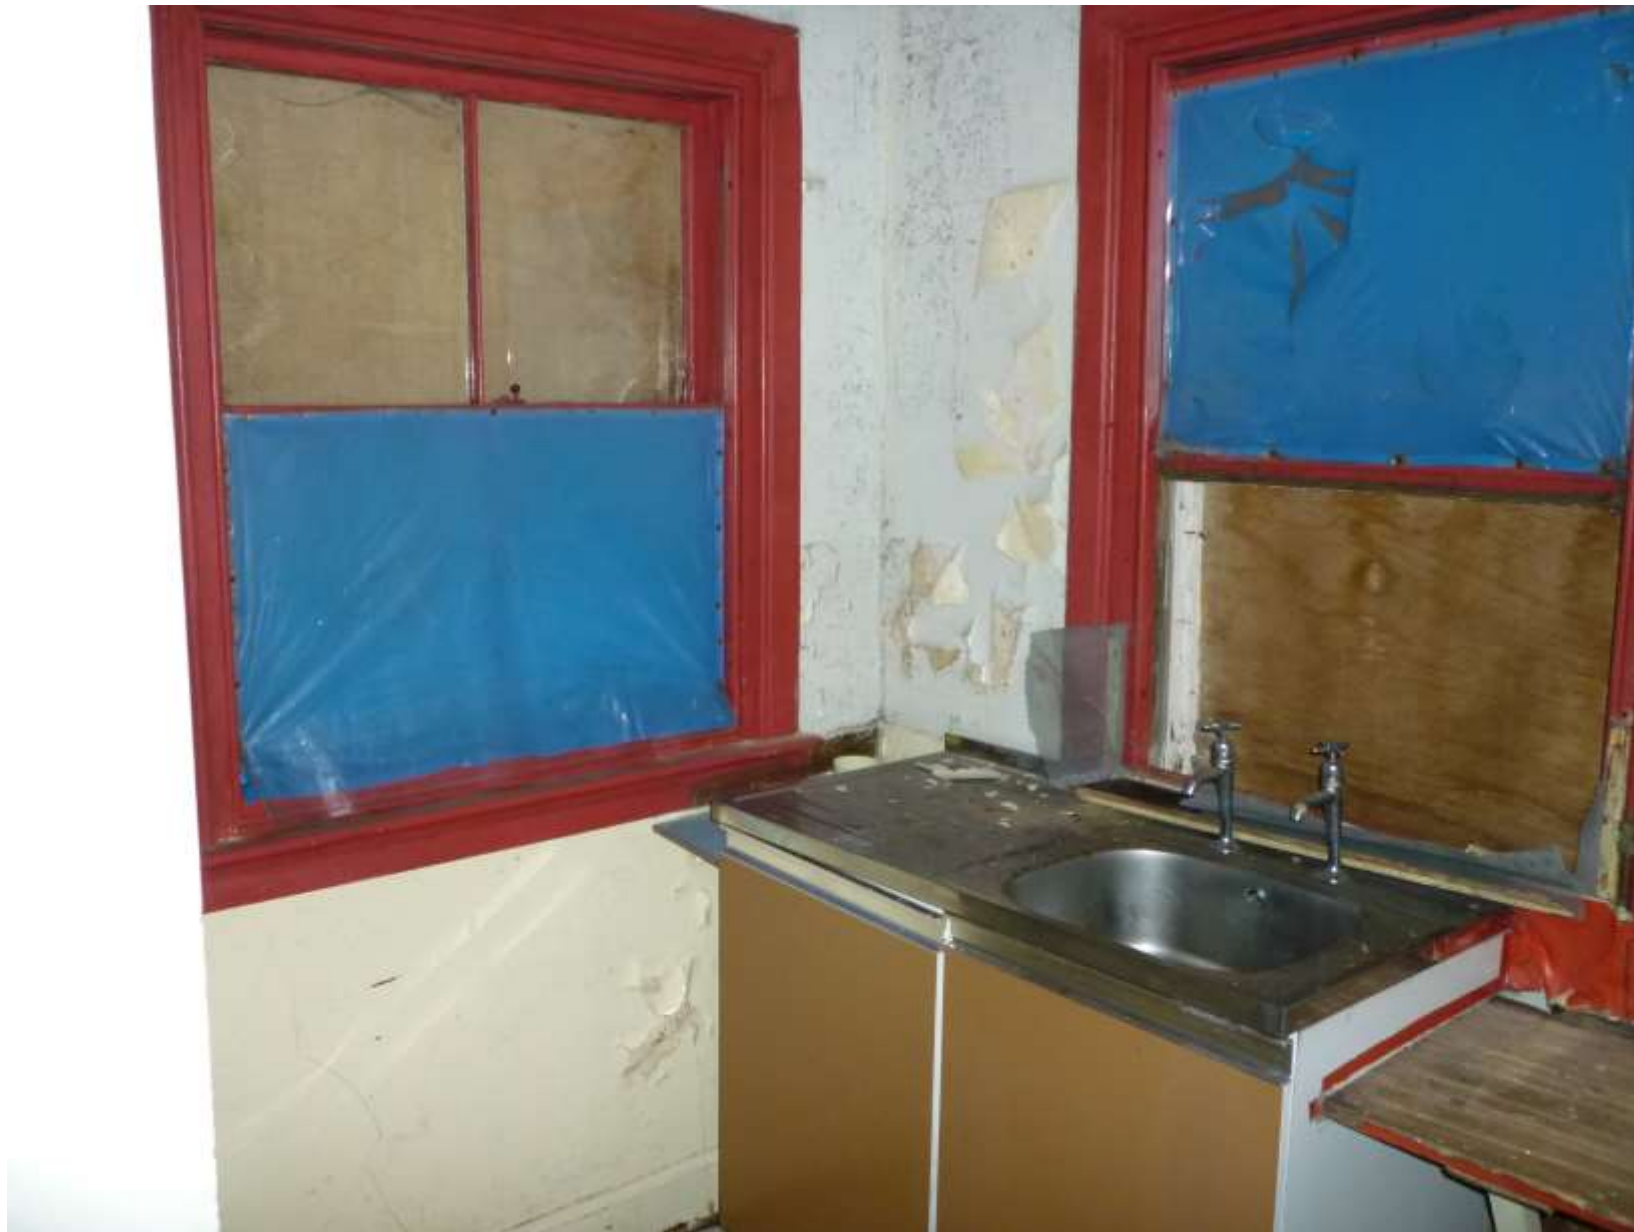
12. East elevation showing detail of scullery annexe, added at unknown date. Behind the damaged render it can be seen that this is brick built, unlike the concrete construction of the rest of the building.

78. Scullery annexe, NE corner (#15). This part is within the small annexe shown from the outside in pic 12.

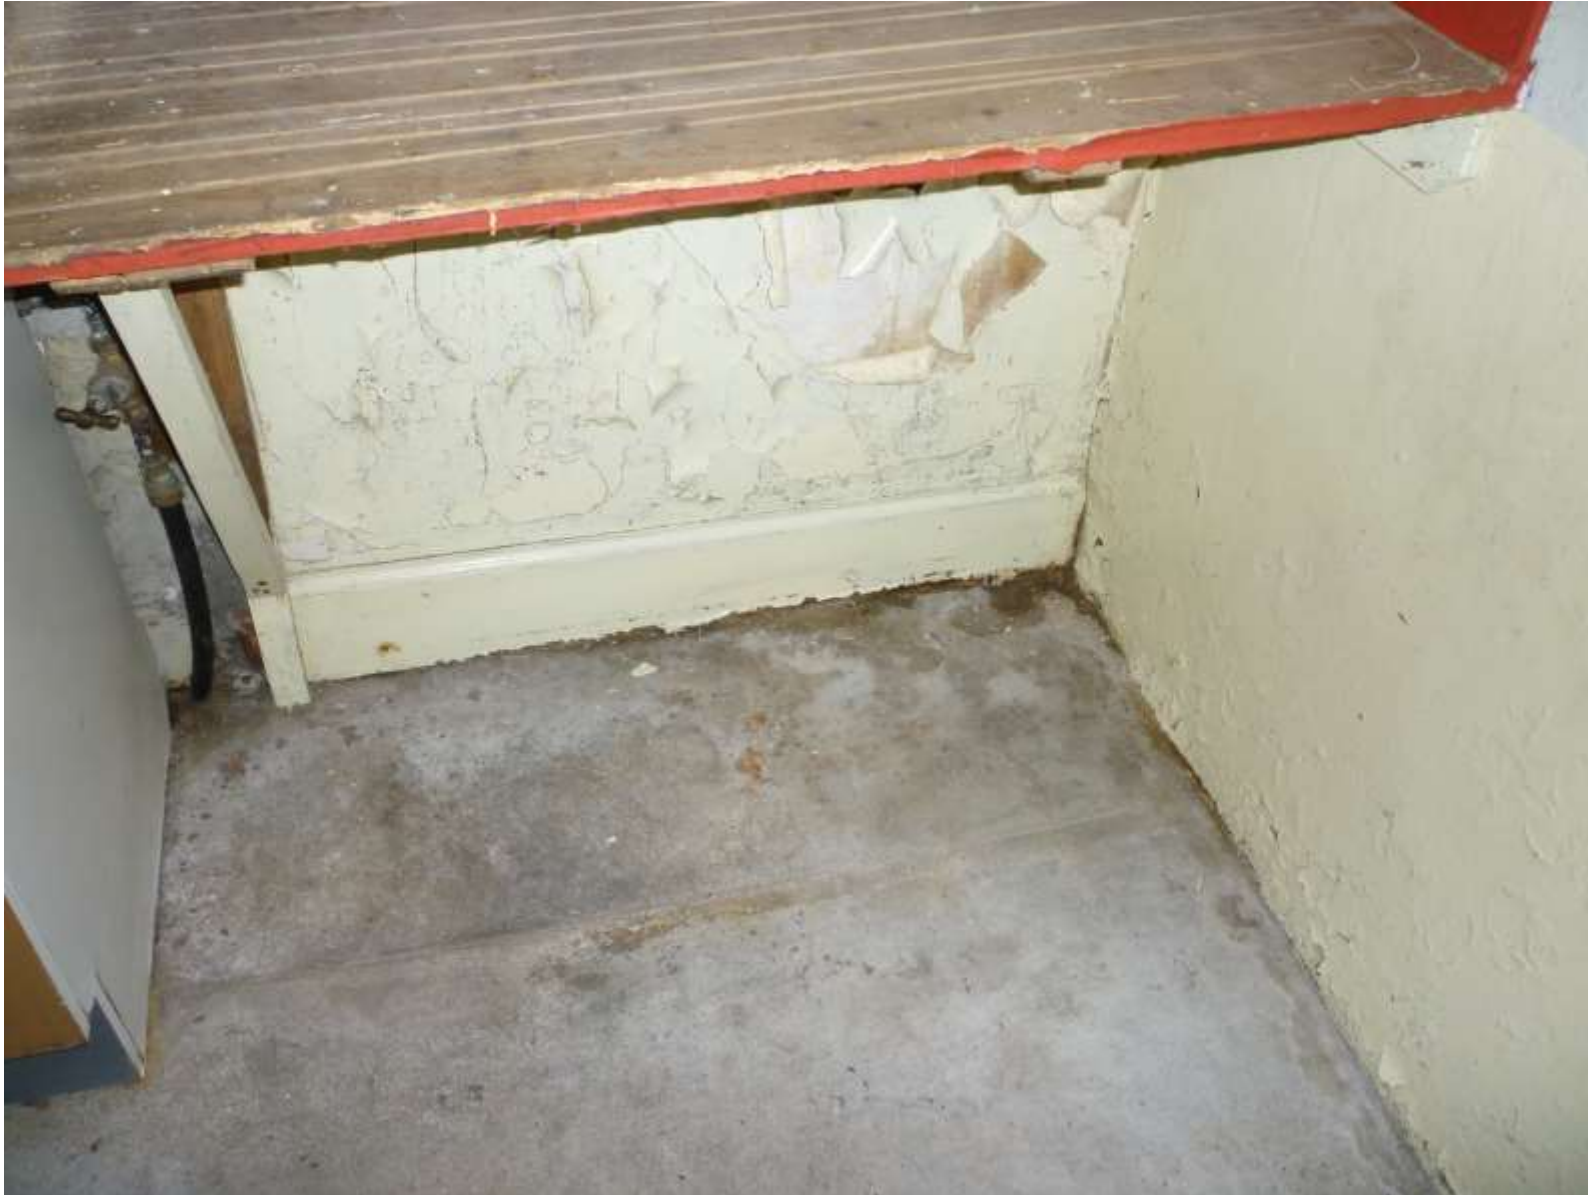
80. Scullery annexe, SE corner, detail of floor and skirting

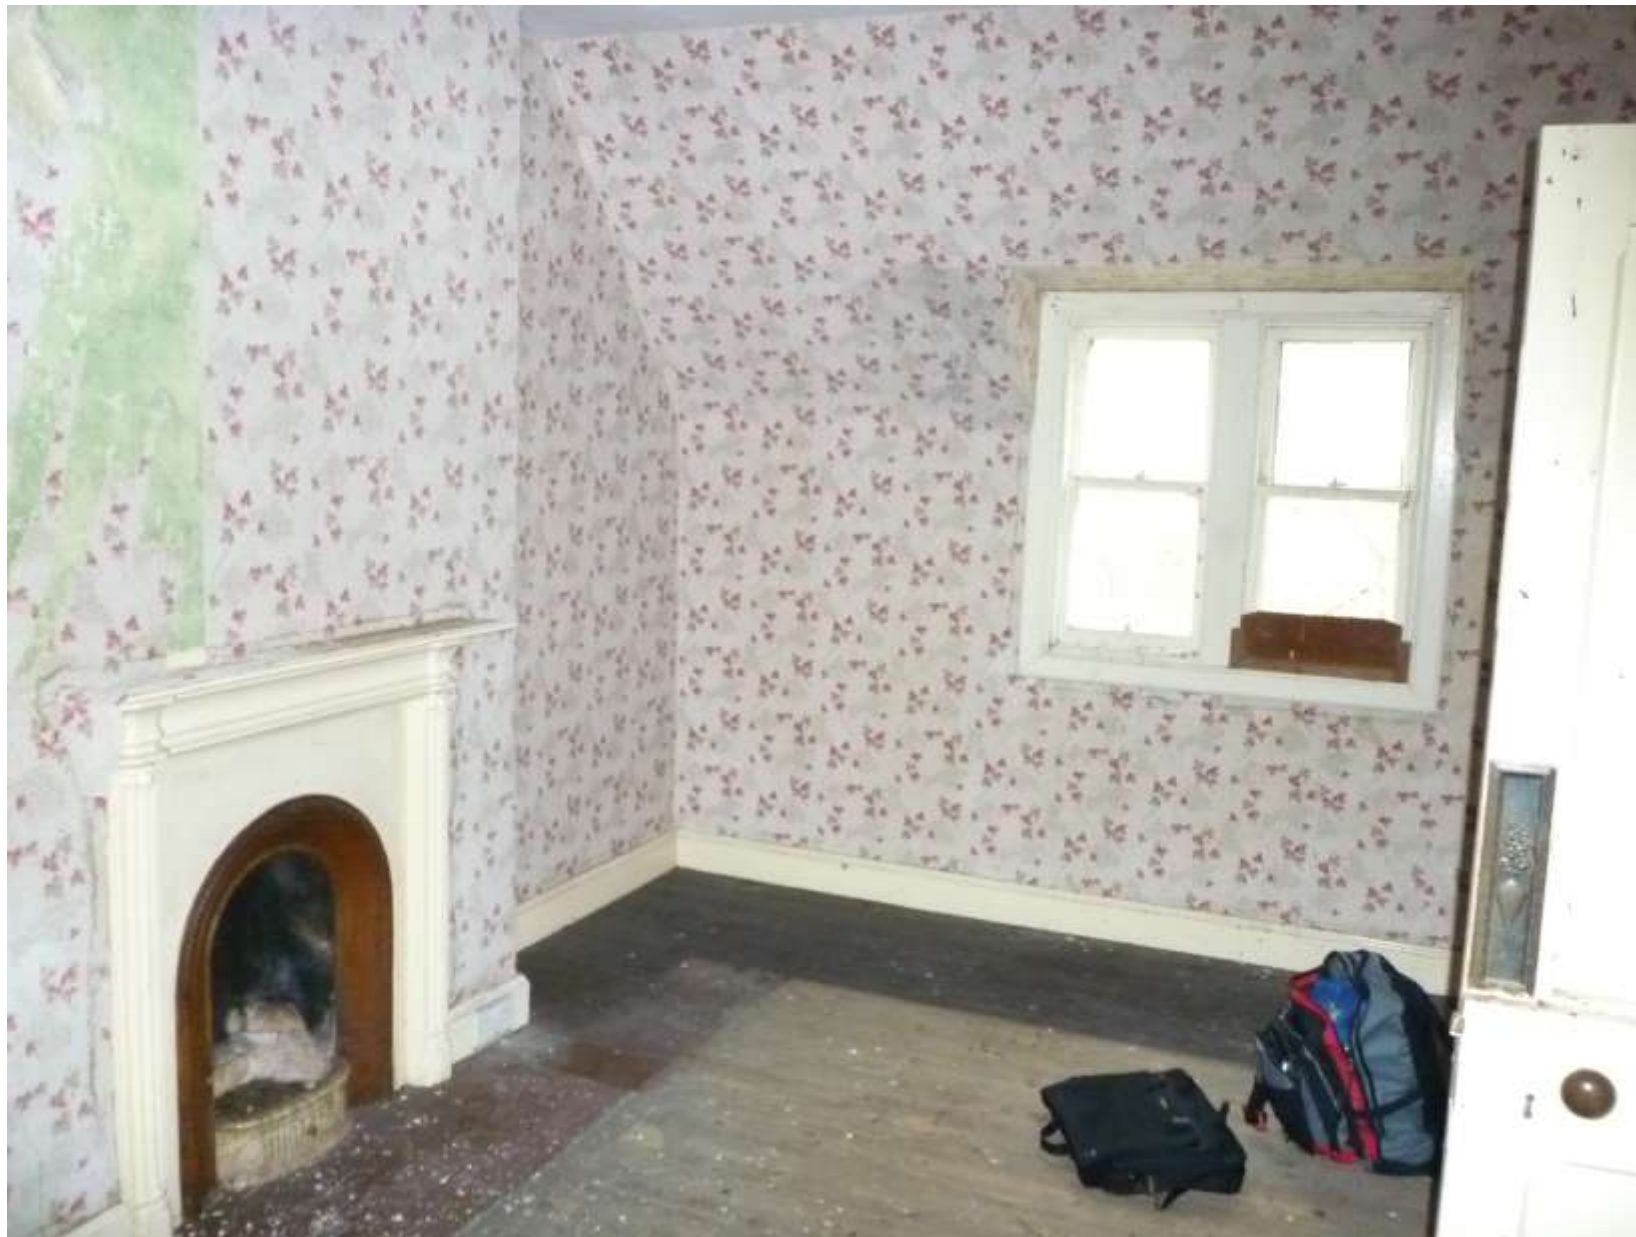
87. Bedroom 2, SE corner

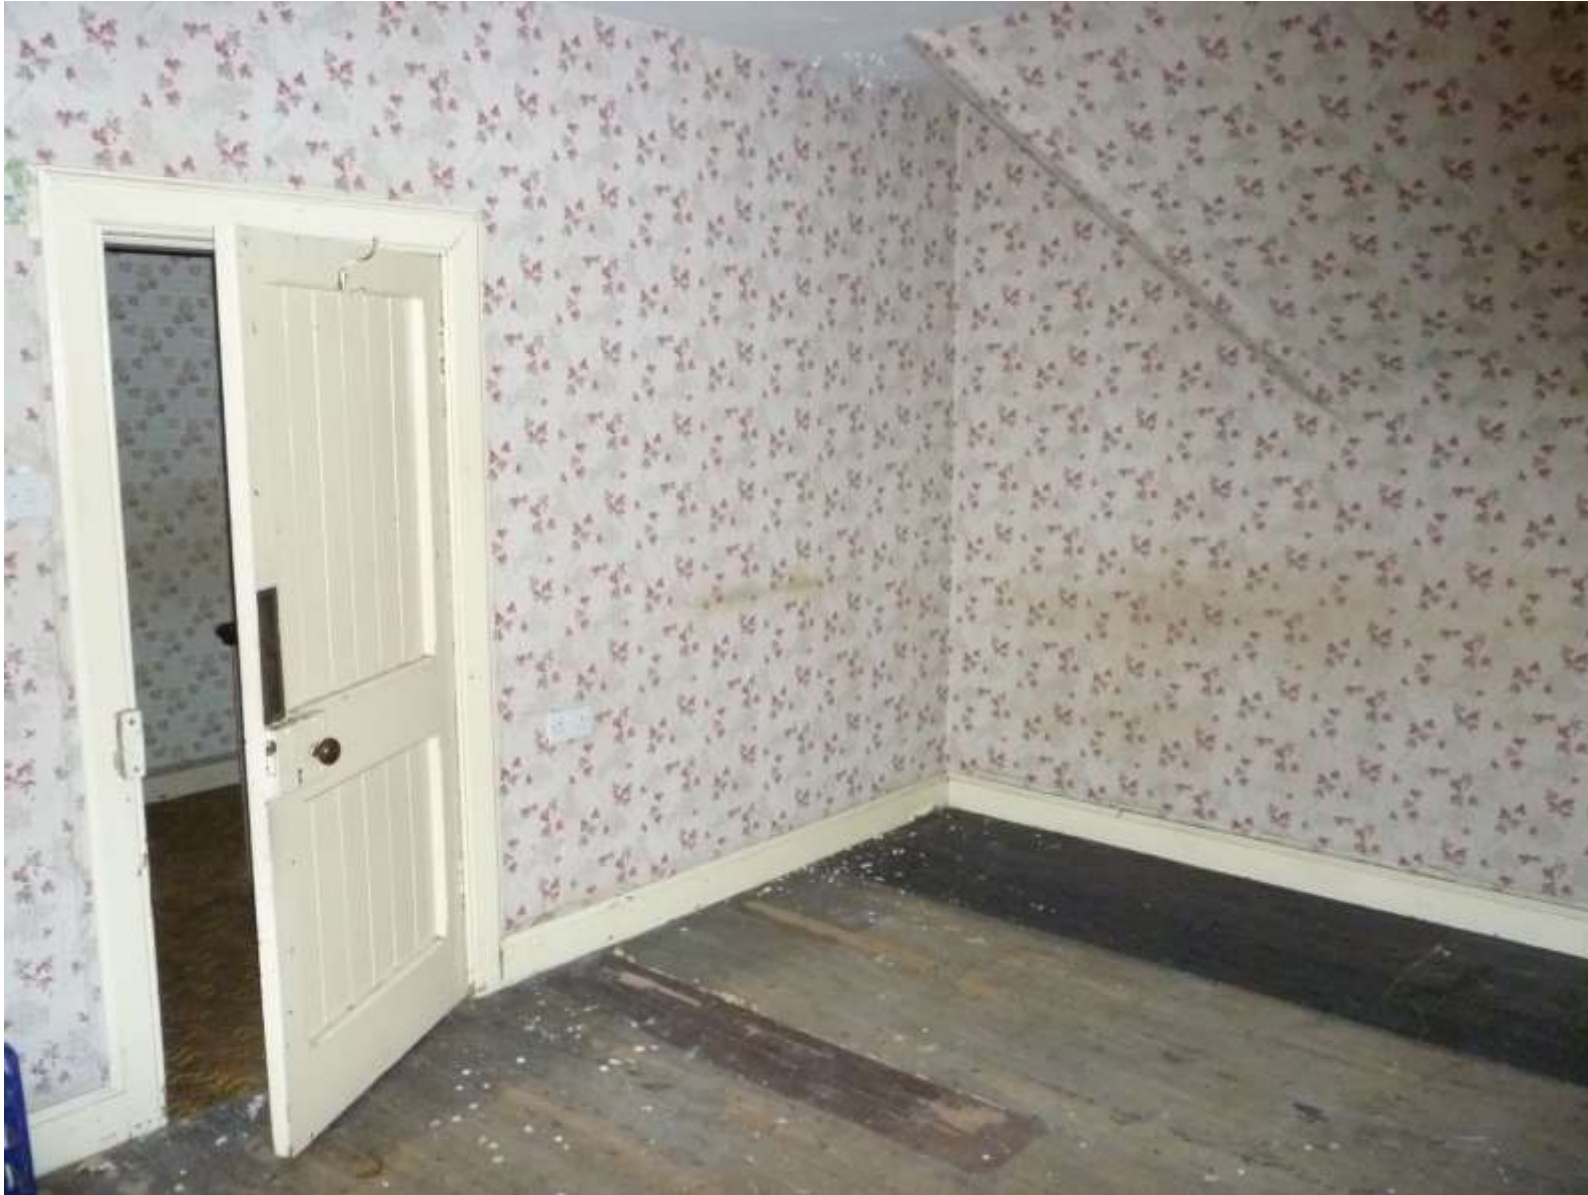
88. Bedroom2, NW corner

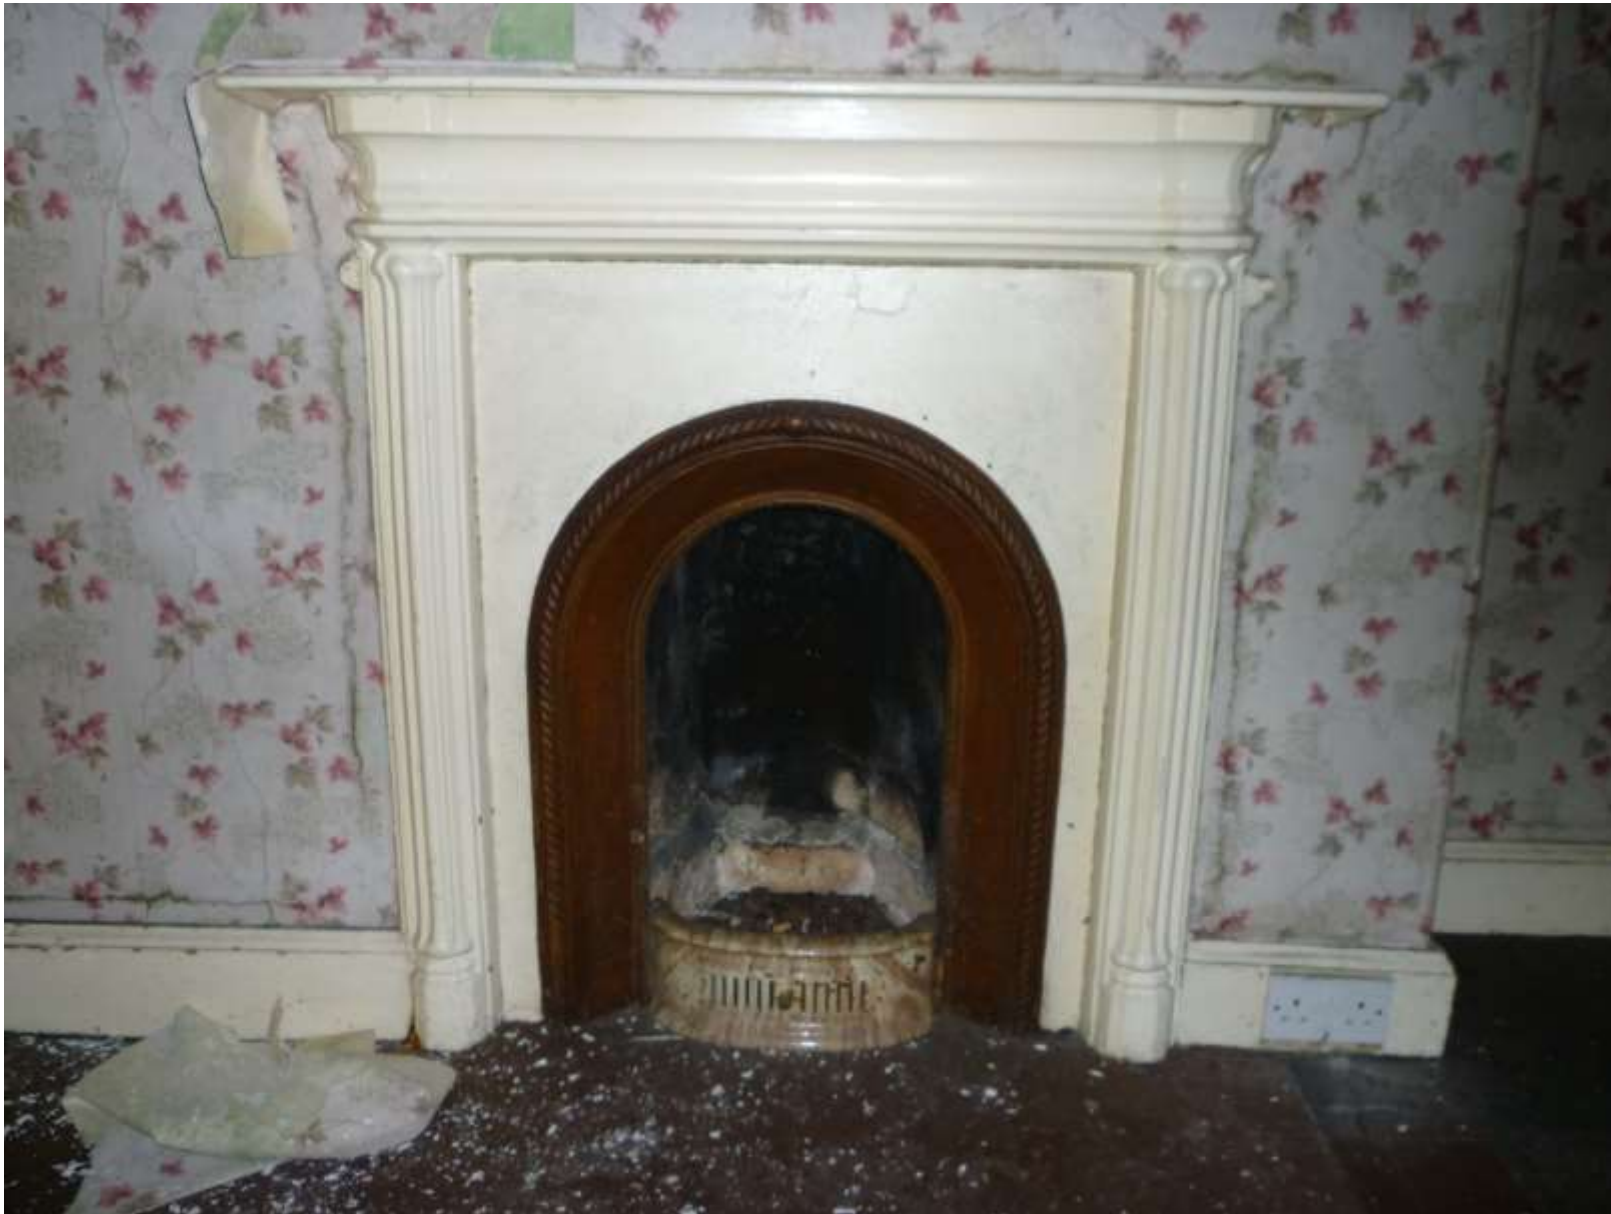
89. Bedroom 2, cast iron fireplace (same model of fireplace in bedrooms 1 & 3)

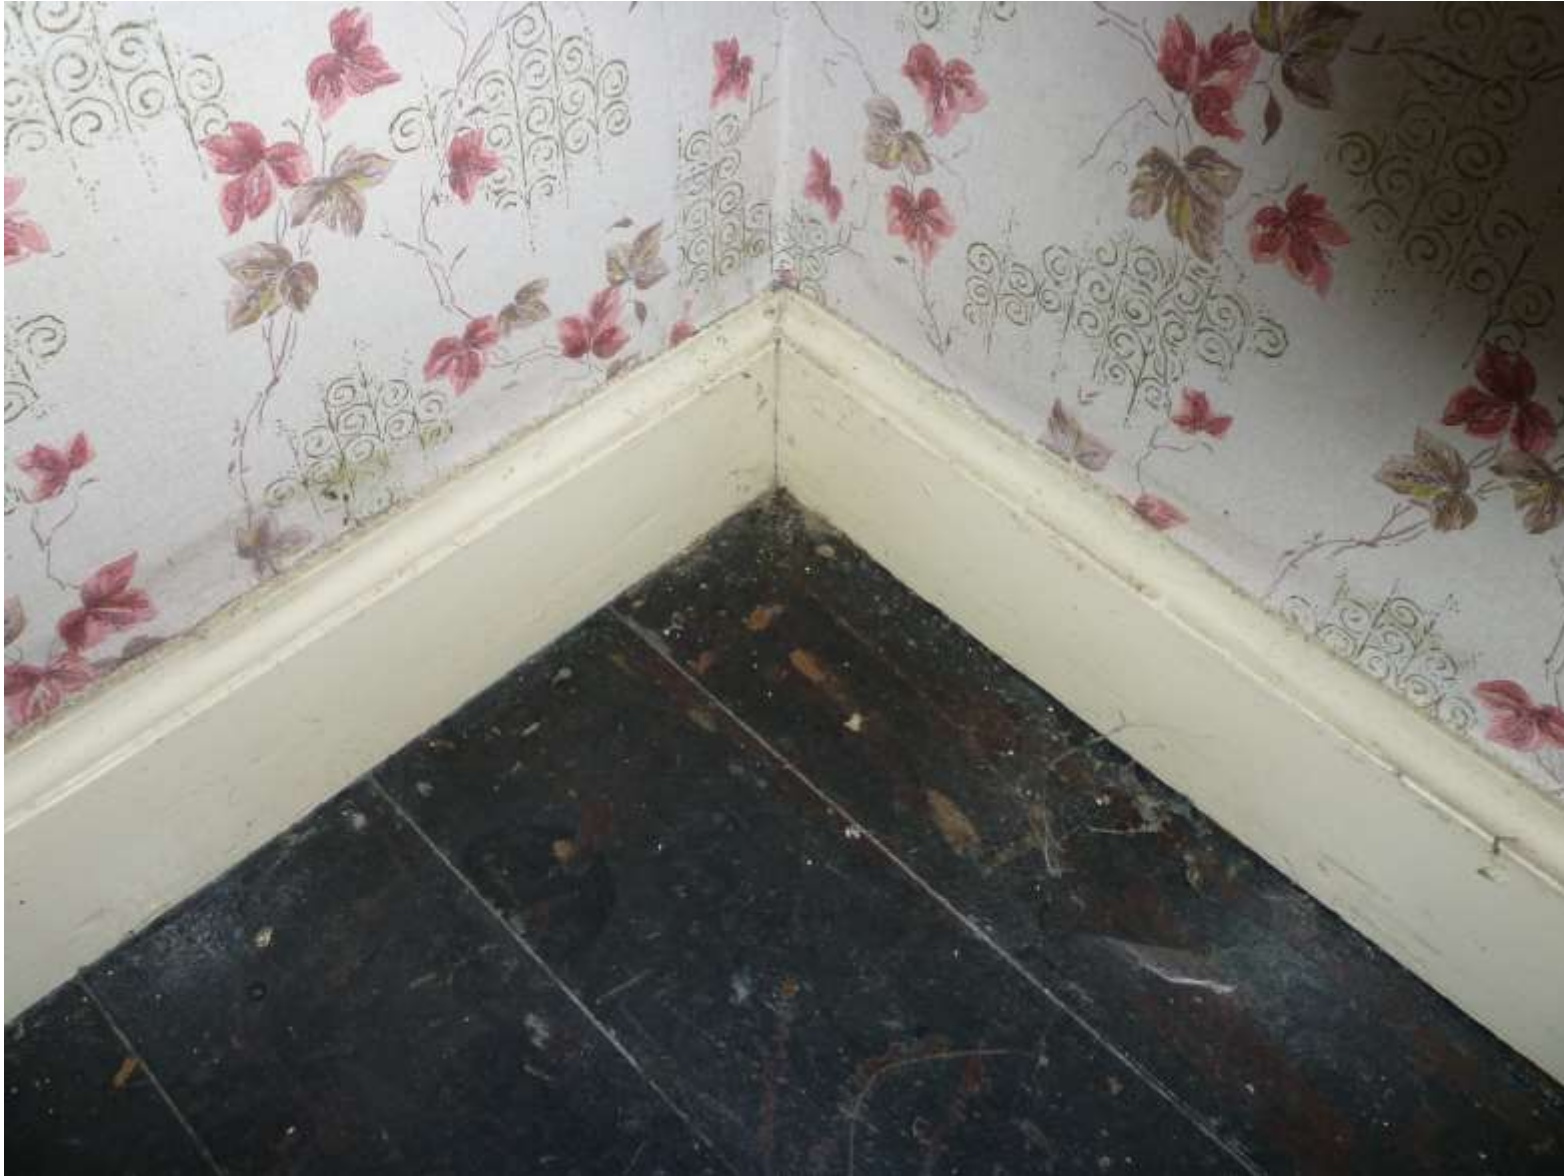
90. Bedroom 2, skirting and wallpaper

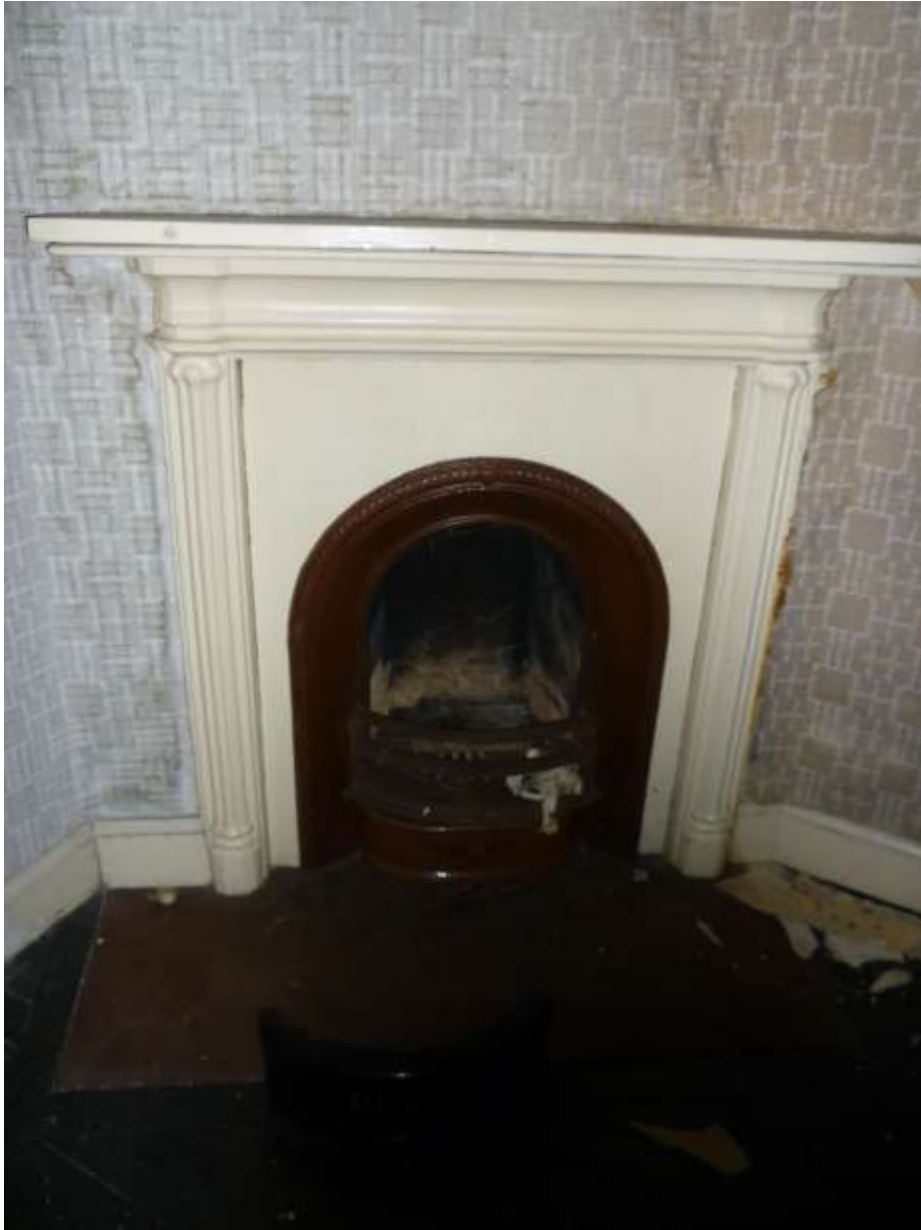
98. Bedroom 1, fireplace
