Helmsdale Station Building

Photographic Record, March 2013

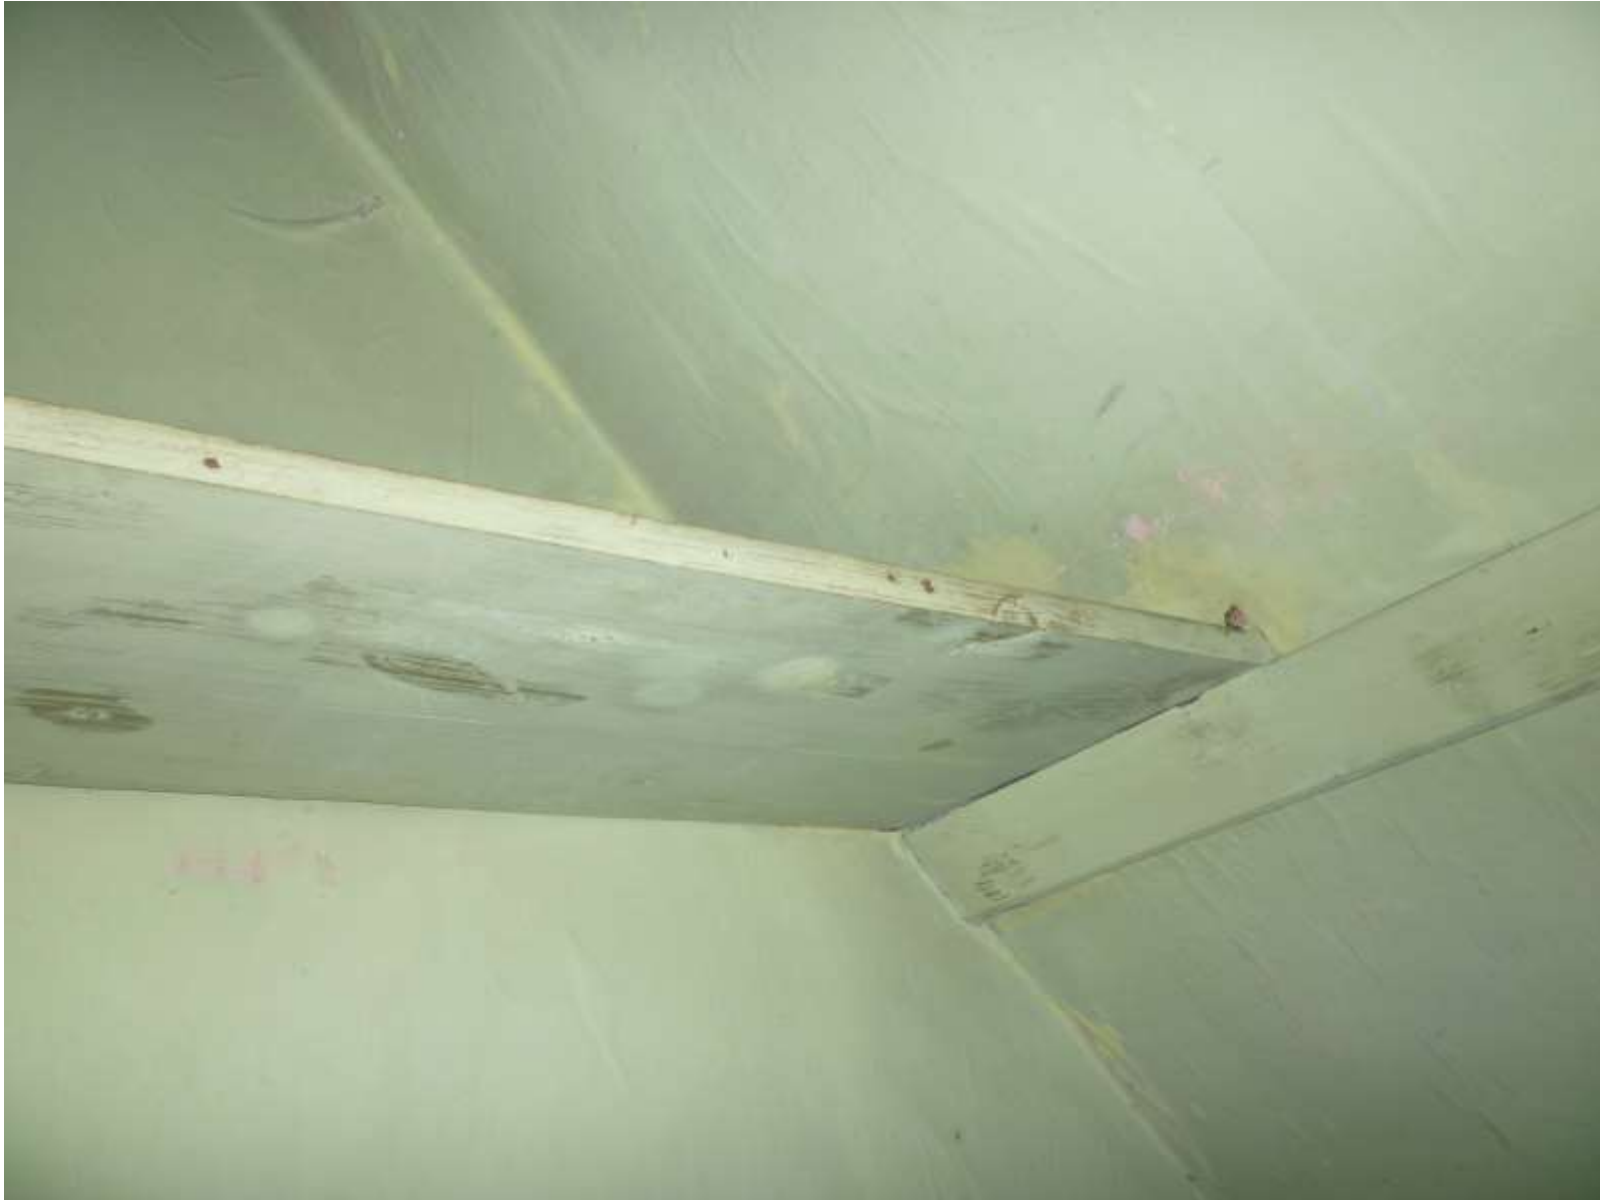
107. Storage area off landing outside bedroom 3, east side (#18)

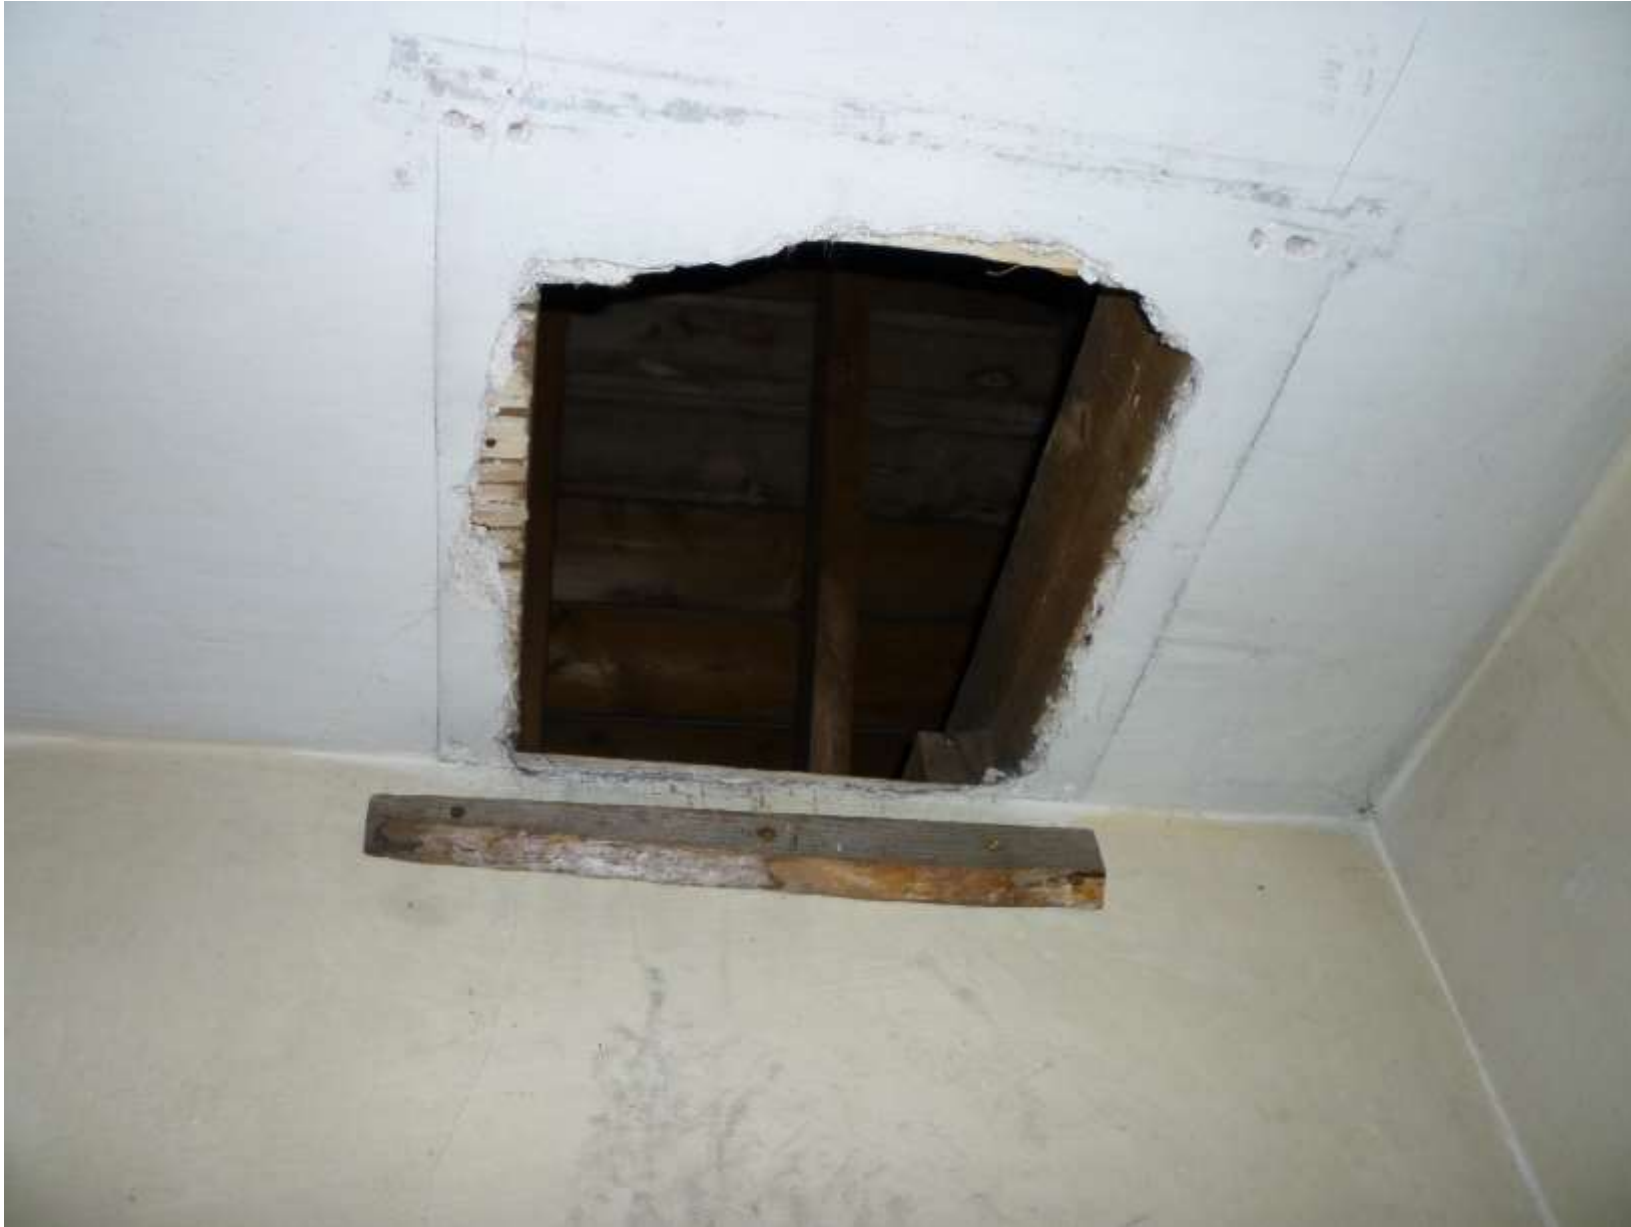
109. Looking out of storage area east, off landing outside bedroom 3 across corridor to door of storage area west

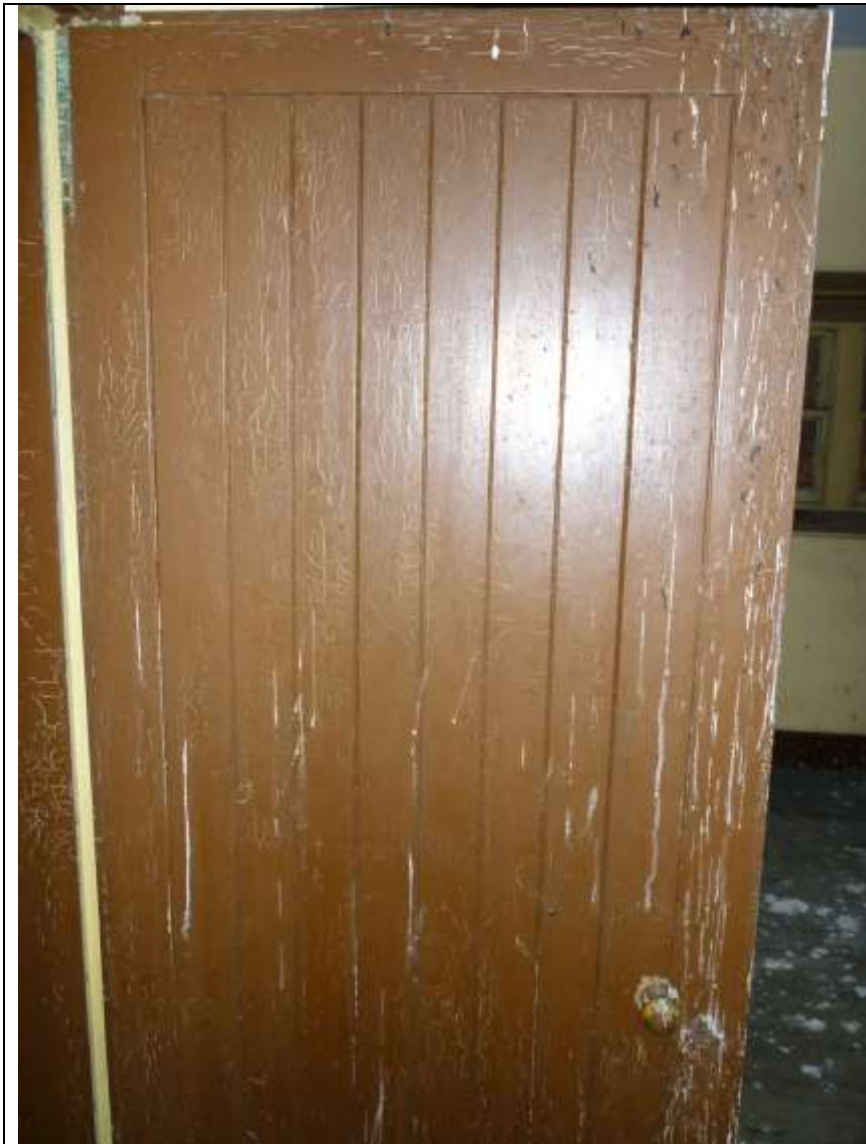
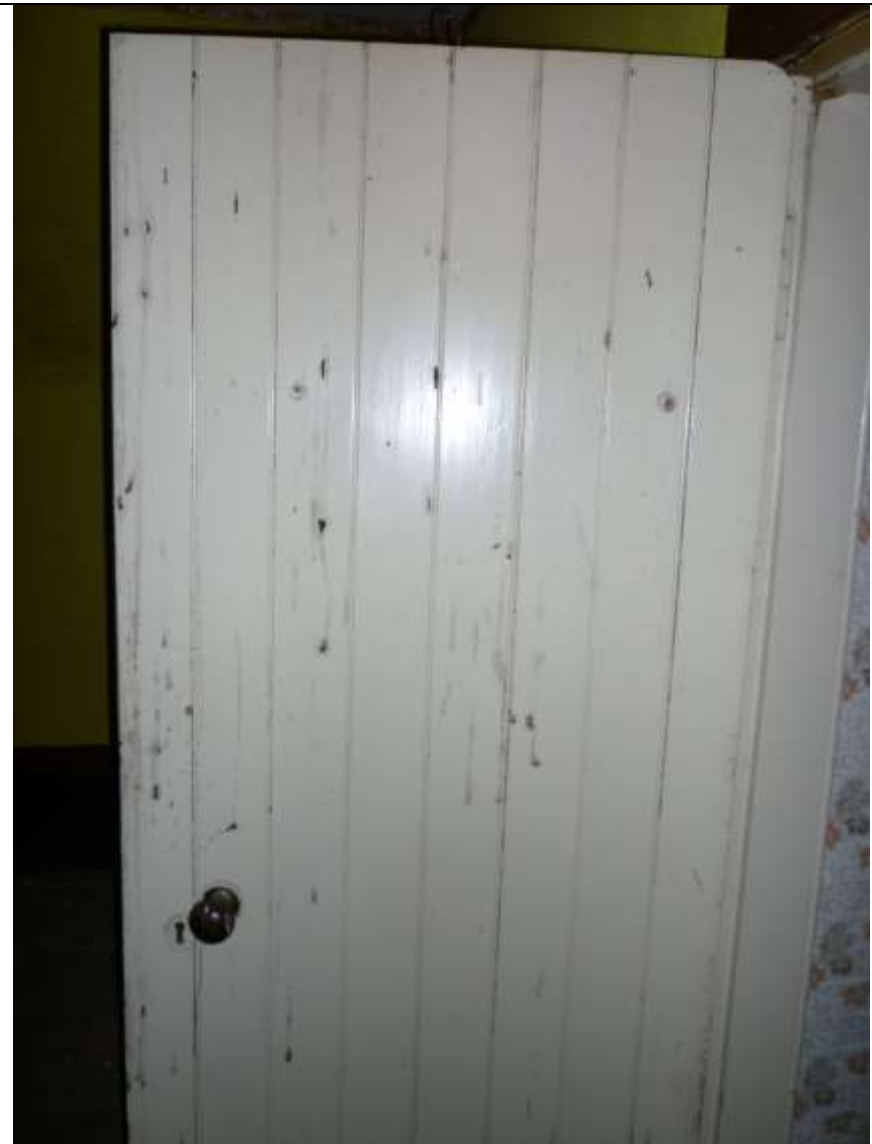
118. Comparison of interconnecting door between bedroom 3&4 (left, 8 boards with flush frame; viewed from bedroom 3 side) and other standard pattern internal doors (right, 8 wider boards on front to frame) confirming that this door is of a later date

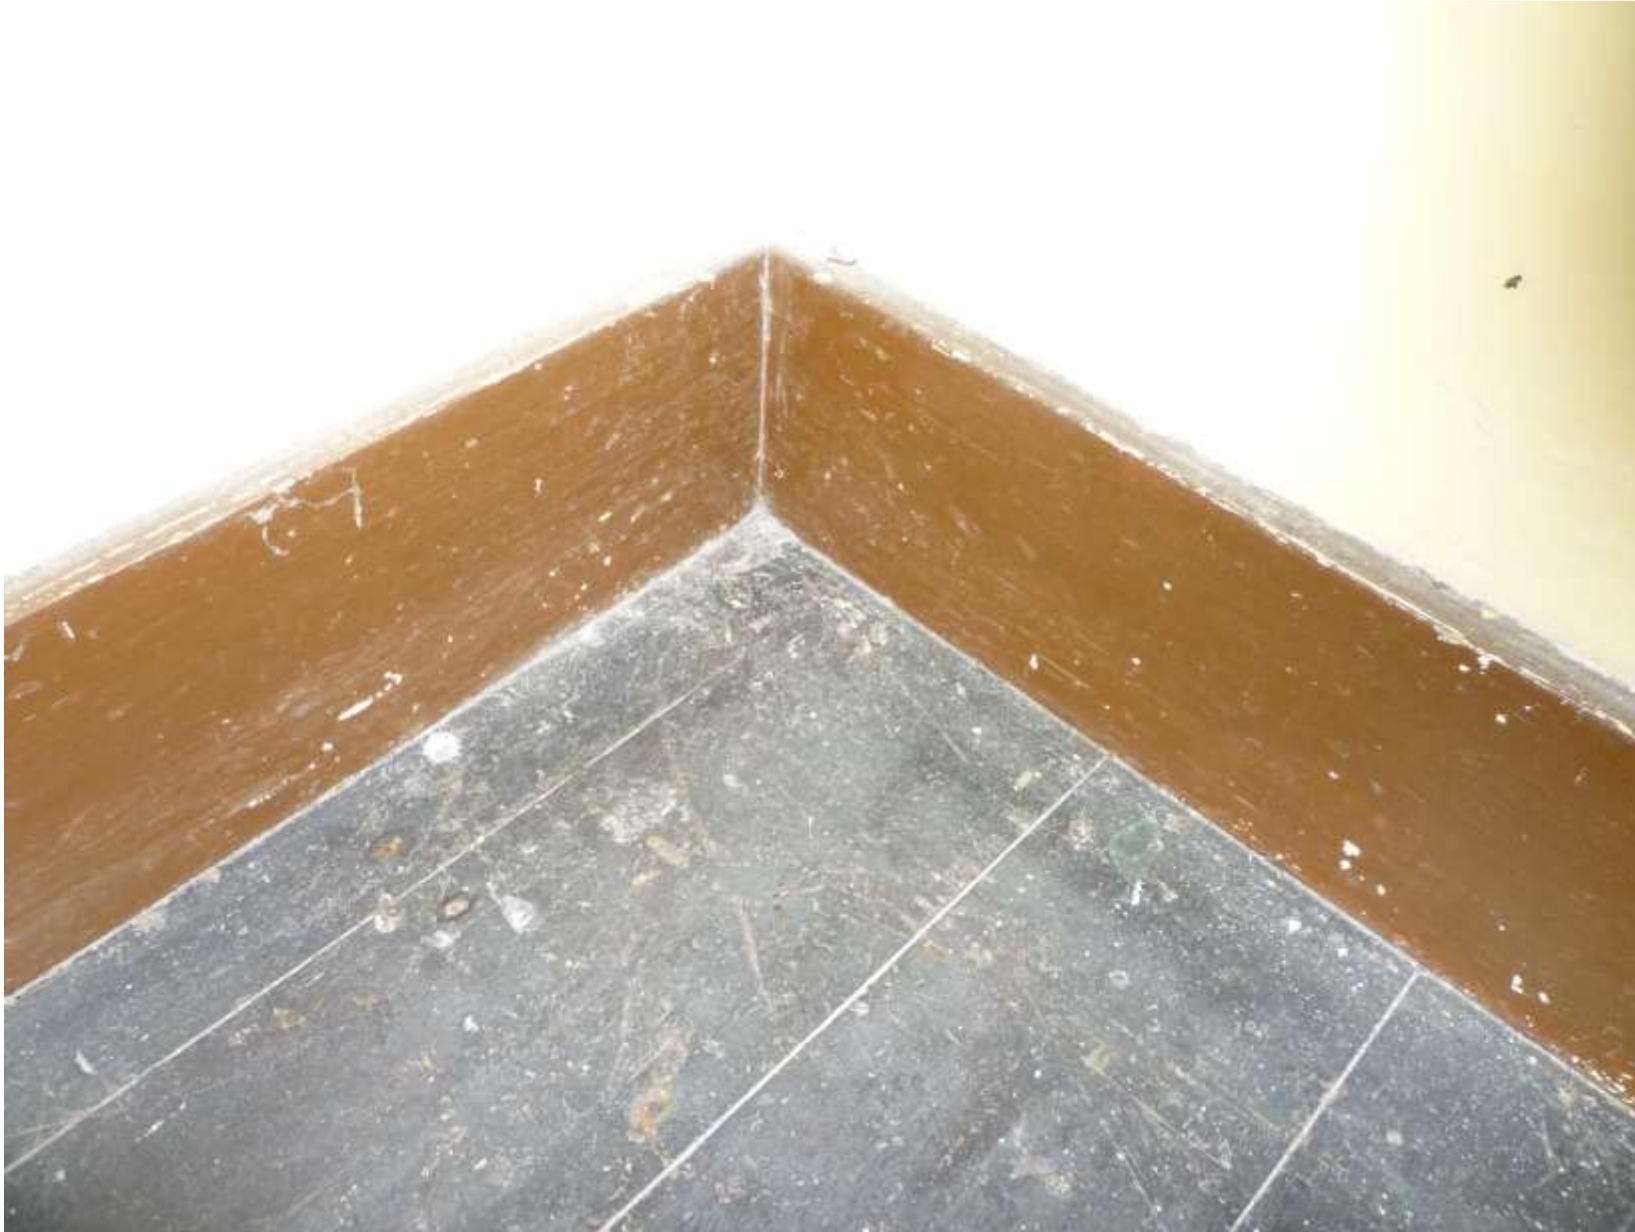
119. Skirting in bedroom 4 (only accommodation room with plain, no moulding, skirting board)

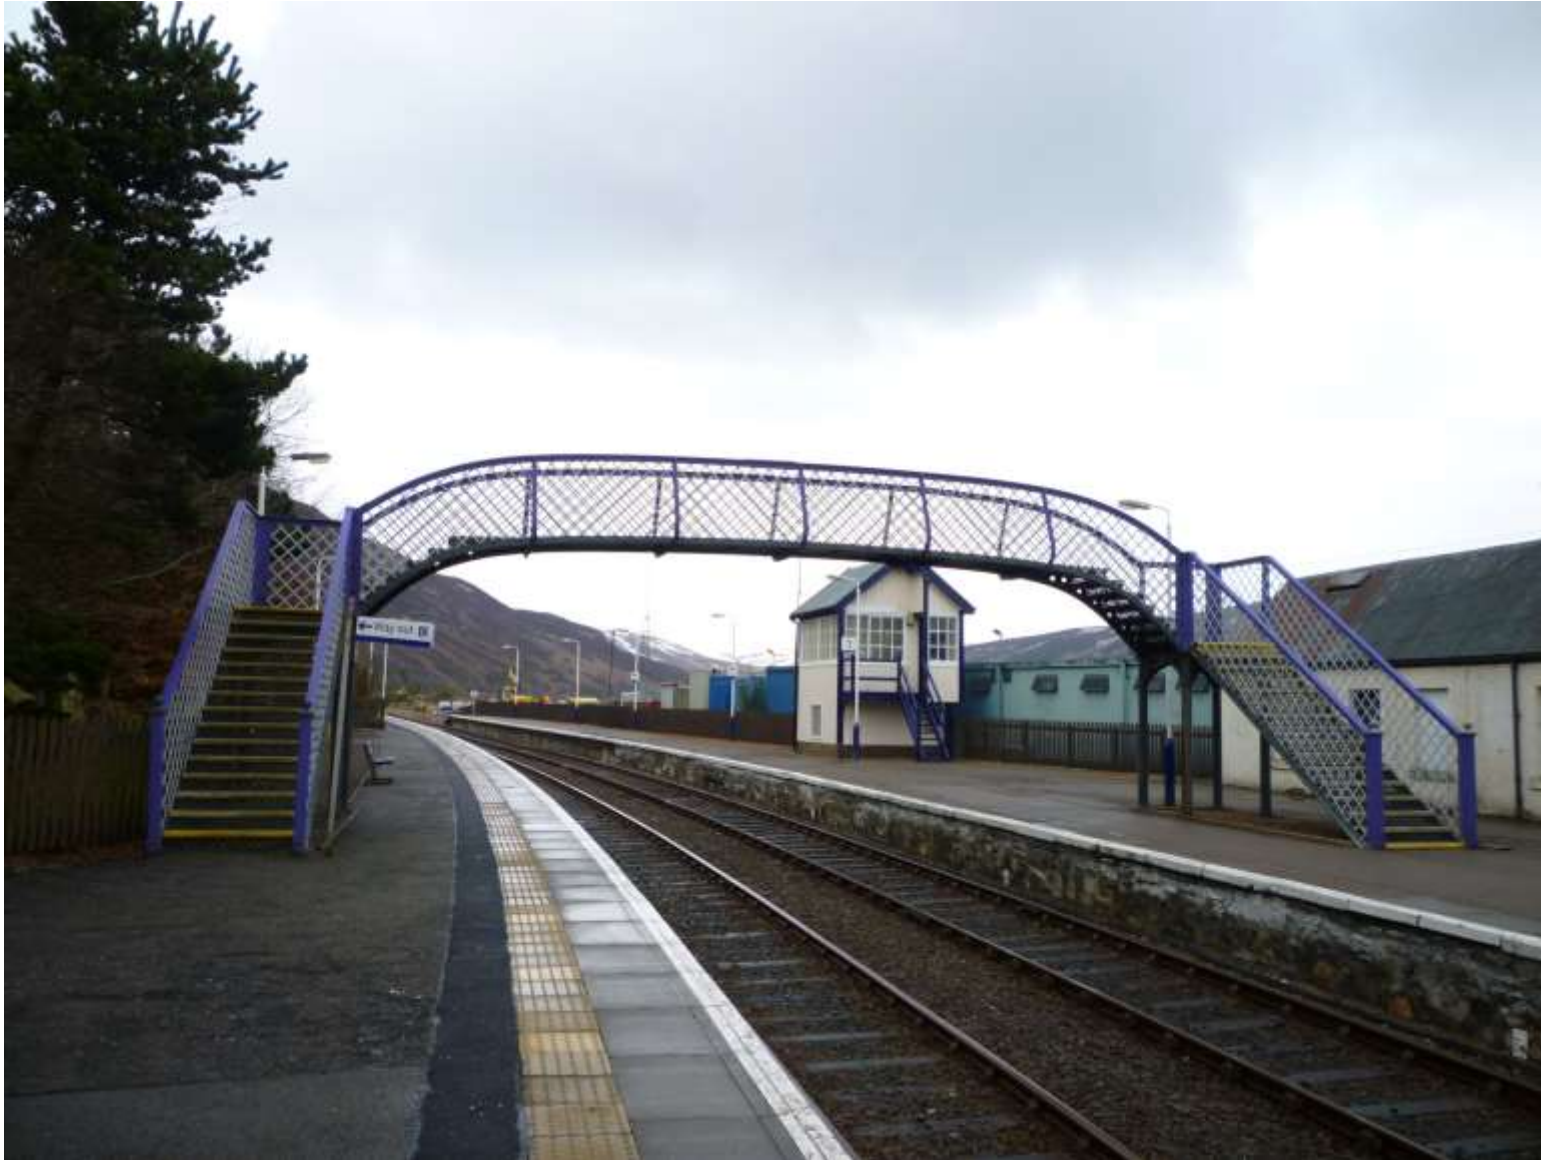
120. Footbridge and signal box which form a category B listed group with the station building

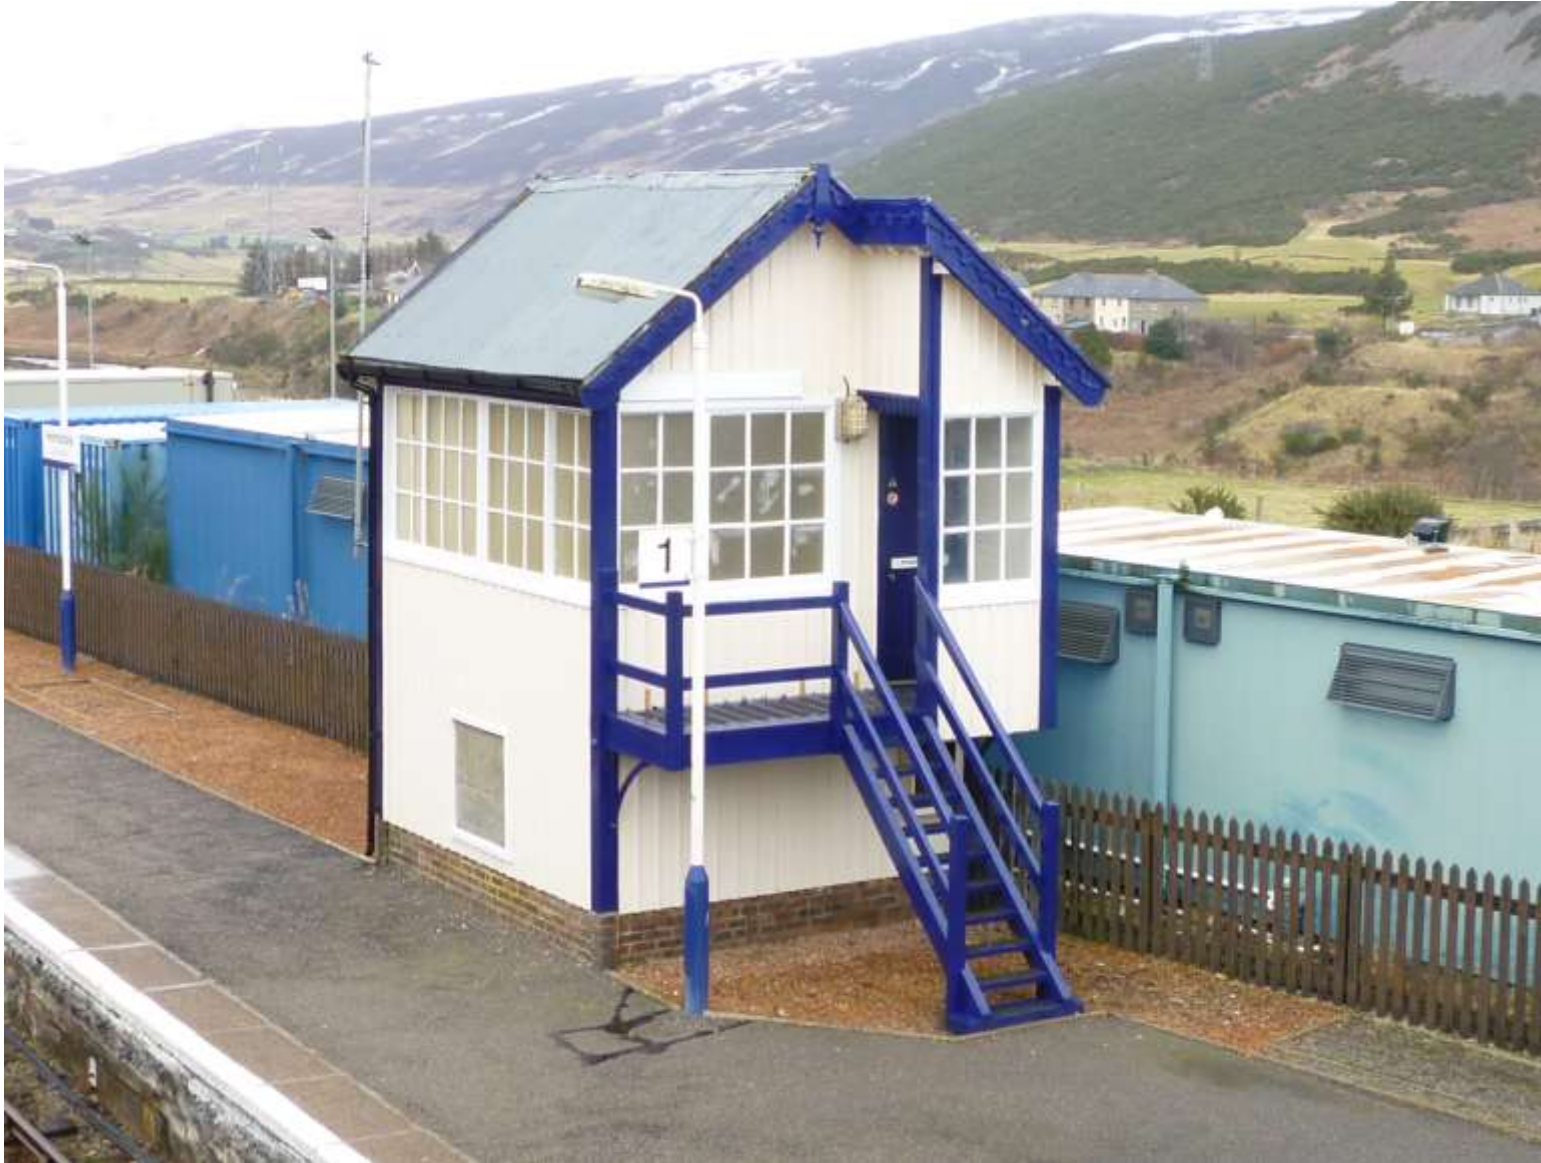
121. Closer view of signal box. Restored and repainted by Network Rail in 2011 (still in use for storage and telecoms equipment)
